Buildings at Risk

2013

Building at Risk

North Dorset District Council

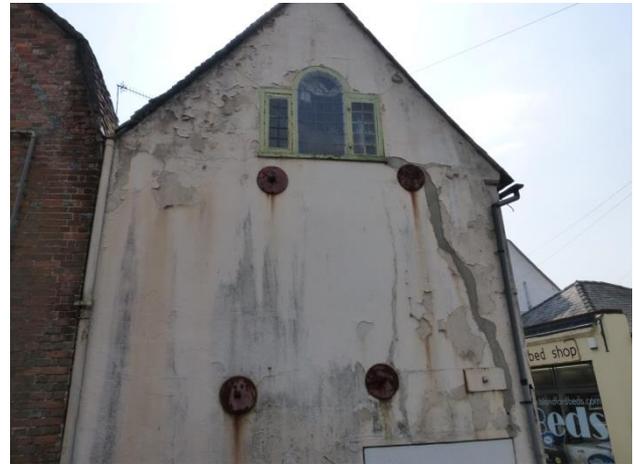
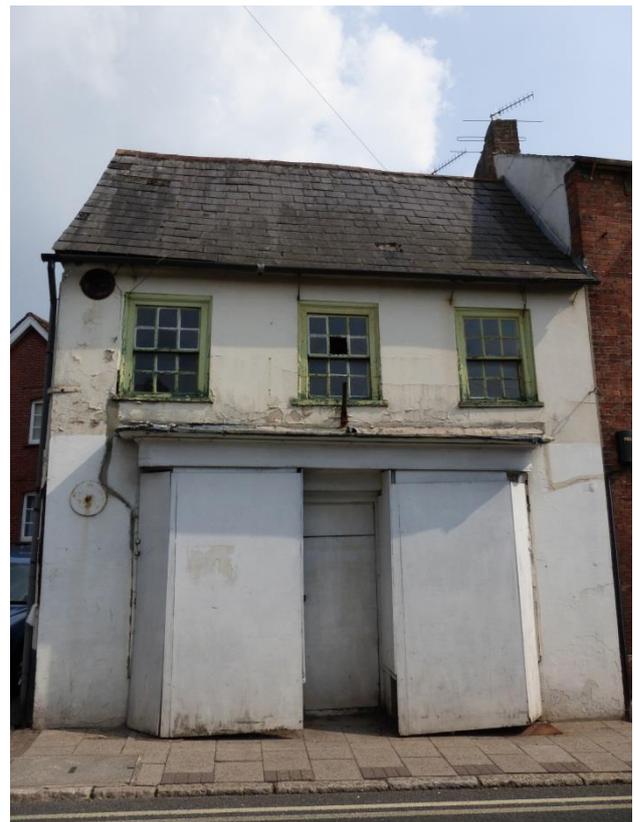
Condition:

Walling: Clear evidence of movement with large cracks appearing, it appears bracing is failing across whole of gable wall, some evidence of poor remedial work.(poor)

Joinery: Poor state of repair of all windows. Lead and glazing of Venetian window appears in good condition, but frame is poor.

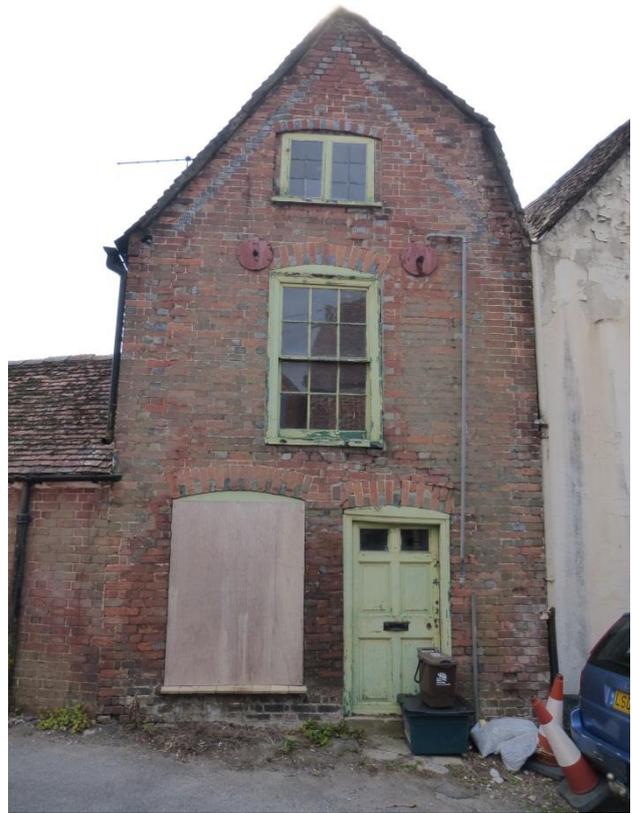
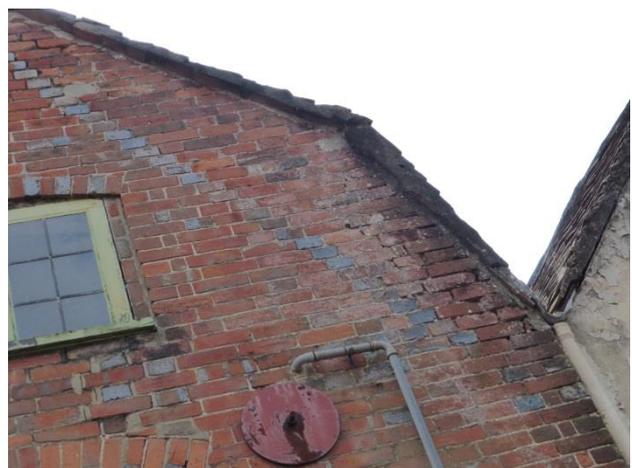
Walling: Evidence of movement butting number 52, especially mansard side and above segmental arch of door (poor). Evidence of deterioration since 2010.

Joinery: Rotting woodwork and decoration required (poor)

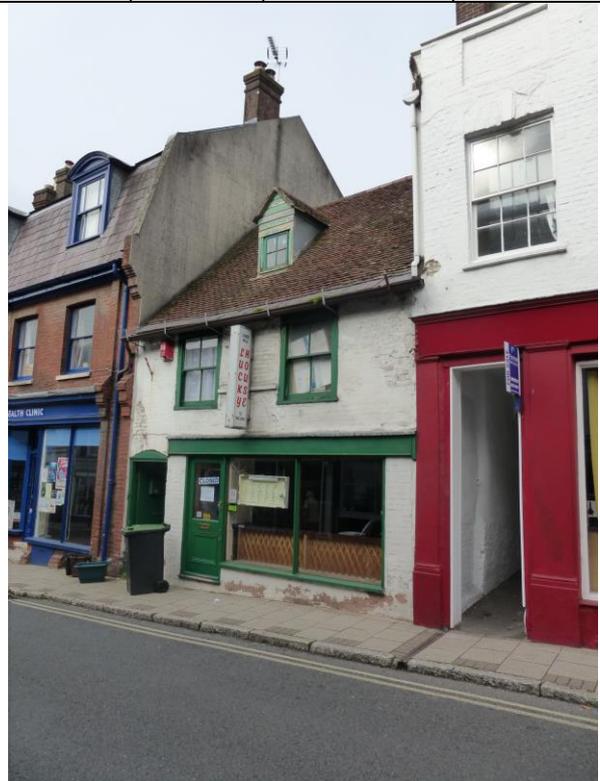
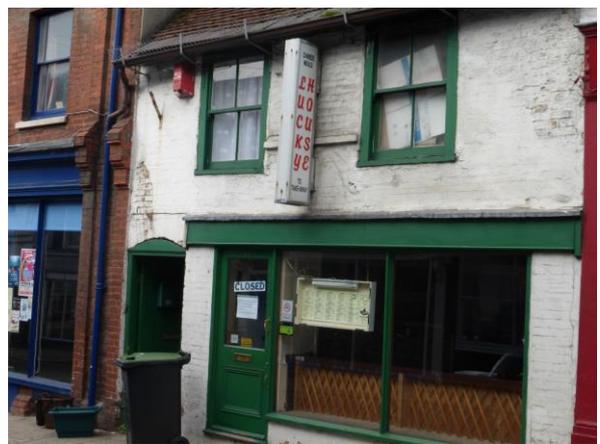
Walling: Fair – some cracks appearing where the structure meets the neighbouring buildings. Decoratively poor.

Pointing: Some missing or loose mortar around the windows but generally fair

Joinery: Some weather damage, especially to the dormer

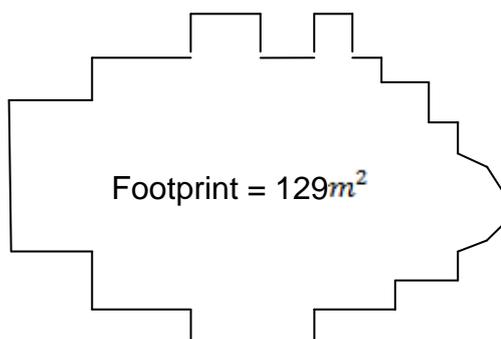
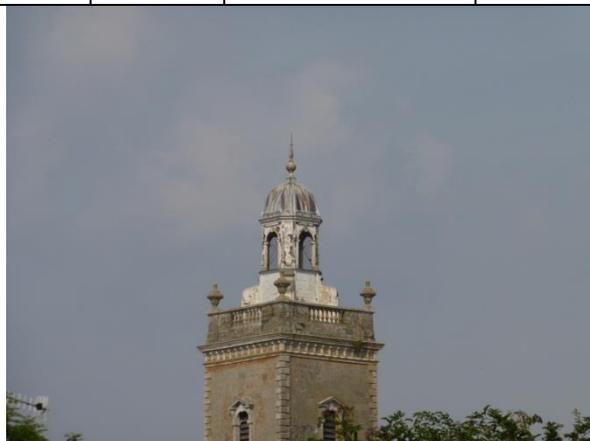
A visual inspection of the cupola is difficult due to access but it is clear that it is in a very poor state, the wood work is in need of attention; additionally the north wall which is built of Shaftesbury green sandstone is in an extremely poor condition. On a visual inspection and photographic evidence it is clear that the wall is de-laminating at several points and urgent attention is required. Pointing generally fair but gaps on south wall of chancel.

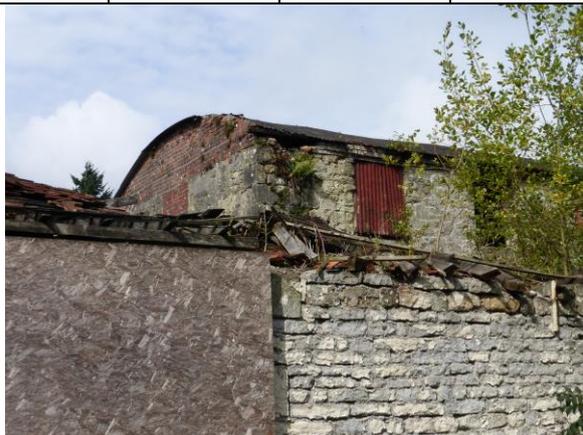
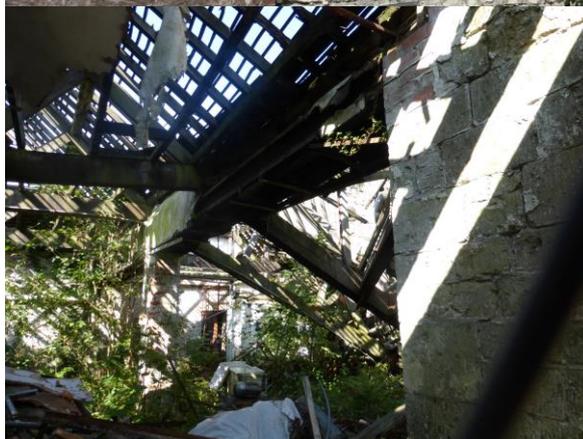
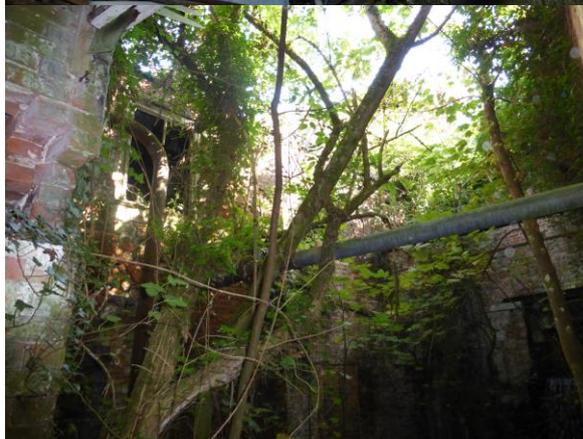
Roof: Very poor, with areas of total collapse. Other parts very unsafe.

Walling: 1820 structure is rubble and ashlar. Adjoining machine house with water race is brick. Significant damage brought about by exposure to the weather and vegetation growth.

Joinery: Most windows and doors are boarded or missing. Any remaining frames are in a poor condition.

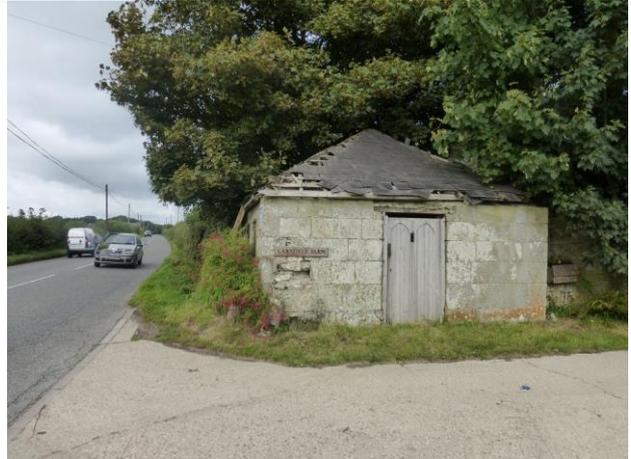
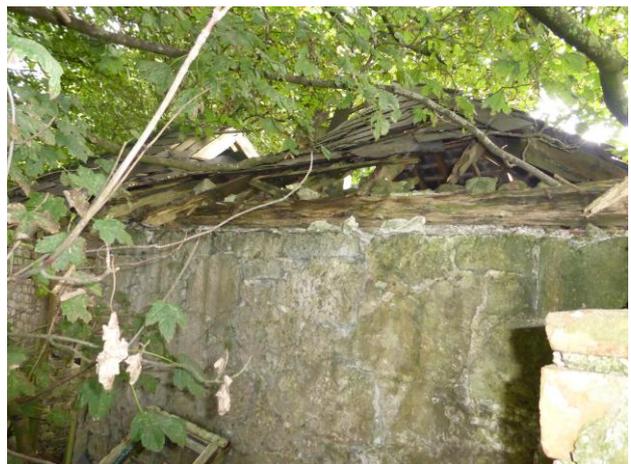
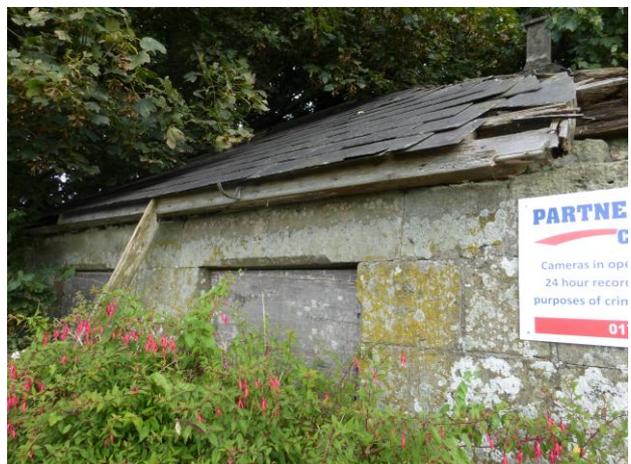
Mid 19th Century Lodge (formerly one of two) constructed of dressed Shaftesbury sandstone possibly from the quarry at Upjohn which was in use until 1888. The roof is a two part hipped style with a bed of slate. There is considerable vegetation growth at the rear of the building, causing further damage to the roof.

Walling: Top of rear collapsed, some minor damage at front, wooden lintel is in extremely poor condition (poor)

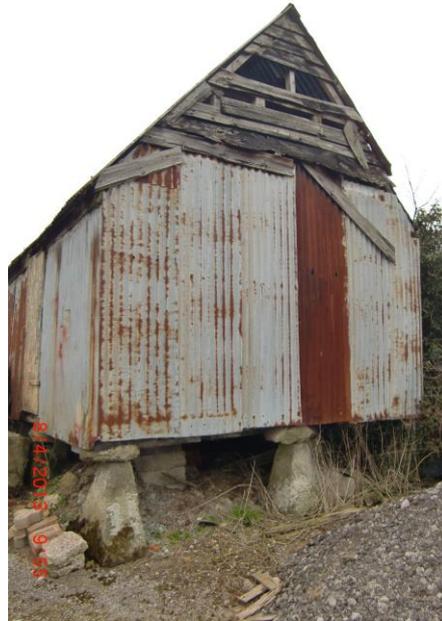
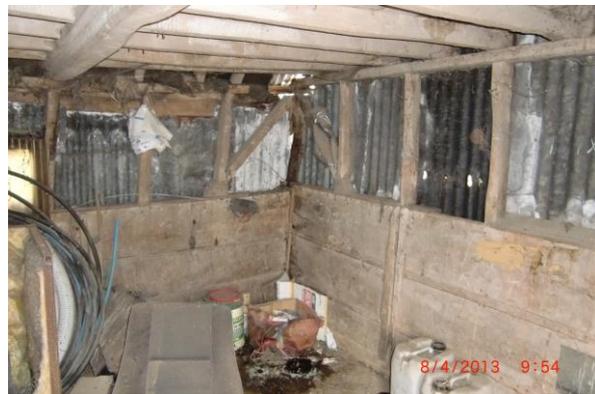
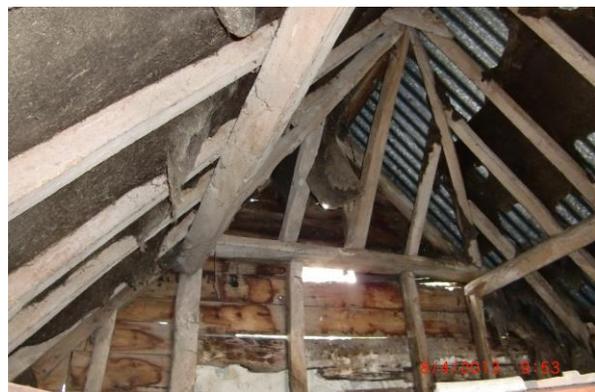
Roof: Pitched corrugated sheeting (signs of some decay).

Walling: Corrugated sheeting. Weather-boarding on the gables rotten and damaged with several missing boards.

Joinery: The timber framing appears in fair condition.

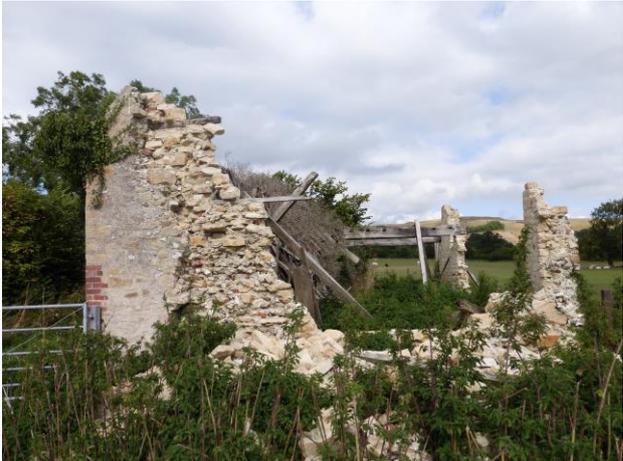
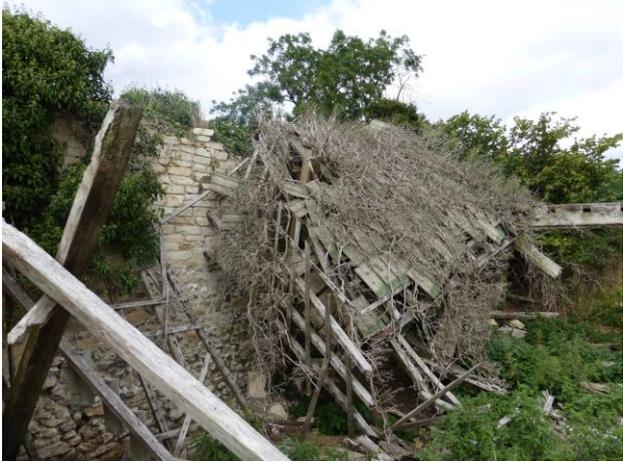
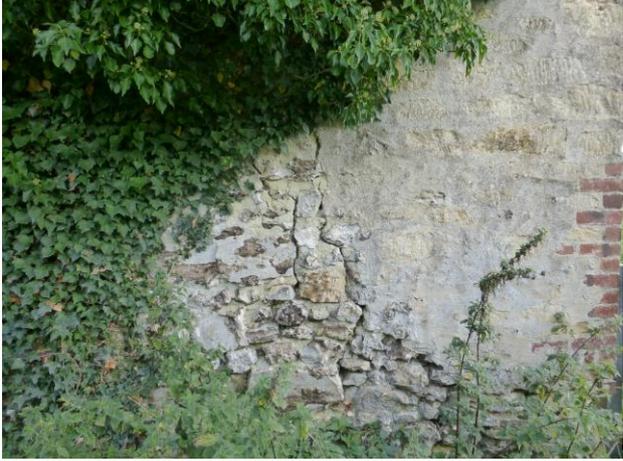
<p>Mid 19th Century Field Barn constructed of Upper Greensand Stone with half hipped roof of concrete tiles, previously of thatch.</p> <p>Since the 2010 survey, the structure has collapsed completely. The stone rear wall has mostly fallen outwards – was this a natural collapse? Without attention, further collapse is imminent.</p>								
Condition:								
<p><i>Roof:</i> NA – all roofing structure has collapsed</p> <p><i>Walling:</i> The rear wall and part of the field side wall have collapsed. The remaining part of the rear wall contains loose rubble and mortar and is very unstable. The track-side wall contains major structural faults.</p> <p><i>Pointing:</i> Various types used, mortar loss throughout the structure (poor)</p> <p><i>Joinery:</i> Extensive damage due to collapse (very poor).</p>

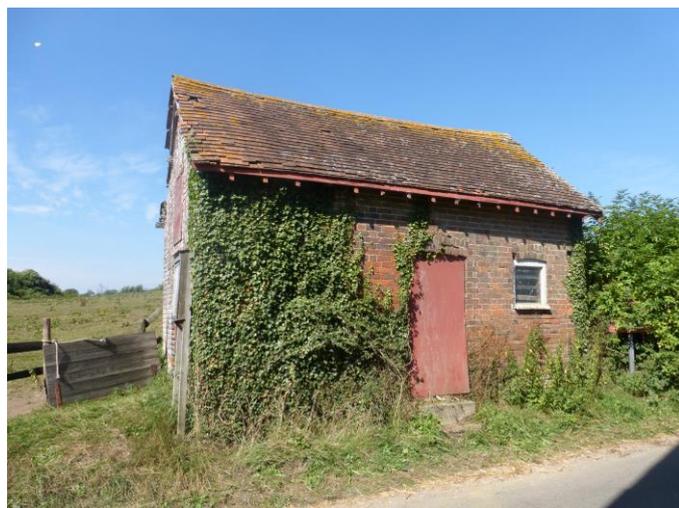
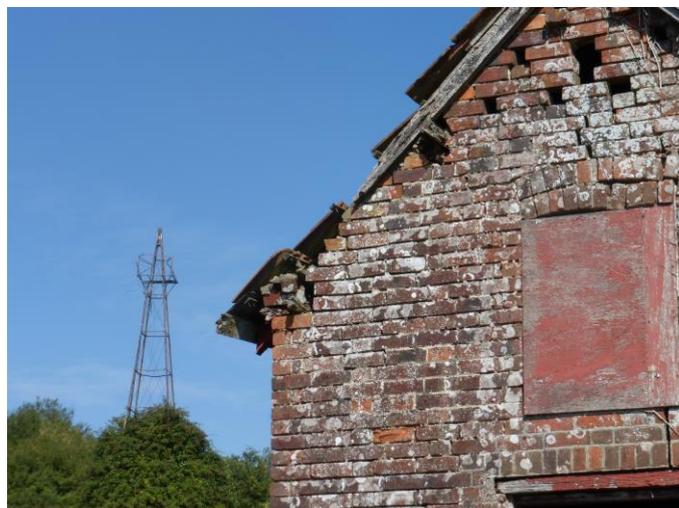
Late 19th Century farm building connected with lower Fifehead Farmhouse, weatherboarding has all but gone in some places and needs replacing asap. Deterioration in the walling since the 2011 survey.

Walling: Stretcher bond with double flat arch on upper storey and segmental on lower, extensive damage on side elevation and end. (very poor). Significant deterioration since 2011 with signs of collapse at gables.

Joinery: Some damage and damp (poor)

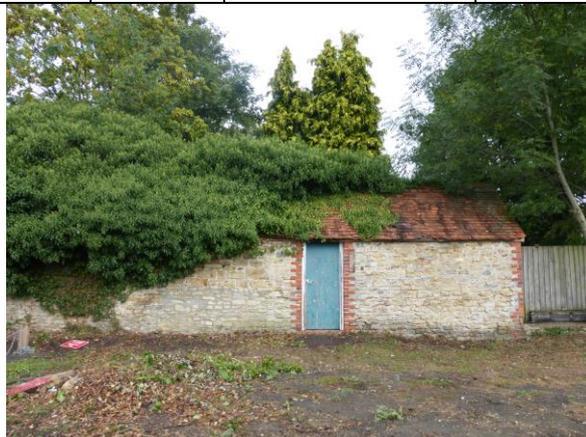
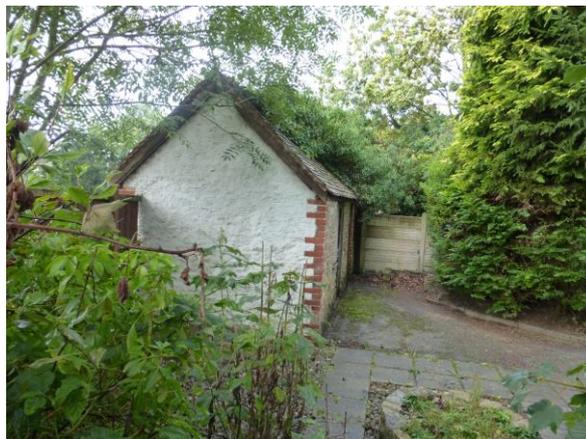
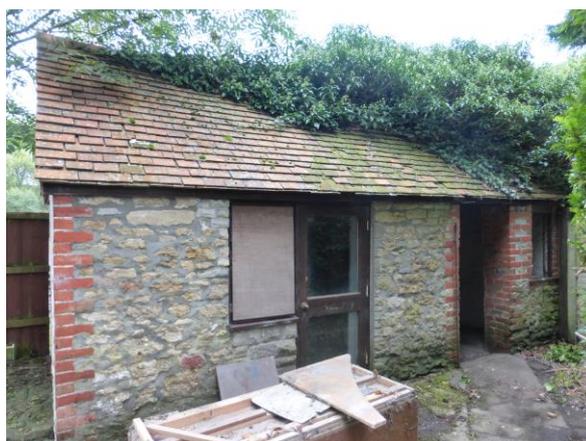
Roof: Clay tile (fair with some missing tiles and slips, made worse by extensive vegetation).

Walling: Natural stone with red brick bands (fair at the rear but appears good at the front and side facing the garden).

Joinery: Some damage (fair).

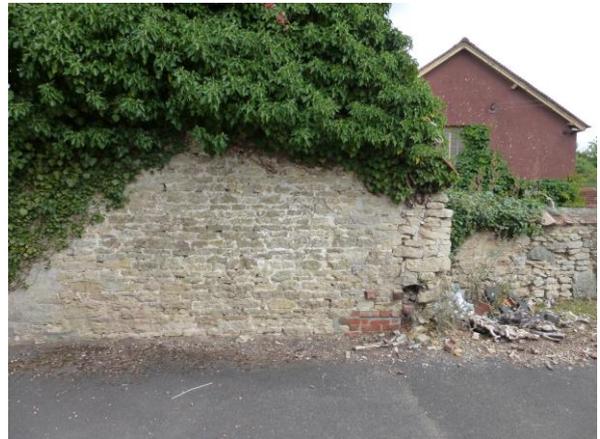
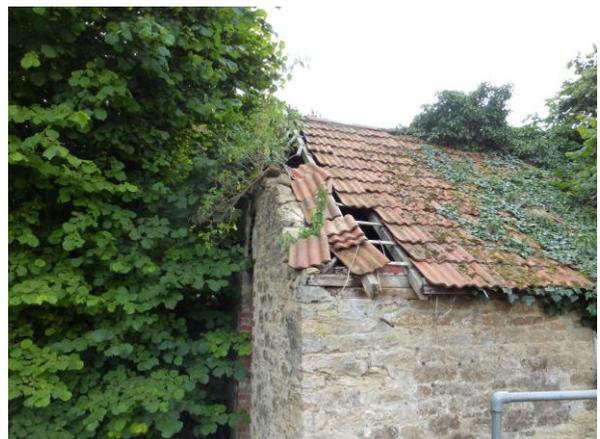
Roof: Clay tile (poor). Tiles missing and slipped on far gable end with damage to timbers. (poor)

Walling: Natural stone with red brick bands (fair). Crumbling and movement in rear wall (car park side) – deterioration since 2010 survey.

Joinery: Some damage (poor).

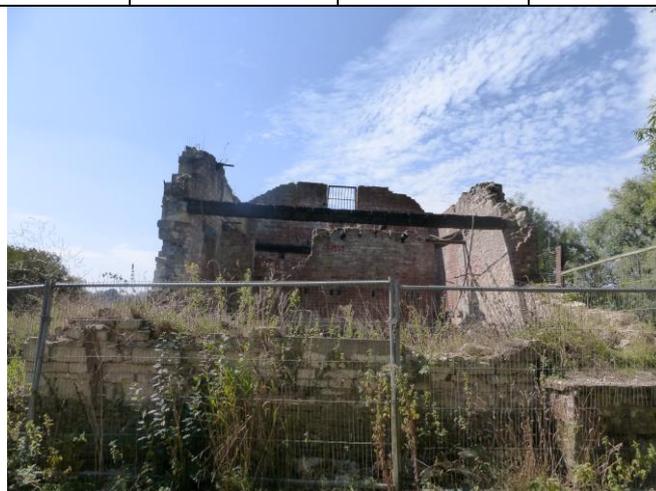
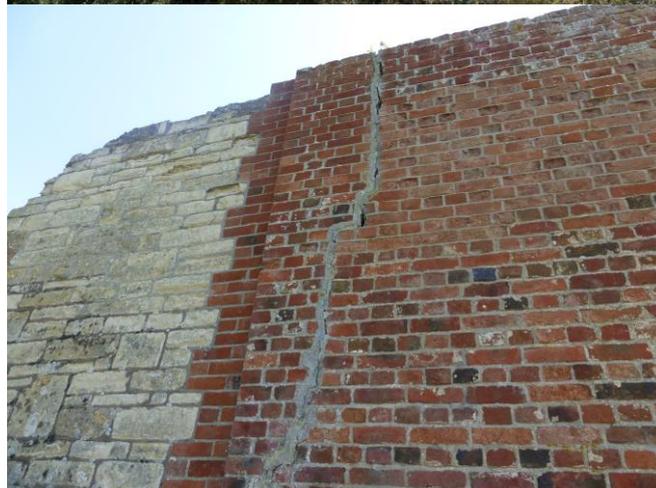
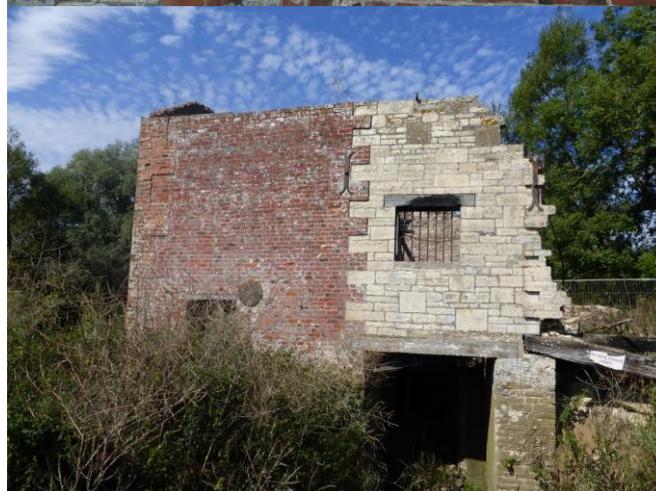
Roof: N/A – roof missing

Walling: Brick and limestone, clear evidence of mortar loss and failure of structure (very poor)

Joinery: Extensive damage with rot and also clear evidence of fire damage. Metalwork intact. A few lintels are satisfactory (very poor)

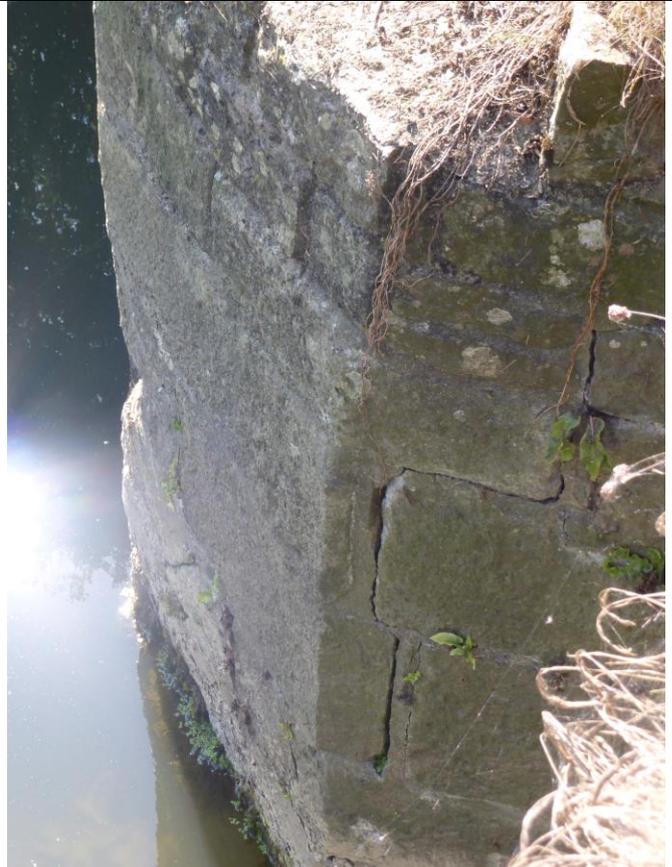
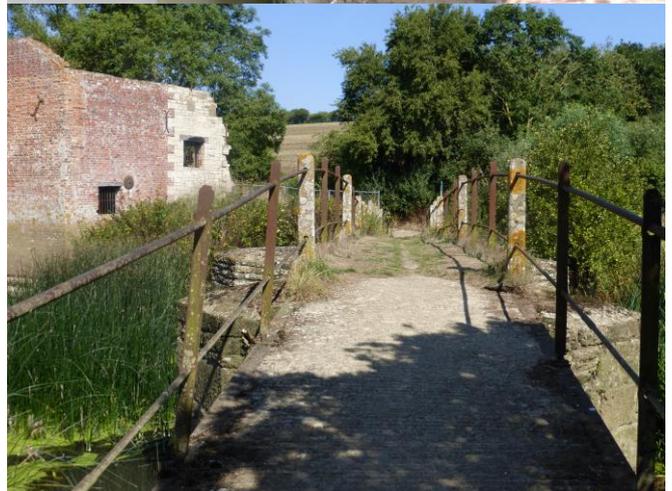
Walling: Block limestone. Movement has spread to all piers since 2011 survey. on central pier (very poor)

URGENT ATTENTION REQUIRED

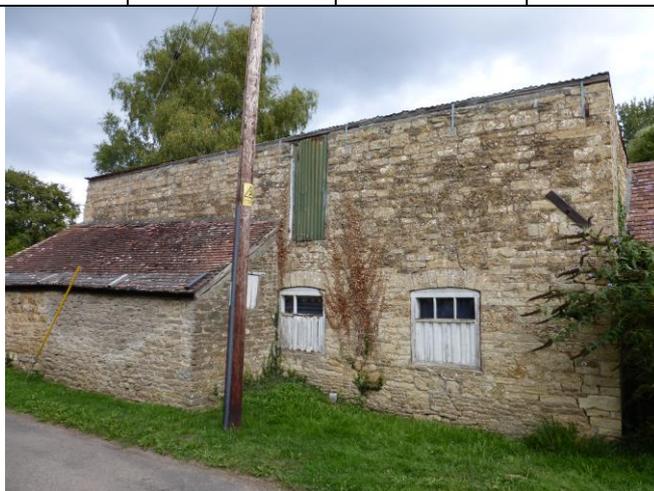
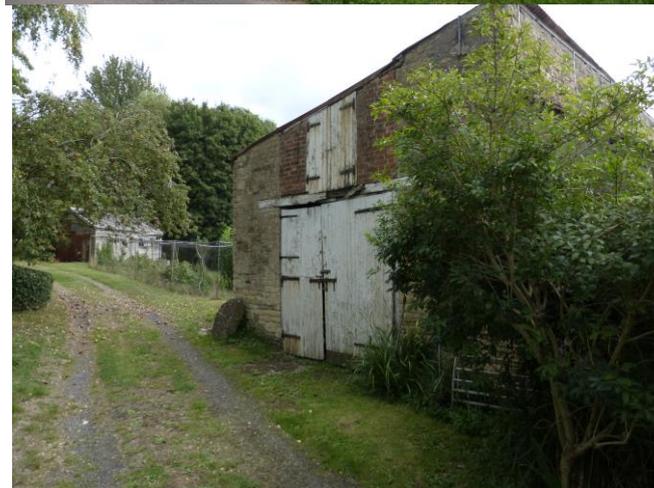
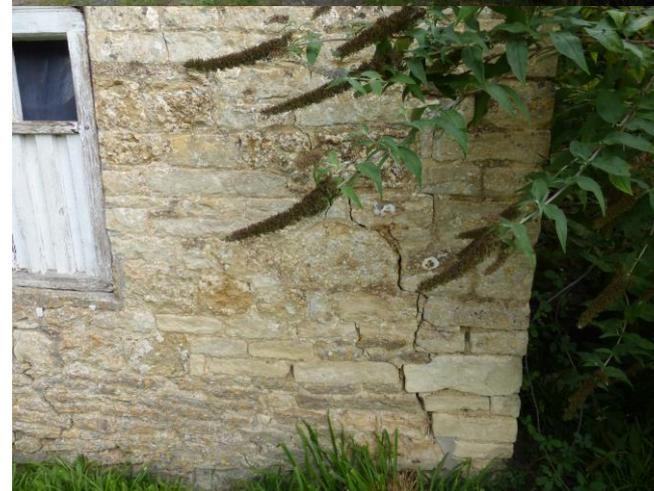
Mid-19th Century former Bakery, appears to be used for storage. Random stone rubble wall attached lean-to building is also random rubble with pan-tile roof, some slippage observed. Taking in door boarded over. Condition unchanged since 2010 survey.

Joinery: Exposure damage and some attention needed to gable wall doors (poor)

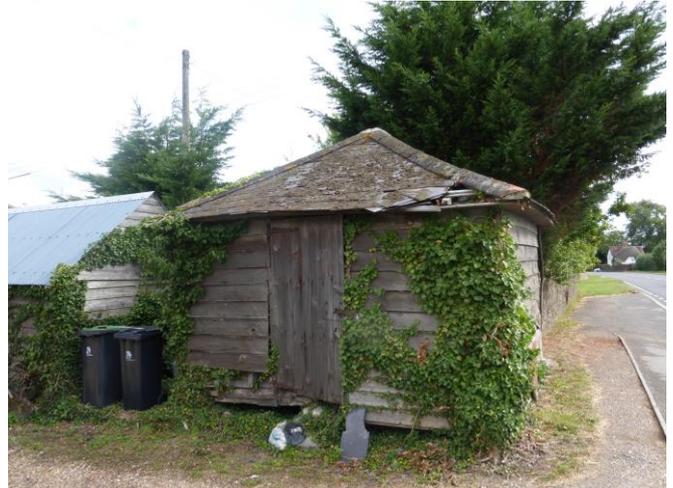
Nine staddle stone, weather boarded Granary with thin slated hipped roof. Four staddles are visible but have clearly sunk or have been buried. There is clear evidence of tile slippage at several points. Further evidence of rot of the main base frame and is in a generally dilapidated condition. There has been significant vegetation growth within the structure since the 2011 survey.

Roof: Thin slate with deterioration since 2011 (very poor)

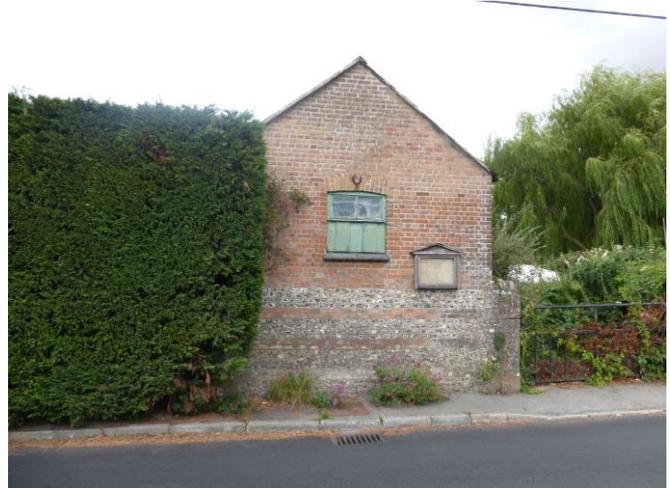
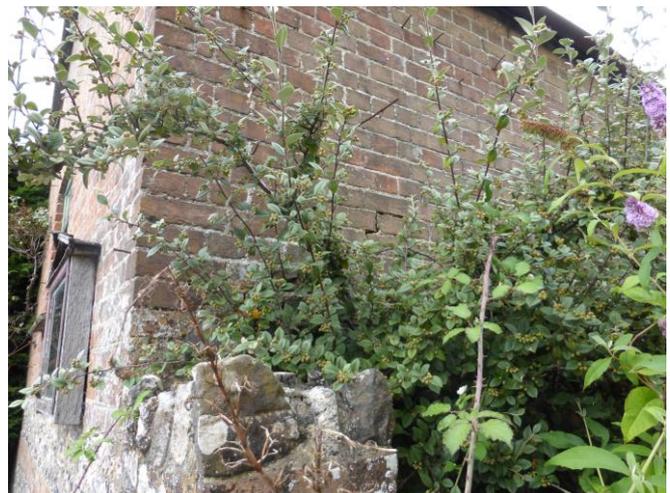
Small outbuilding of brick and flint. Former stable block with hayloft – mid to late 19th century. Extensive structural cracking – front gable apex. No significant deterioration since the 2011 survey apart from further encroachment of vegetation at the sides.

Walling: Flint and brick, loss of mortar, extensive cracking (poor)

Joinery: Evidence of rot, redecoration and replacement required (poor)

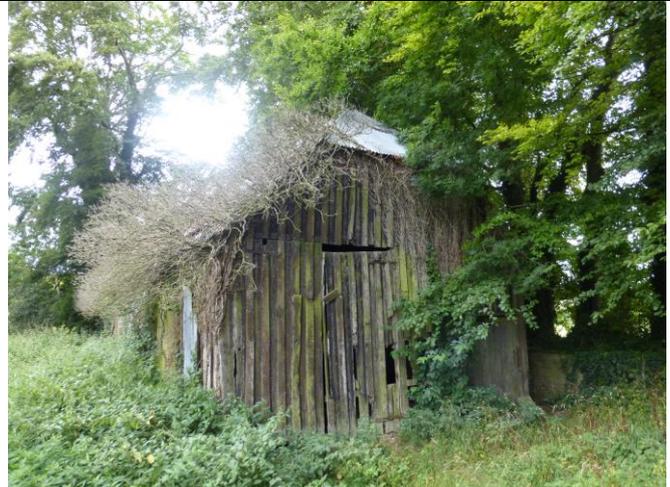
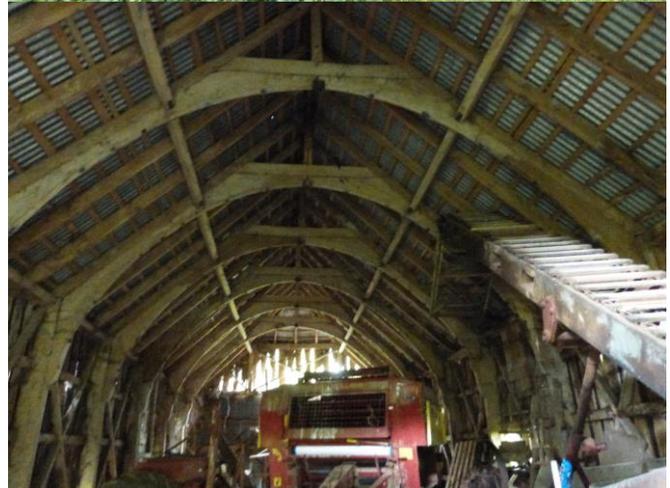
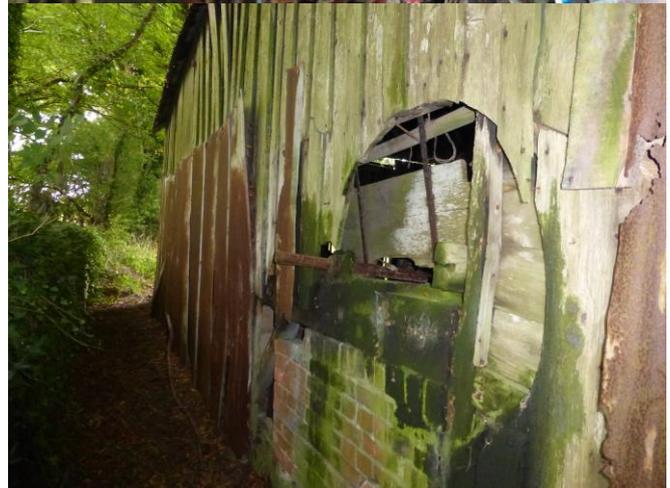
Roof: Half Hipped mostly tin sheeting some of the original roof can be seen interiorly – extensive rust – heavy vegetation on far gable end (very poor)

Walling: Timber – extensive timber loss, extensive rot (very poor)

Joinery: Extensive damage and rot (very poor). Inside, the 8-bay frame with wall posts, arch braces, trusses and king posts, and the walling frames, appear in fair condition.

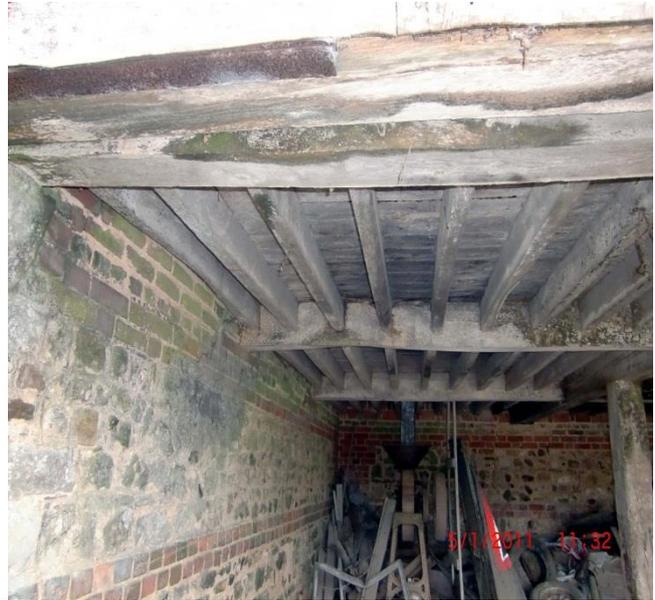
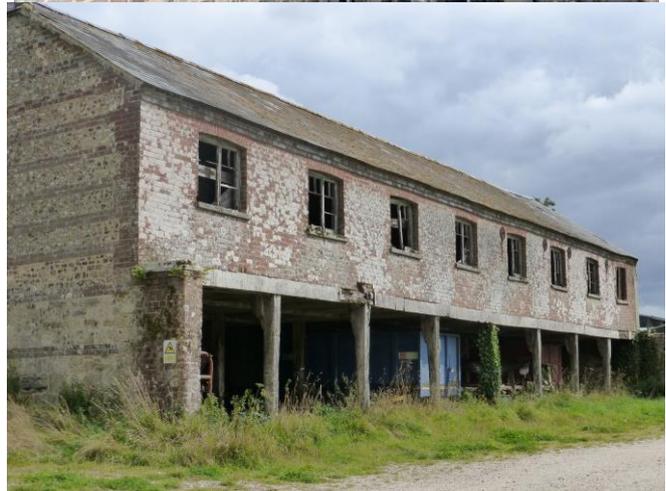
Cart sheds, early 19th century, storage below. First floor dilapidated. Gable ends constructed with flint and brick coursing. Side walls, brick construction segmental arches. Window joinery virtually destroyed at front. It should be noted that posting below the windows is in extremely good condition. Condition unchanged since 2011 survey.

Joinery: Extensive damage (poor)

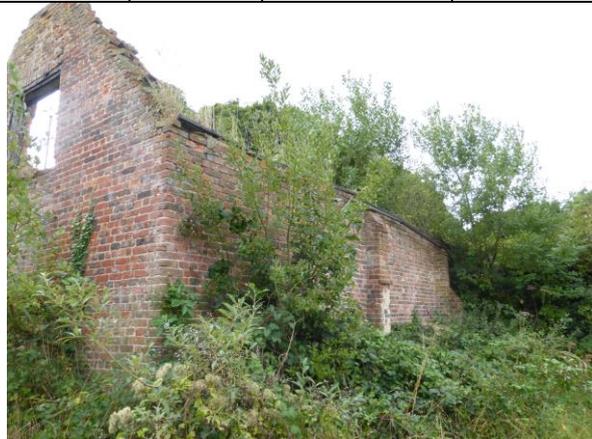
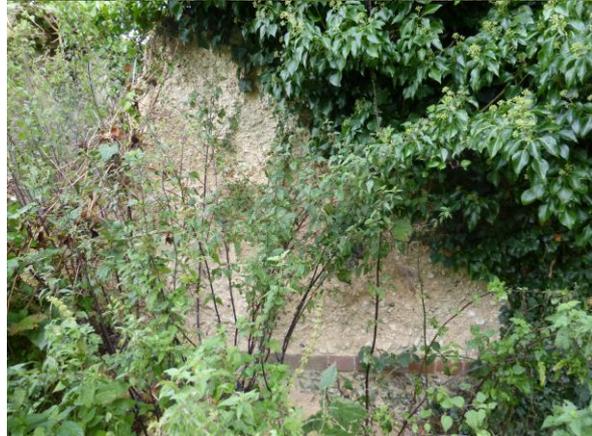
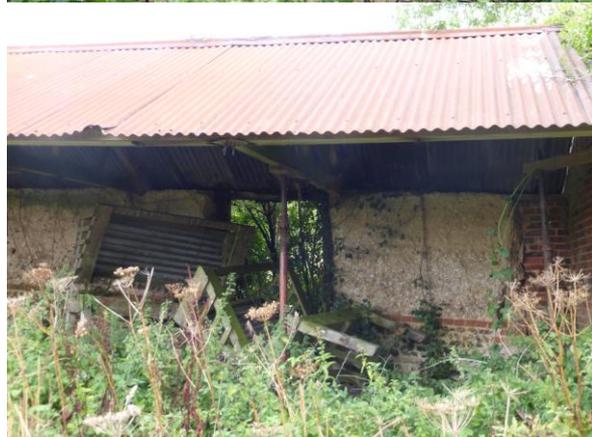
Pointing: Fair on the lean-to. Significant mortar loss on the brick barn.

Joinery: Completely rotten and damaged throughout. Most of the roofing timbers on the brick barn are missing.

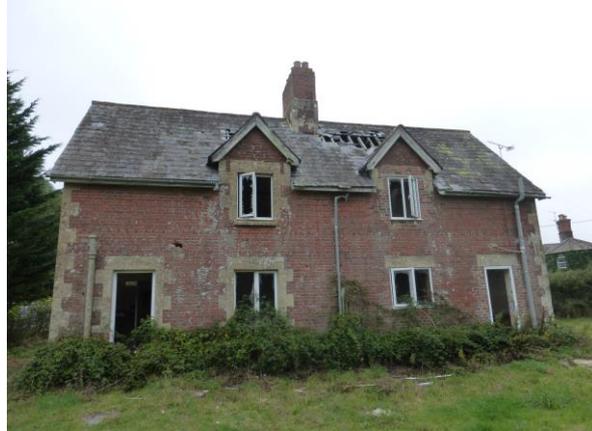
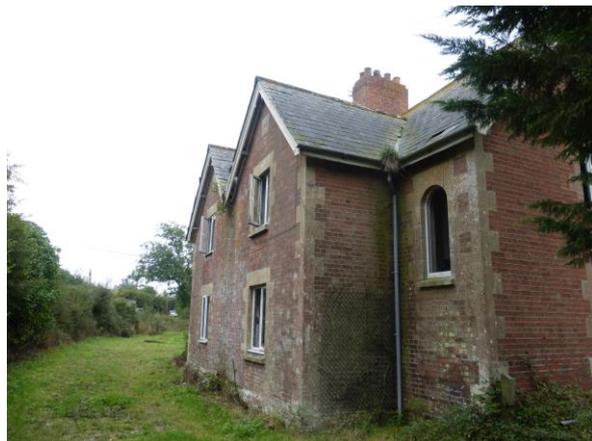
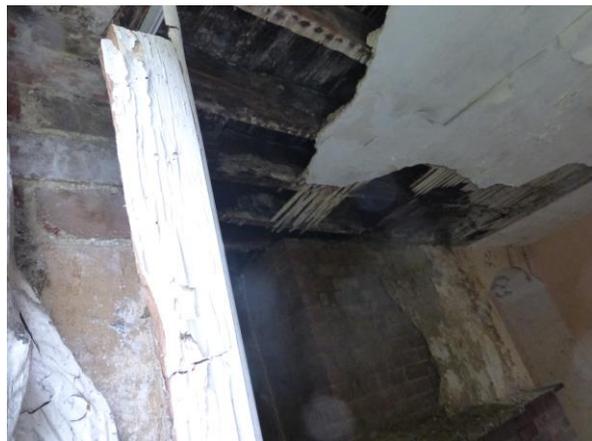
Pointing: Poor – large areas of mortar loss.

Joinery: All windows and doors are UPVC – all are in a shocking condition, having been smashed and vandalised.
