# Shaftesbury

Agricultural		Domestic			Retail		Ecclesiastical	
MAP Reference	Co-Ordinates		Address				Parish	Survey
ST862222	E386364 N122297		Holyrood Farm, Watery Lane				Shaftesbury	19/09/13
SURVEYOR	BOA	RS	CA	Grade	Windows	Roofing	WM	SR
MRW/DJC	2	3	No	II	Casement	Interlocked tile	Brick/stone	4*

## Description:

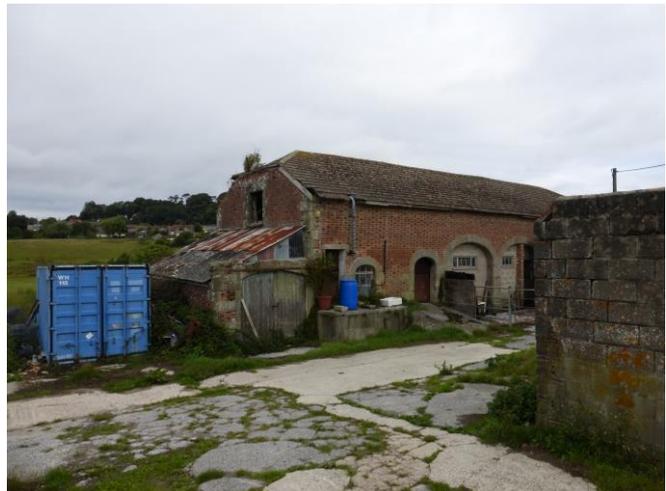
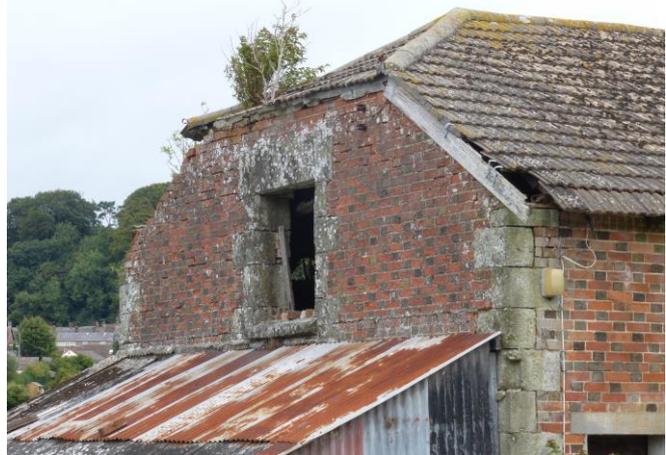
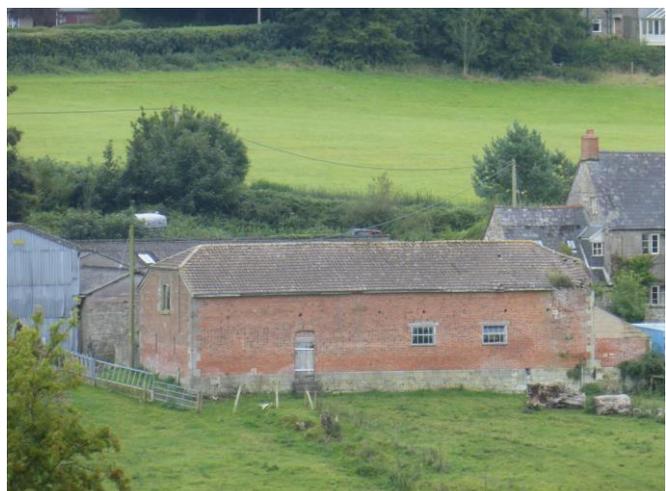
*Roof:* Interlocked tiles – generally good but several missing at front left gable and evidence of some collapse in rear left corner with missing tiles broken timbers

*Walling:* Dutch Flemish bond brickwork (good but some damage on gable end at eaves)

*Joinery:* Some repairs needed (fair)

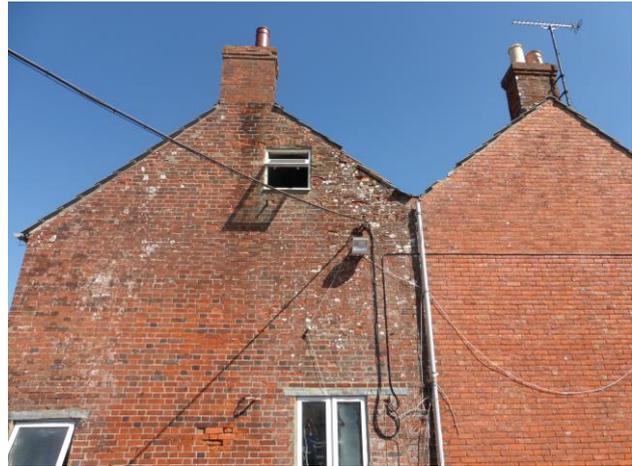
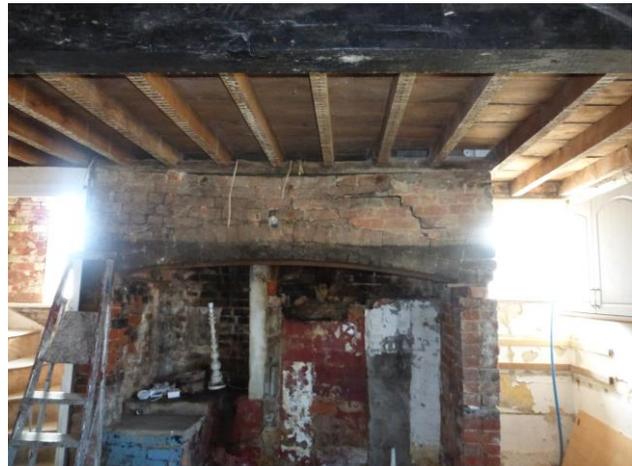
*Walling:* Extremely poor (barn). Walls on farmhouse show signs of movement (poor).

*Pointing:* Generally fair but poor at the rear (farmhouse)

*Joinery:* Extremely poor where the joinery is still in situ (barn). Farmhouse joinery is being restored or UPVC windows installed.

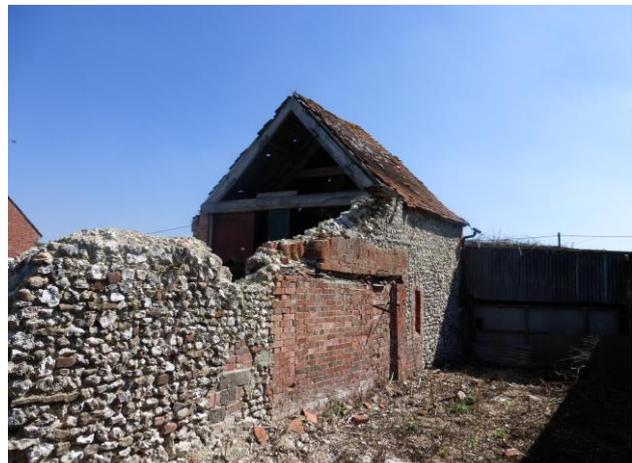
Barn

At the rear is a mid. 19<sup>th</sup> Century agricultural barn with extensive damage and loss of two thirds of the roof. There appears to be evidence of damage inflicted by farm machinery on the rear wall. Loss of timbers but no evidence of damp/woodworm or other damage. Building is currently extremely vulnerable. The new owner wishes to explore ways of restoring and converting this barn.

*Roof:* Some clay tiles left on barn (extremely poor).

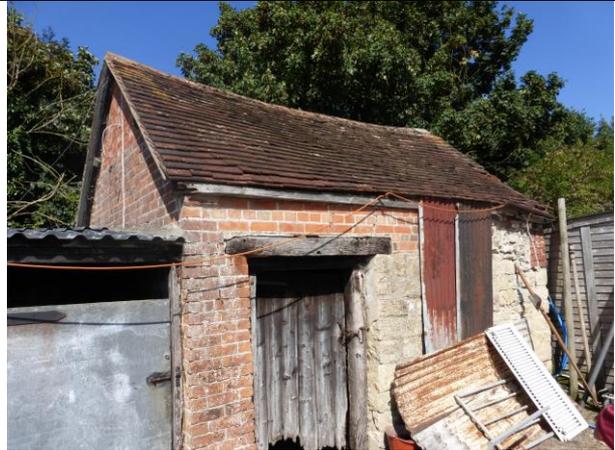
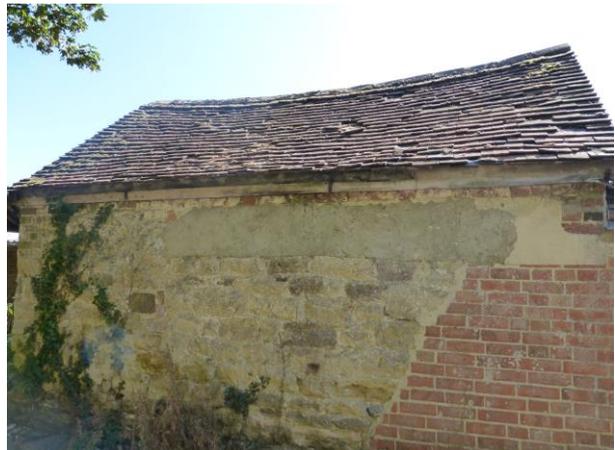
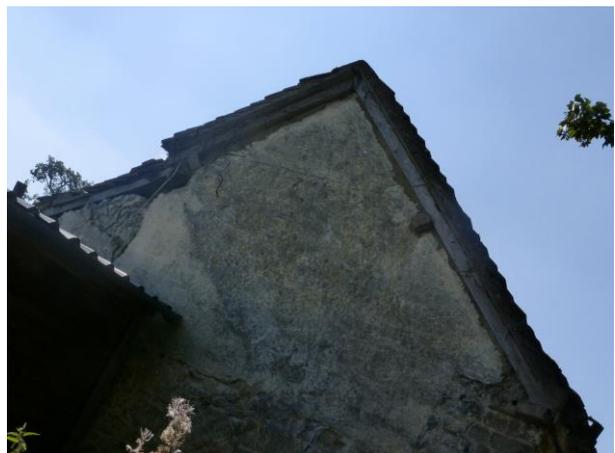
Roof: Poor – collapsed in far corner

Walling: Poor – significant movement and cracks in the walls. Far gable end open to the weather. Some old remedial work at the rear.

Pointing: Poor

Joinery: Poor, though roofing timbers have been replaced in the last 50 years – rear plate beginning to slip on rear wall

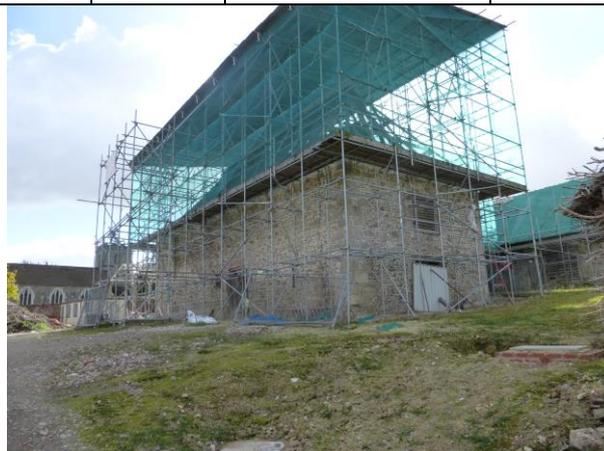
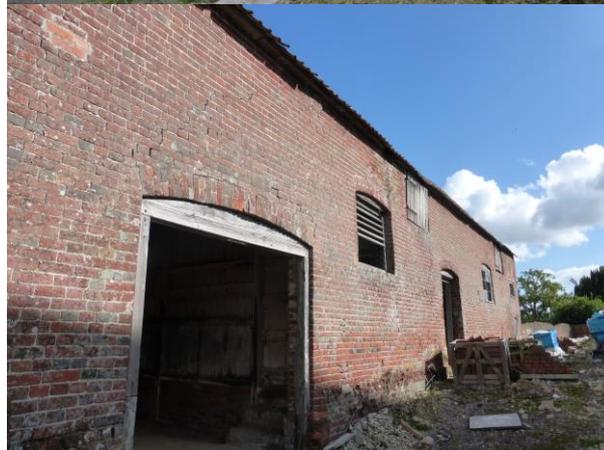
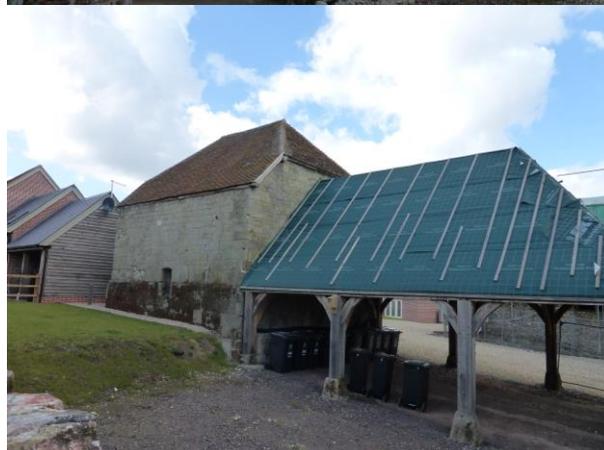
The dovecote has been restored and the adjoining store converted into a car port (roof unfinished). The tithe barn remains under scaffold, but the walling looks significantly improved since the previous survey. The brick stables have been cleared of vegetation, but still require significant work with some missing tiles, loose mortar and some structural cracks.

The perimeter wall of cob and flint appears unstable in places with loss of fabric.

*Roof:* Poor (barn). Good (dovecote). Fair (stables).

*Walling:* Fair (barn). Good (dovecote). Poor (stables).

*Pointing:* Fair (barn). Good (dovecote). Fair (stables)

*Joinery:* Fair (stables)

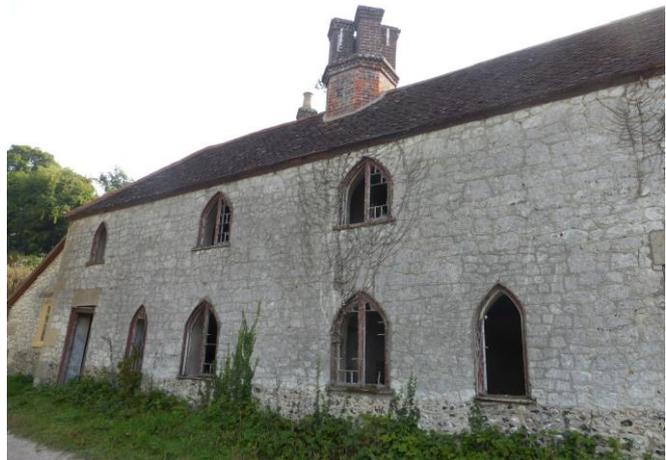
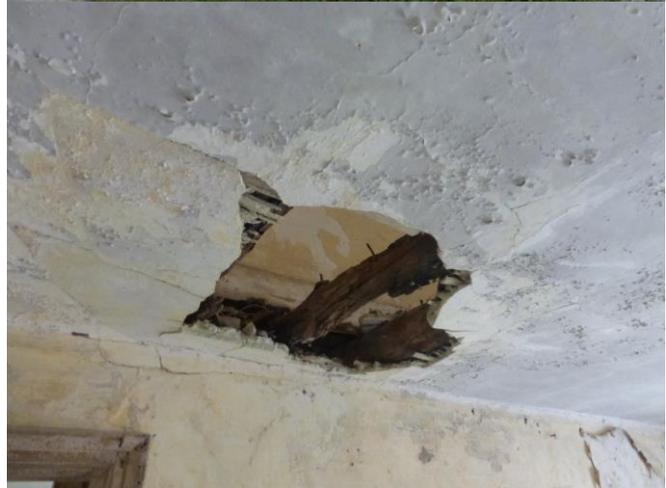
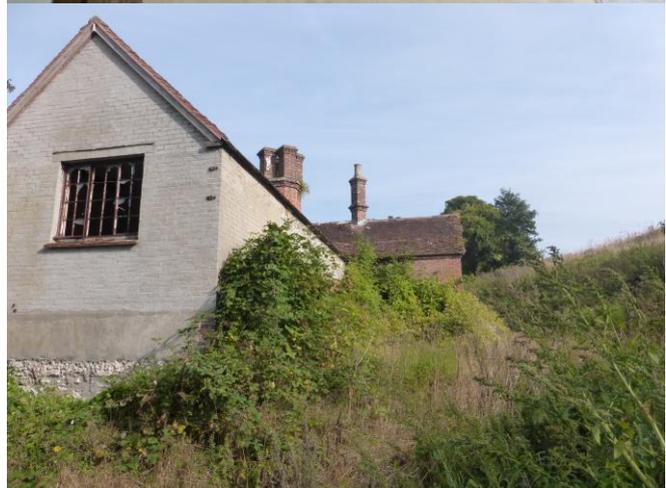
*Roof:* Plain tile, has been entirely renewed since the 2011 survey (good)

*Walling:* Stone and flint façade with brick extension at the rear (good)

*Joinery:* Broken or missing externally and internally. Some damaged flooring timbers. (poor)

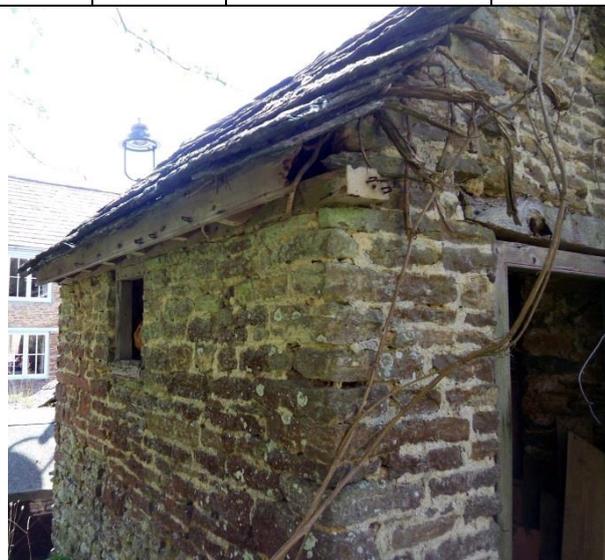
2011

*Roof:* Stone tile (fair)

*Walling:* Coursed stone work (fair)

*Pointing:* Lime mortar (poor)

*Joinery:* Some dry rot damage (poor)

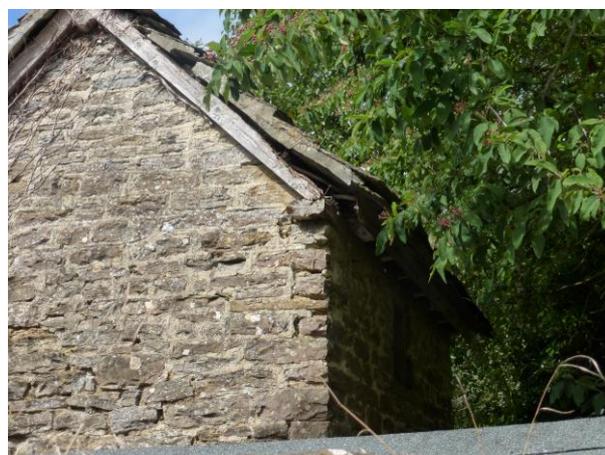
2013

19<sup>th</sup> Century privy now used as a wood store. One of only three known examples in North Dorset. Access has been severely restricted since 2011, but the condition appears unchanged. Listed by association with Snowdon House (II).

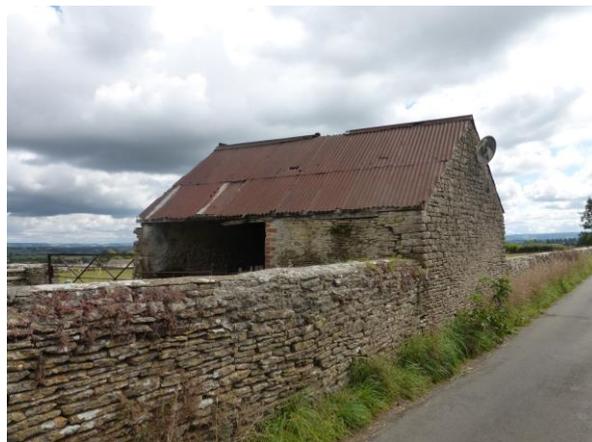
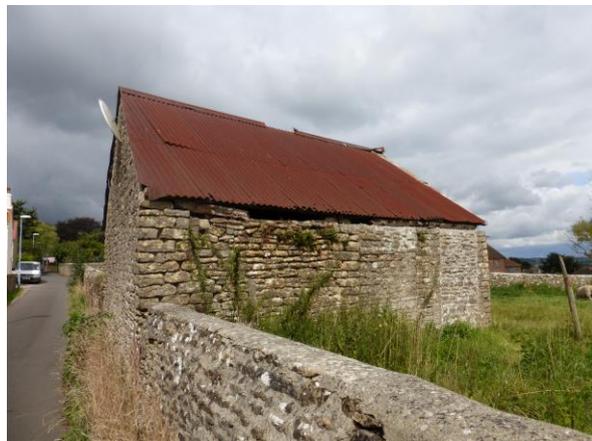
Roof: Corrugated, significant rusting and several holes.

Walling: Stone (very poor) – some major structural cracks

Pointing: Poor

Joinery: Rotten with some damaged or missing timbers

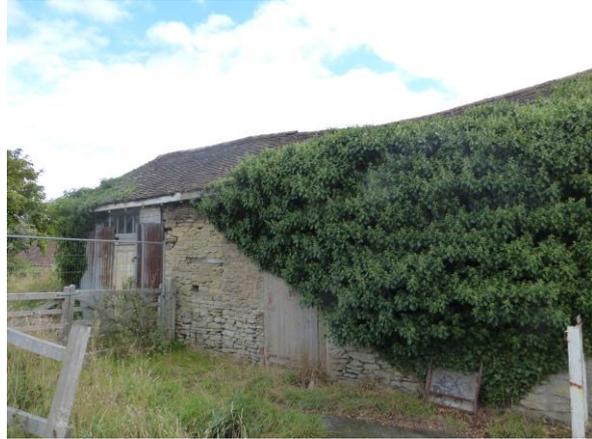
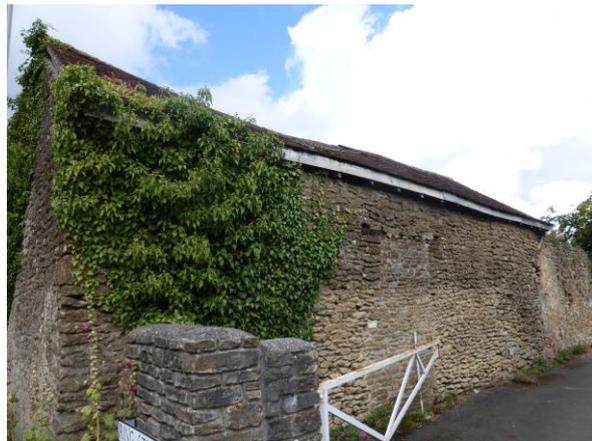
*Roof:* Clay tile – significant dimpling around the skylight (poor)

*Walling:* Stone and rubble – some precarious areas especially around the lintel of the door, significant vegetation growth (poor)

*Pointing:* Poor throughout

*Joinery:* Evidence of some damage due to rot – corrugated patches.

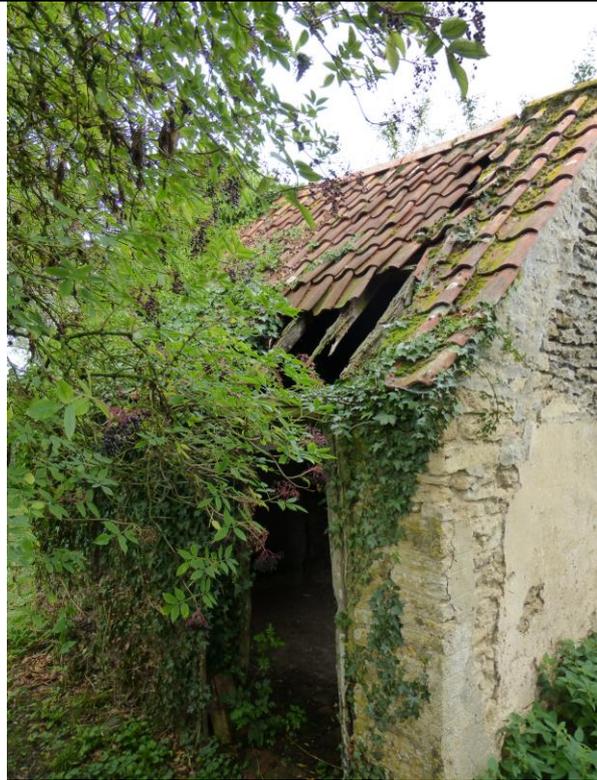
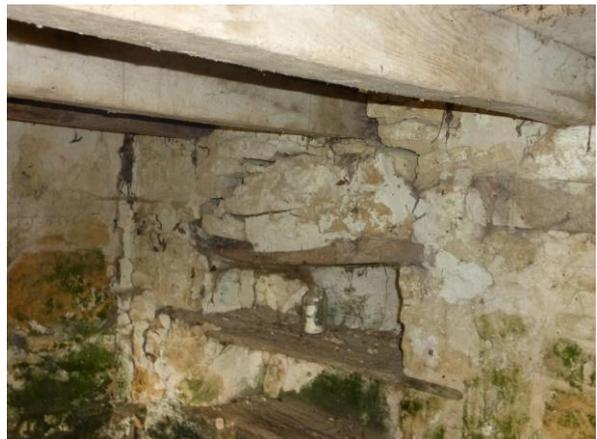
*Roof:* Tile with extensive loss (very poor)

*Walling:* Signs of significant structural movement, especially around the lintels (poor). Former remedial work on the side wall with application of some render.

*Pointing:* Poor

*Joinery:* Poor and rotten. Where the tiles are missing, the rafters are also broken and rotten. Roofing timbers and mezzanine joists generally good.

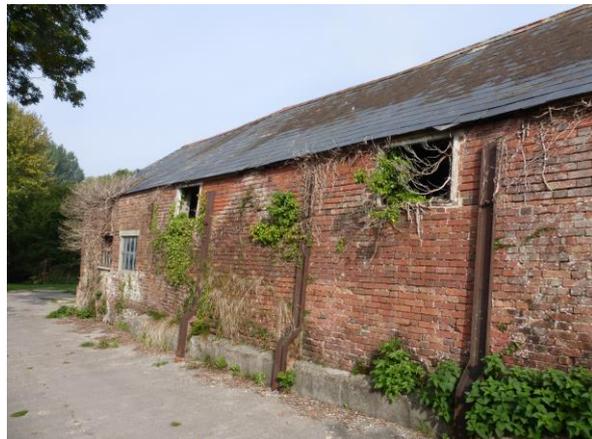
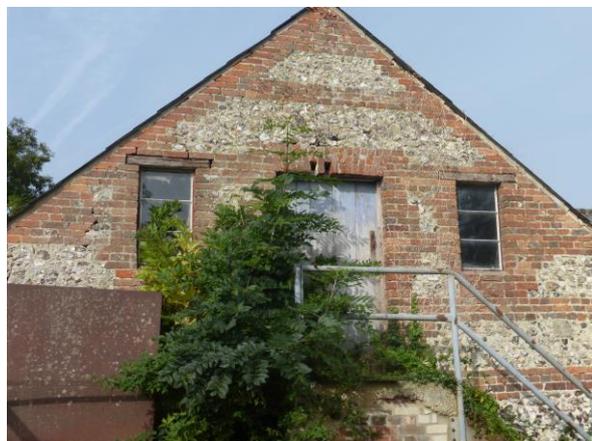
*Roof:* Some slips but generally good. Roofing timbers good.

*Walling:* Signs of structural movement. Supported by steel buttresses.

*Pointing:* Significant mortar loss – vegetation growth between the bricks

*Joinery:* Poor throughout

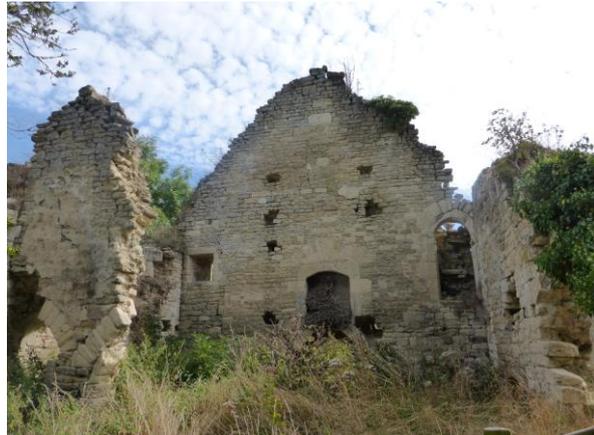
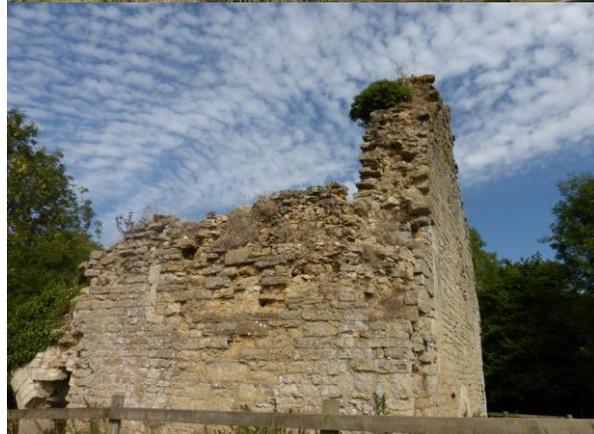
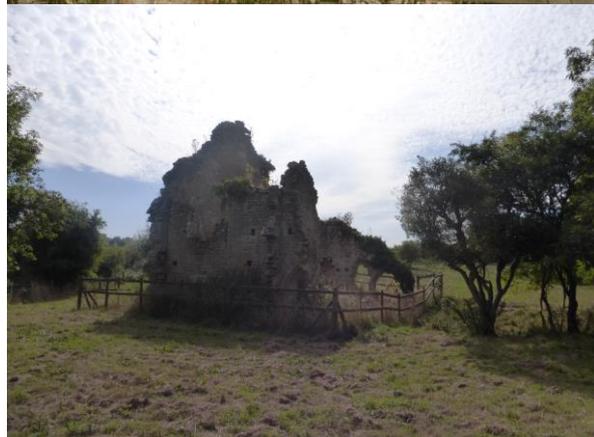
*Walling:* Very ruinous state, some water ingress into masonry which together with mortar deterioration and vegetation is leading to increased likelihood of further loss. Signs of deterioration since the last survey with loose and recently fallen masonry.

The owners plan to stabilise the ruins and to clear the promontory landscape in consultation with EH, NDDC and the local history society. Ultimately, they wish to make the site accessible to the public.

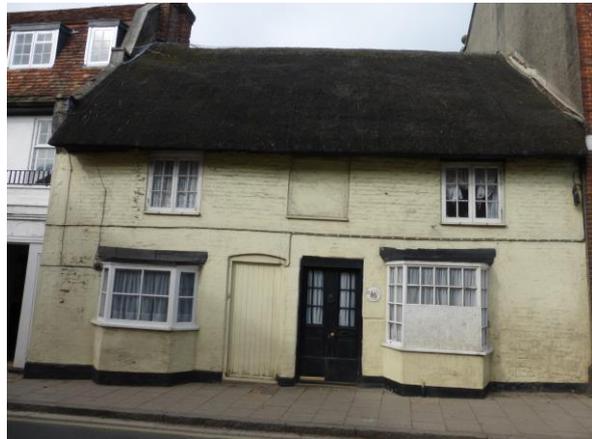
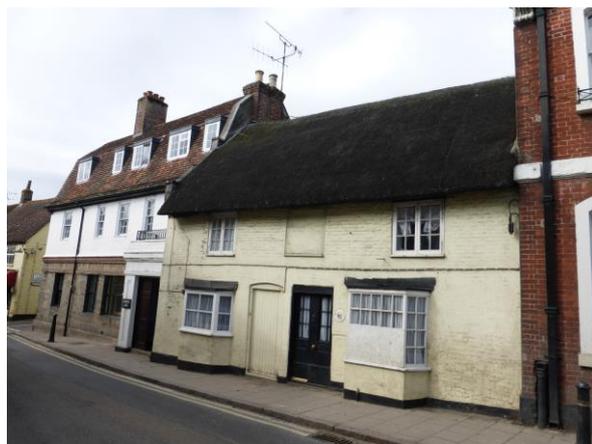
*Roof:* Thatch (good)

*Walling:* Brick – Flemish bond (fair)

*Pointing:* Some missing or loose mortar (fair)

*Joinery:* 2 canted bays, the left with 4-pane windows and the right with glazing bars. Above are 2 wooden casements with glazing bars. Fair. Left door and frame under segmental arch showing signs of rot at the base. Double door on the right is in fair condition.

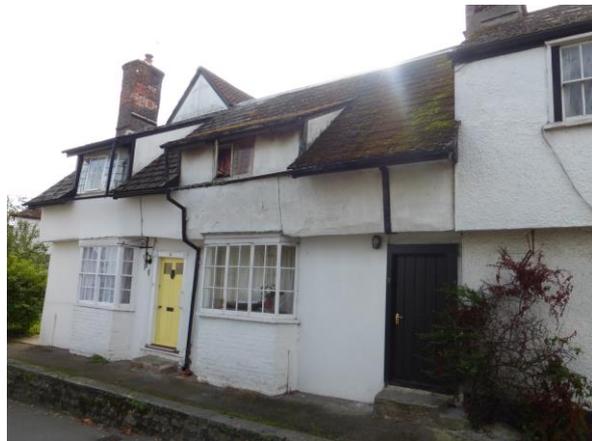
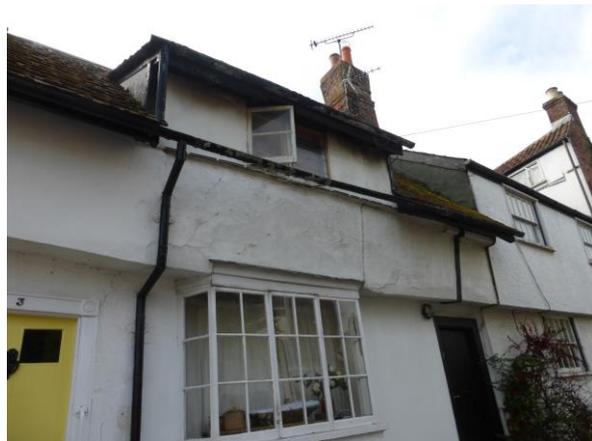
*Roof:* Slate, covered with moss

*Walling:* Render above the bay and door is cracked and has significant damp damage (poor).

*Pointing:* Fair on the brick bay

*Joinery:* Dormer shows signs of rot. Bay and door are in fair condition.

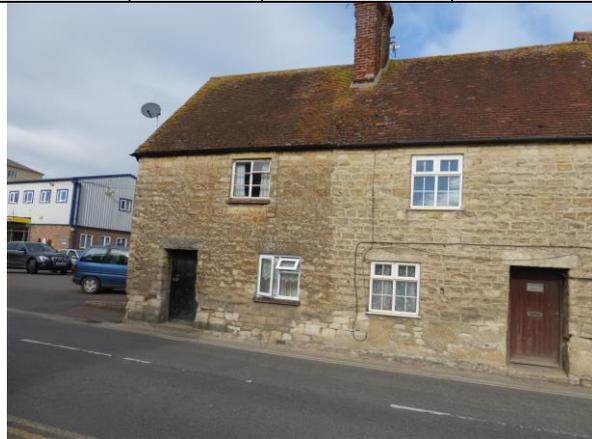
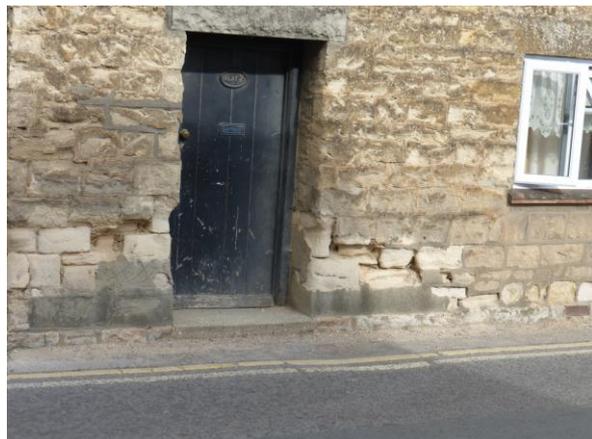
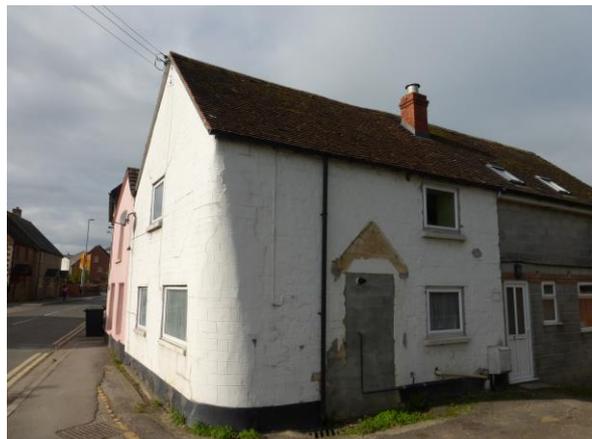
Ashlea

*Roof:* Plain tile (fair)

*Walling:* Local coursed stone, some significant damage at road level on Flat 2. On Ashlea, the coursed stone has been rendered. Very significant cracks and damage on the render (poor).

*Pointing:* Significant loss, some modern remedial work (poor)

*Joinery:* Metal-framed casements (poor condition). UPVC casements on other cottages.

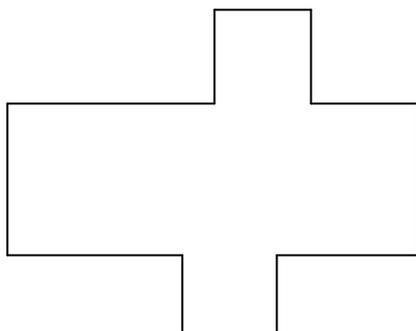
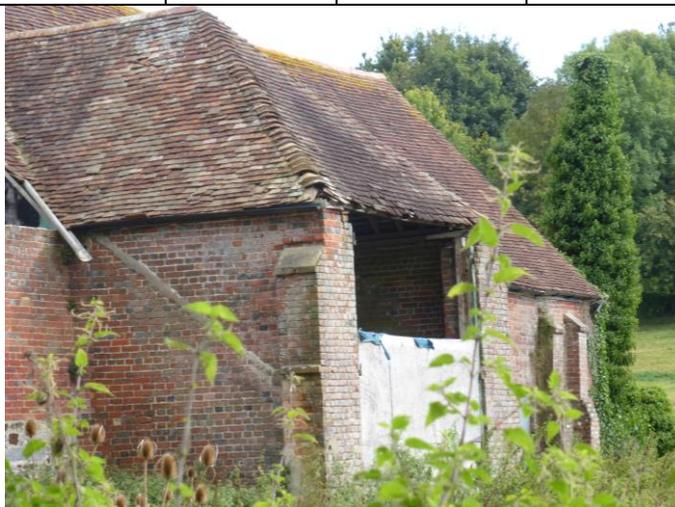
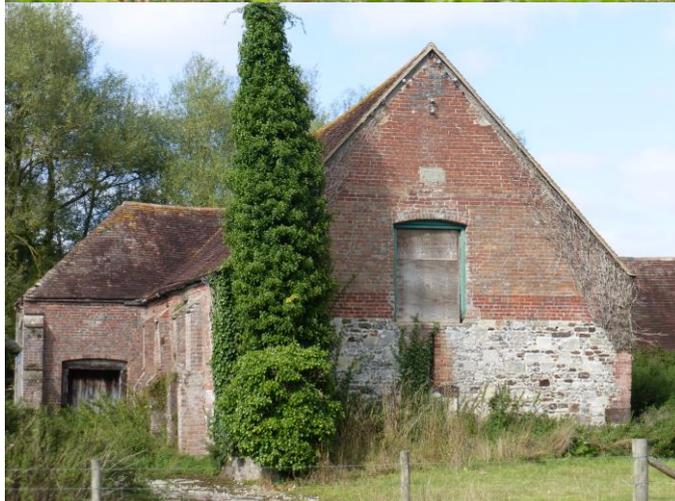
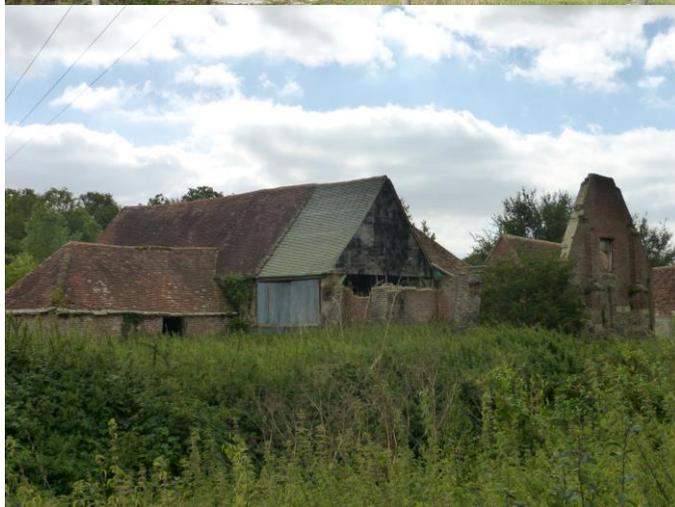
*Roof:* Small heel gable with hipped porch entrance at front. Extensive tile lose to hipped porch, secondary sector of roof is entirely missing. A lot of dipping across entire roof span (poor).

*Walling:* Lower sections constructed of flint rubble intersected with iron stone and upper greensand, upper sections rebuilt brick work. Brick built double angle buttresses (poor). Extensive movement and damage in roofless wing.

*Joinery:* Interior, collar beam rafters (fair).

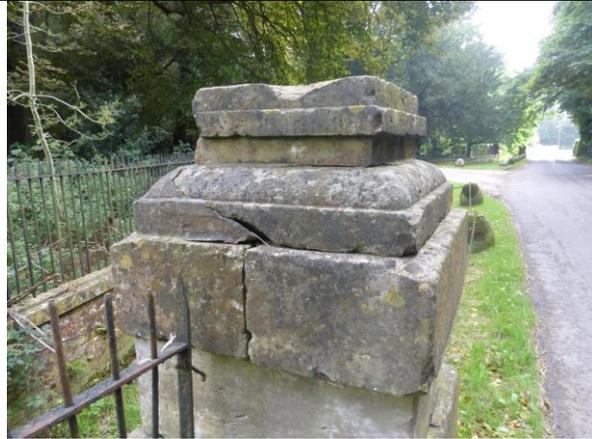
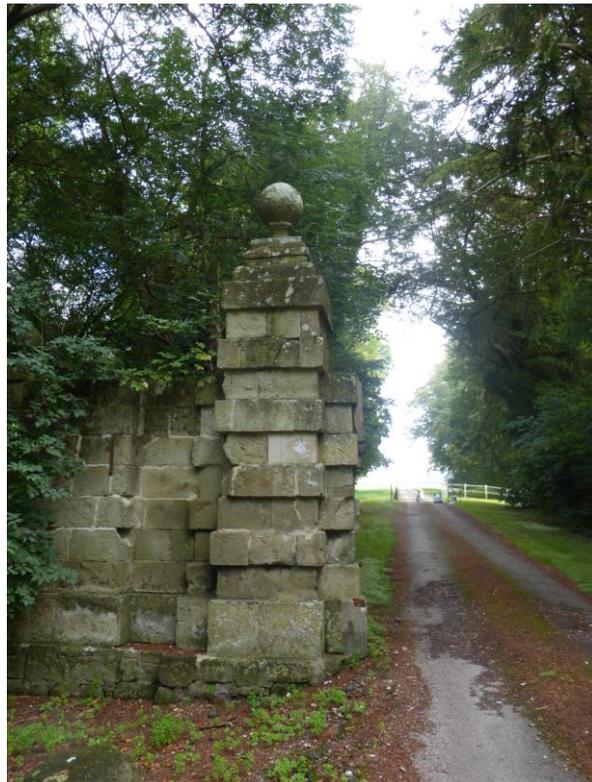
*Walling:* Facial integrity of the ashlar is poor and there are extensive cracks in the banding on main and side piers (poor)

*Pointing:* Significant loss of mortar (poor)

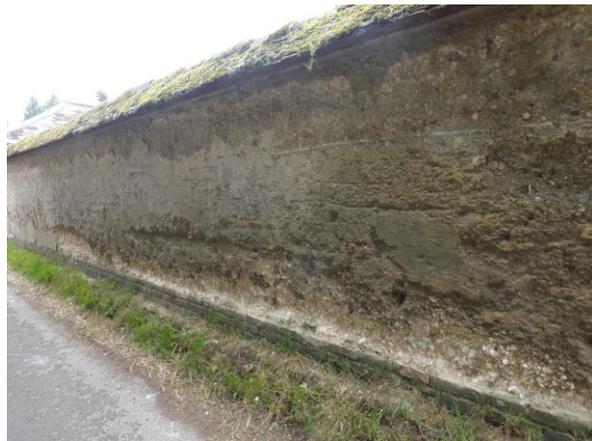
*Walling:* Cob with brick plinth. Significant loss of fabric and some recent vehicle damage (poor).

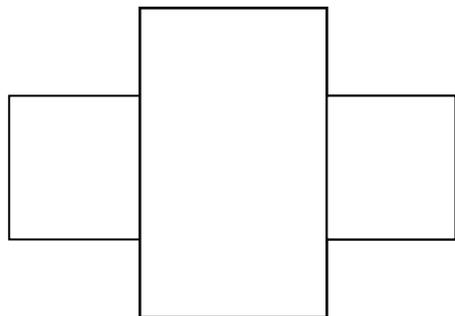
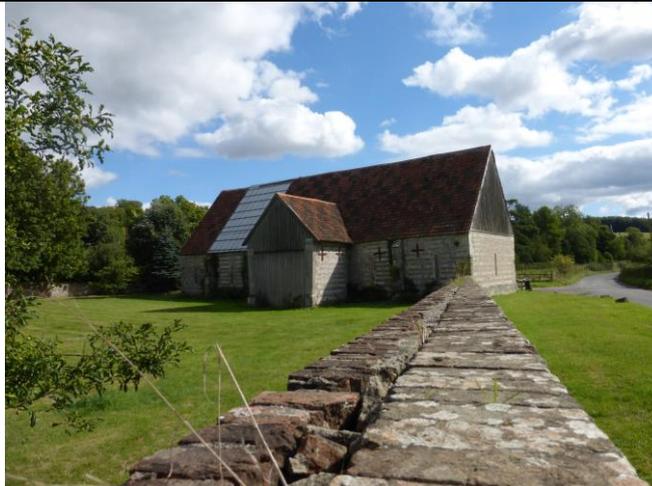
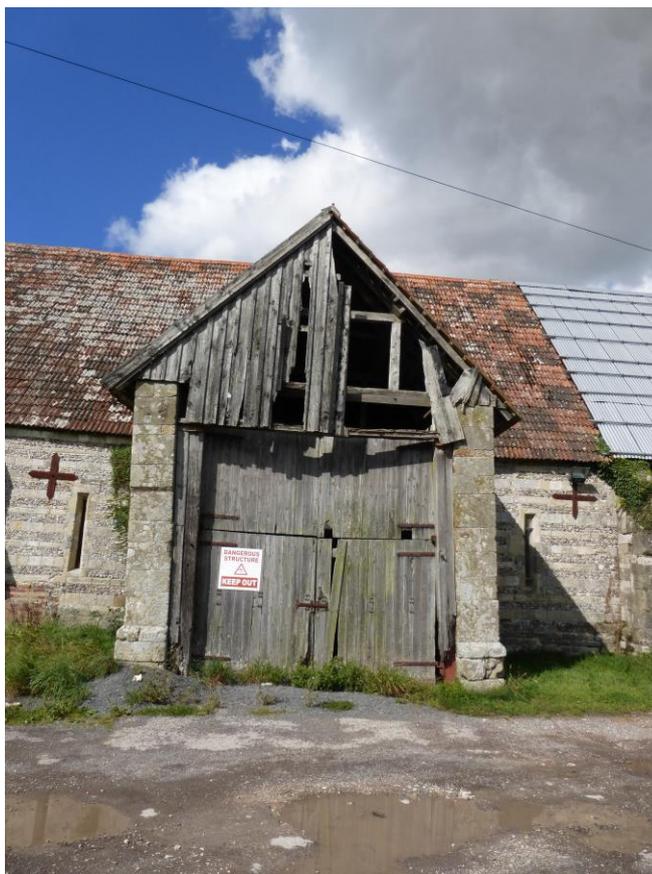
Tithe Barn with 16<sup>th</sup> Century walls with ashlar dressings and banded flint and rubble. Some remedial patch brickwork. The roof timbers are 15<sup>th</sup> Century and consist of the greater part of seven hammer-beam trusses, The Royal Commission Historic Monuments (RCHM) suggest that the trusses may have come from a monastic building at Milton Abbey. There is a Gabled roof with Pan tiles and a temporary tin roof structure repair. Angled buttresses. Gabled porch entry and weather boarded with slit ventilators with cross section and strengthening rods. Currently extremely structurally poor.

*Walling:* Extensive structural movement, loss of mortar joints in many areas (poor)

*Joinery:* Extensive damage with rot (poor)

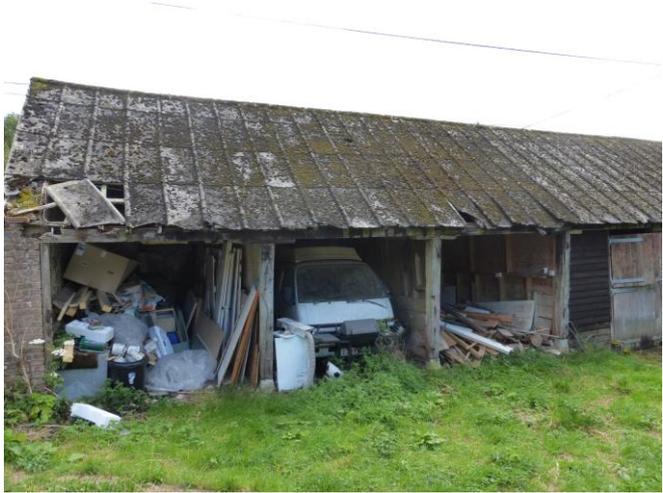
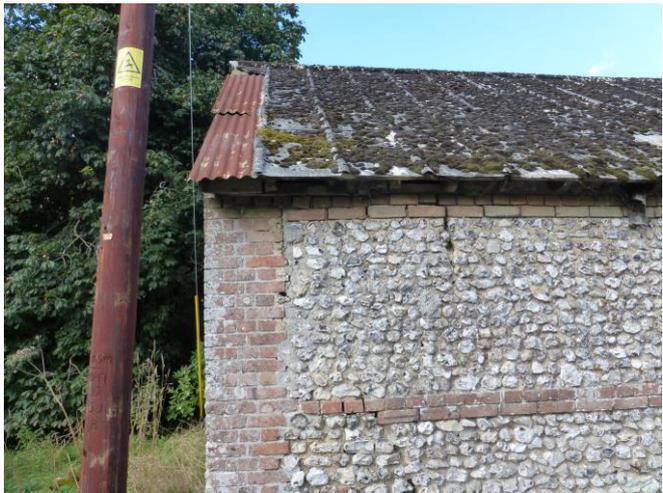
Early 20<sup>th</sup> century cart sheds with gabled roof. Gables are constructed of flint with brick coursing and dressings. Extensive damage to farmyard side of roof. No change in condition since the 2011 survey, but owner hopes to obtain planning permission for conversion.

*Walling:* Flint work with brick, some evidence of major structural cracking on road side wall (poor)

*Joinery:* Evidence of rotting and some damage (fair.)

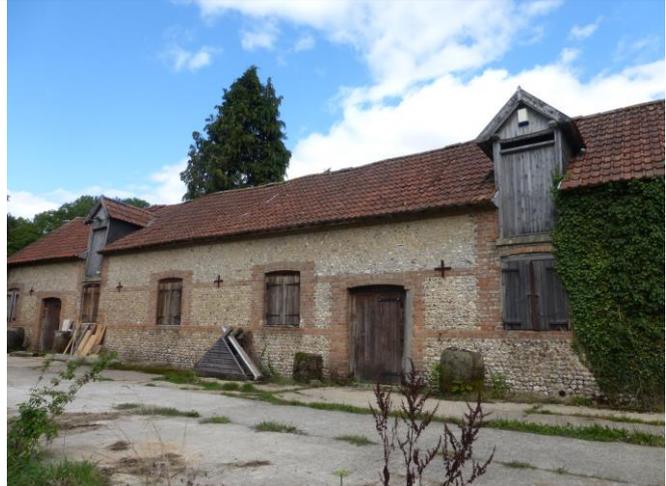
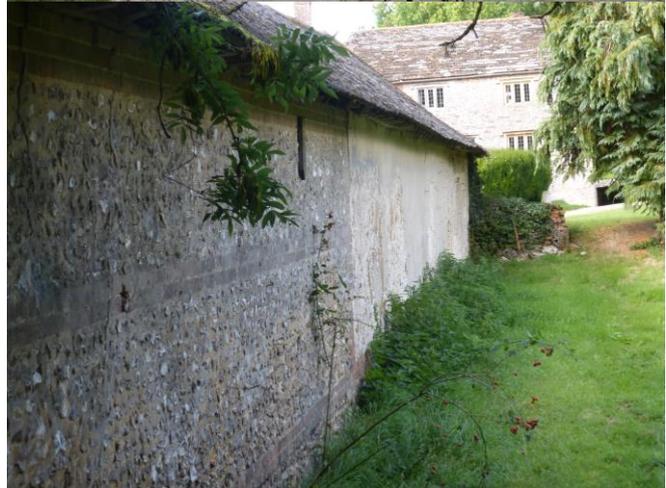
*Walling:* Predominantly flint with brick coursing - condition fair. Rear wall is cob and appears to have received some remedial attention since the last survey (fair)

*Joinery:* Some decoration required (fair)

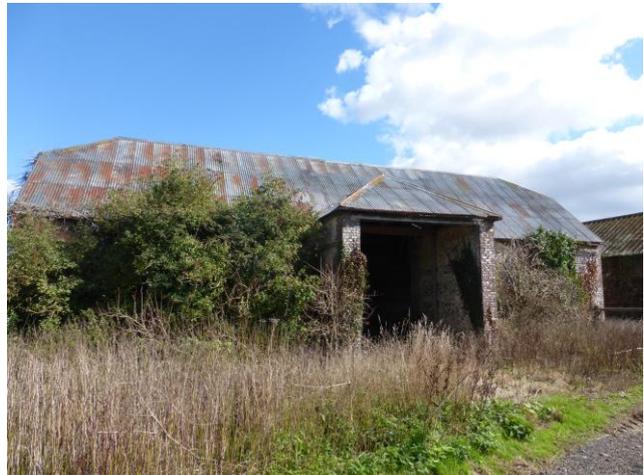
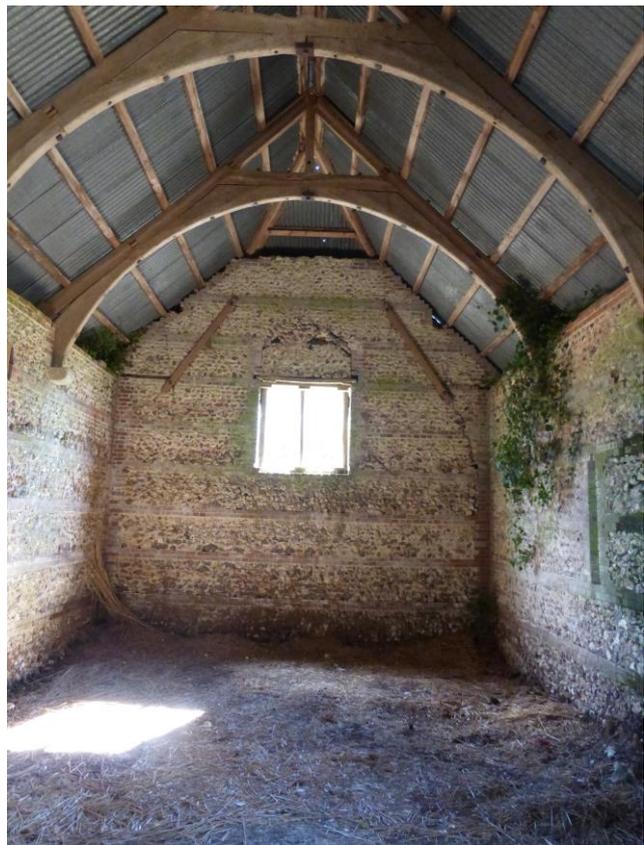
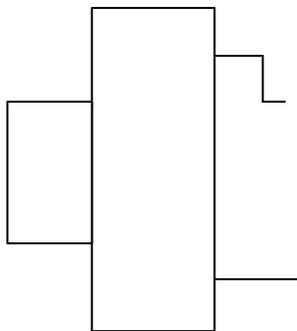
*Walling:* Coarsed, flint work and brick (good). Significant structural crack in the right gable wall.

*Joinery:* Barn doors missing at front, and the rear entrance only has the upper left section of door left which appears to have been cut away. The interior roof void is a simple construction (poor).

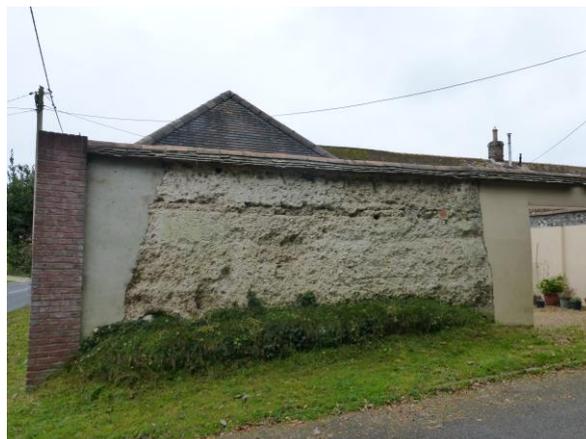
Part of an old cob wall on the boundary of a housing development consisting of former agricultural buildings, once Windwhistle Farm. The cob is exposed and will be subject to further decay unless remedial action is taken.

*Roof:* Tile capping (fair).

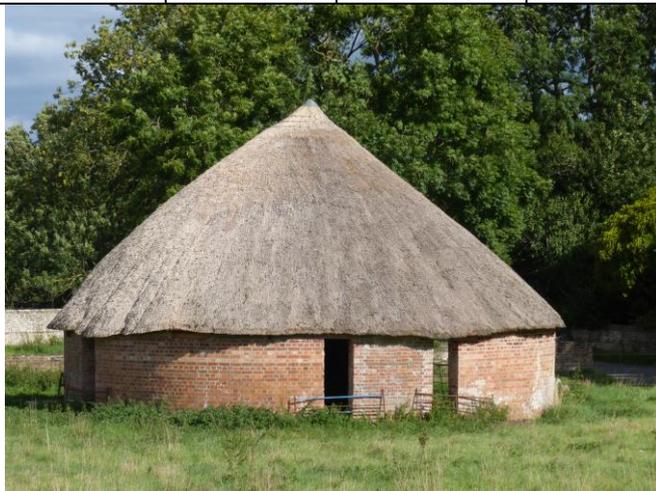
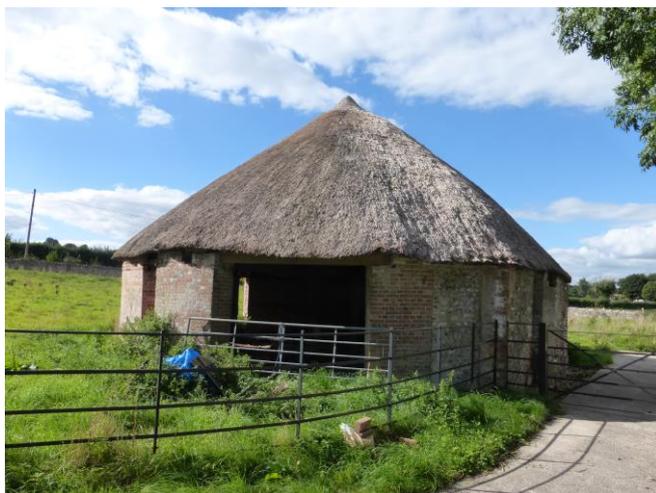
*Roof:* The thatch has been renewed since the 2011 survey (good). However, EH have written to the owner advising he replace it with water reed.

*Walling:* Brick (Good) – much improved from the crumbling walls reported in 2009.

*Joinery:* Fair

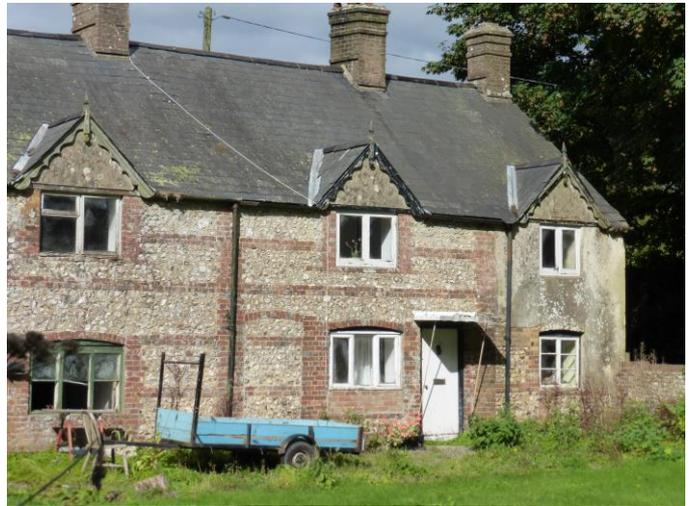
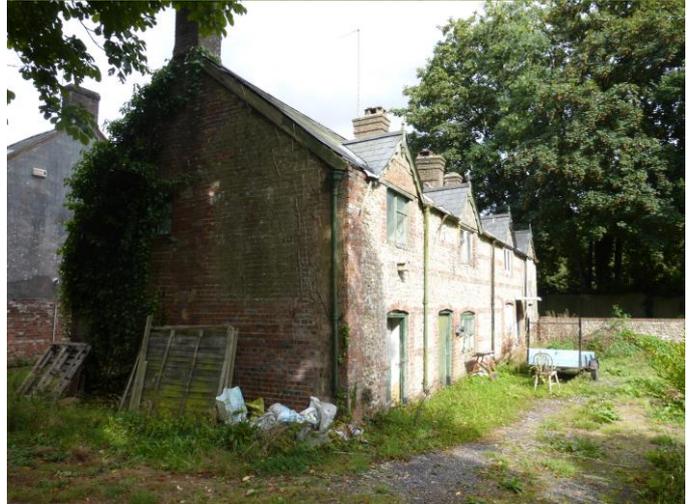
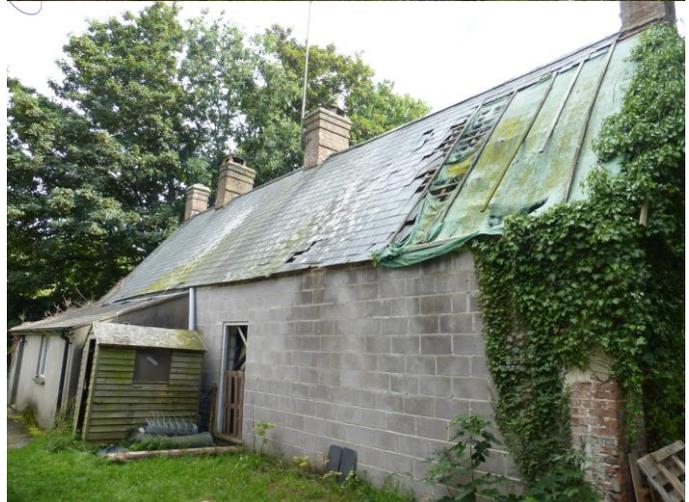
*Walling:* Brick and flint coursing (fair). Concrete breeze blocks at the rear.

*Joinery:* Damage throughout (poor)

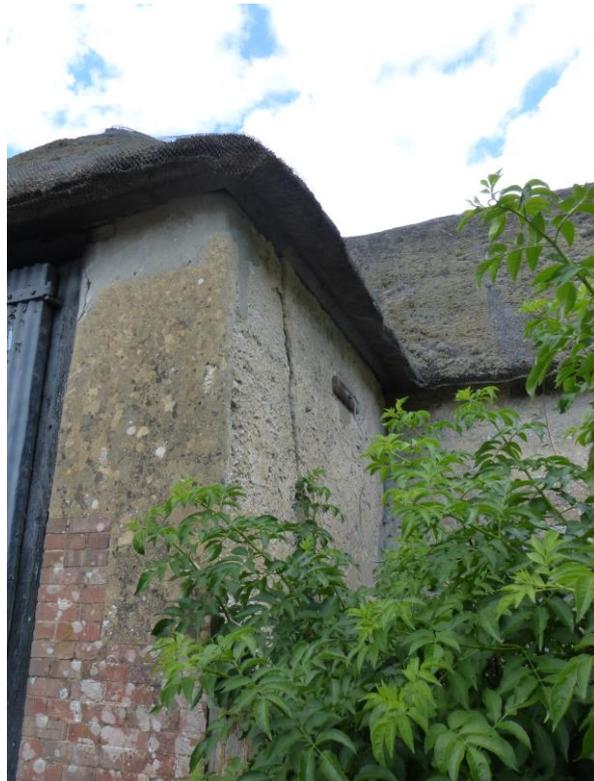
*Walling:* Extensive damage to cob walling. Major structural crack on the right wall of the porch (poor).

*Joinery:* Fair condition

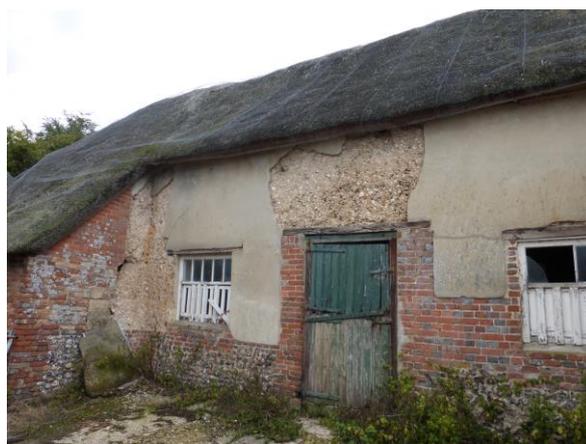
*Walling:* Cob and render on a flint and brick plinth. Extensions are brick. Large areas of render are missing, exposing damaged cob. Significant damage in the corner of one of the later extensions.

*Joinery:* Very poor.

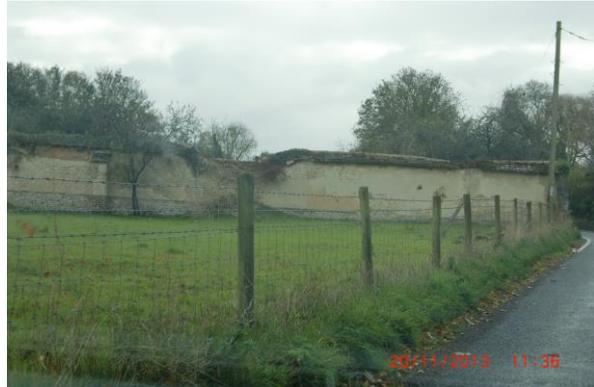
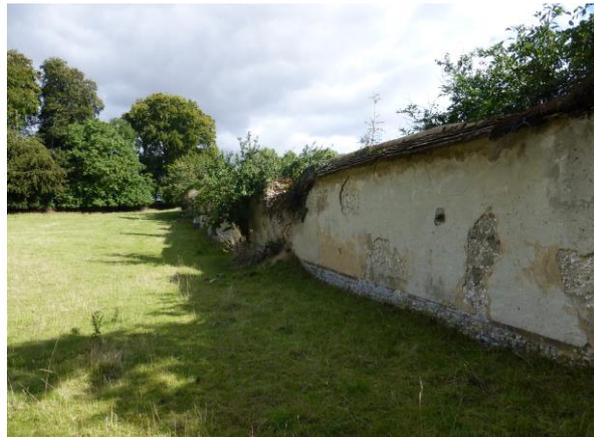
**Condition:** Significant delamination. One section has partially collapsed with loss of capping tiles and fabric (poor)

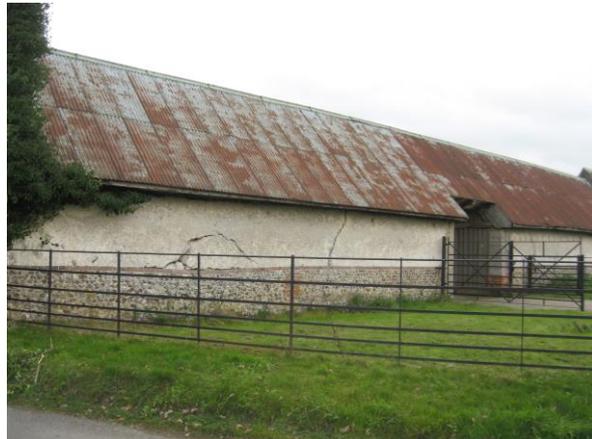
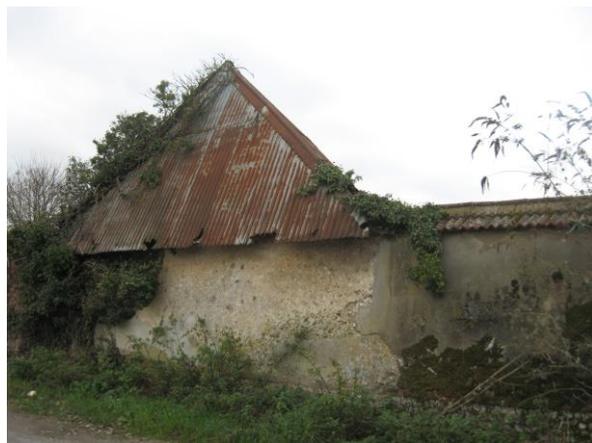
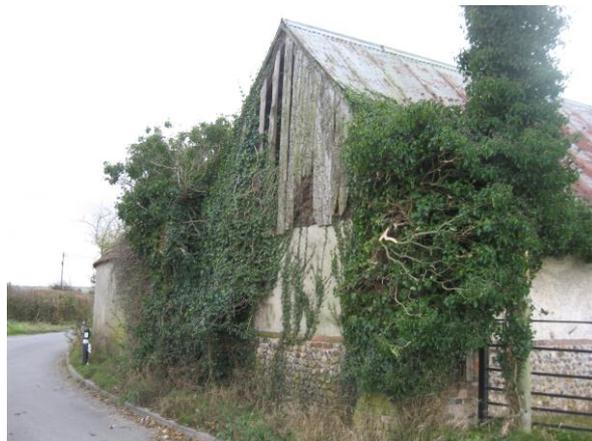
*Walling:* Cob on a base of flint and brick. Major structural cracks in the cob and significant delamination (poor)

*Joinery:* Some weatherboarding – damage and rot caused by exposure and vegetation (poor)
