PROJECT NAME  
DINAH'S HOLLOW, MELBURY ABBAS

REPORT  
SLOPE STABILITY OPTIONS APPRAISAL

CLIENT  
MELBURY ABBAS & CANN PARISH COUNCIL

REFERENCE NO  
C11895

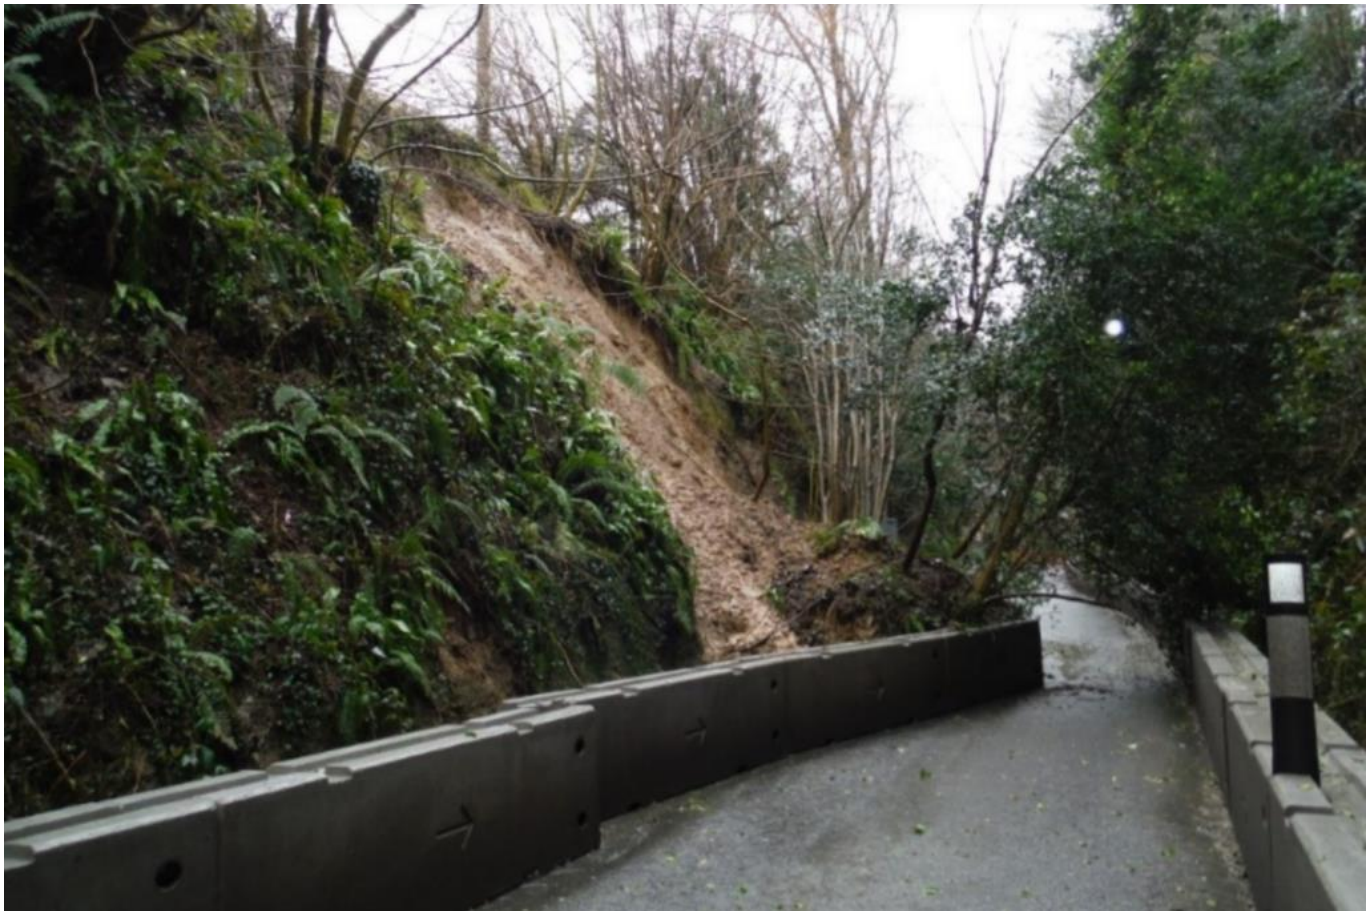
Figure 3-1 2016 slope failure

In March 2016 approximately 35 tonnes of soil slipped from the east bank onto the road which caused its temporary closure. A further three slips were recorded in October 2021 from the east bank. Approval to reactivate and progress the scheme was discussed and approved by DCC in 2020 and 2021 with WSP being commissioned in 2022 to review the scheme design and confirm it remained adequate and conforms to current standards.

A similar option would be to utilise barriers similar to those already in place, but higher, to catch material. These should be appropriately anchored into the ground to withstand the horizontal forces that will act upon them in the event of a failure. There is once again the risk of material overspilling into the road and/or the barrier deforming much like occurred in the 2016 failure (See Figure 3-1 below)

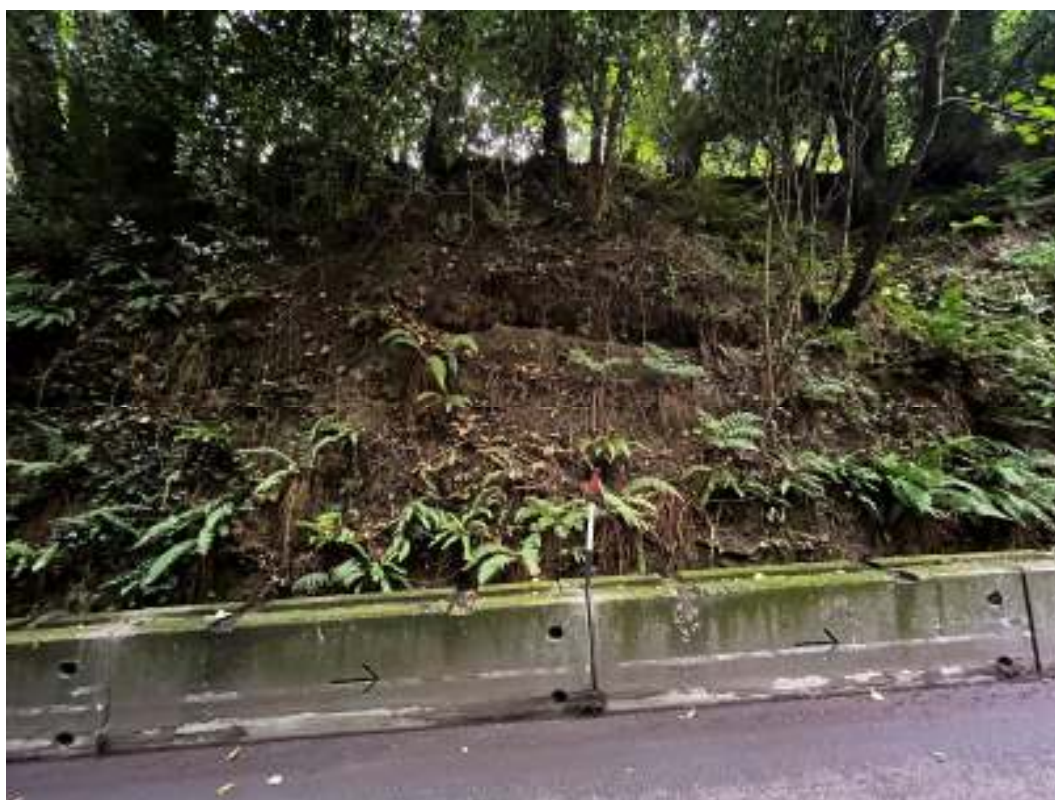
*Figure 4 Evidence of back scar formation on the lower slopes, western bank.*

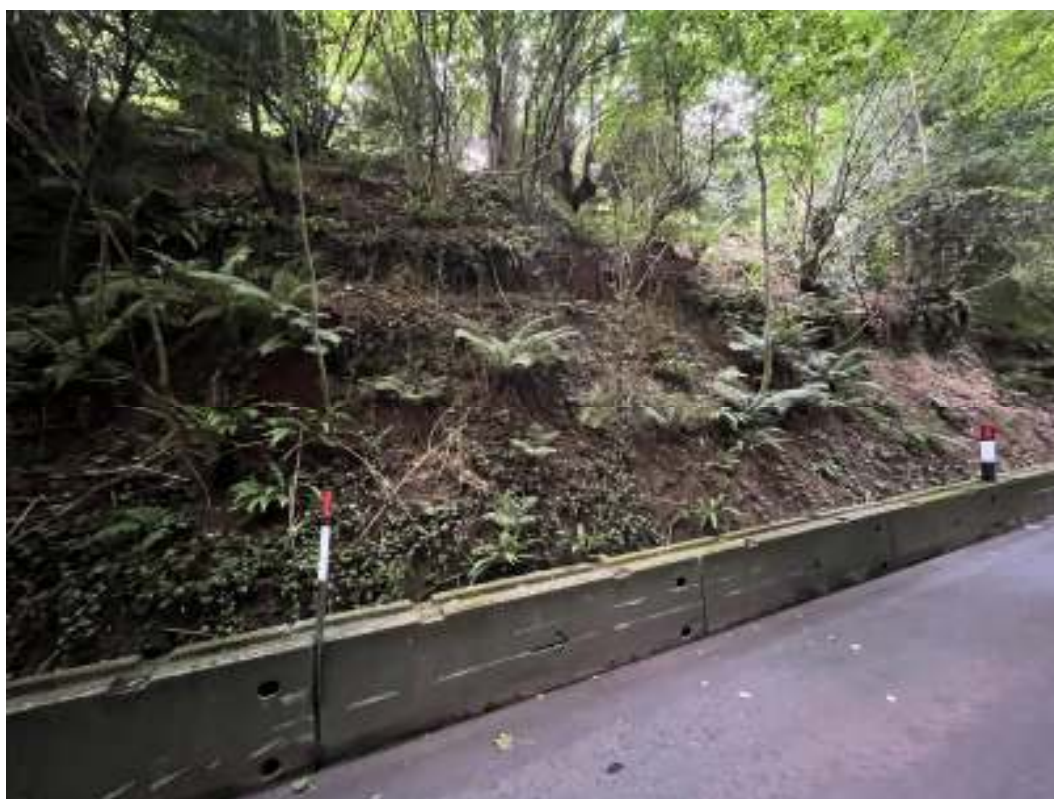
*Figure 5 Back scar formation on the western bank.*

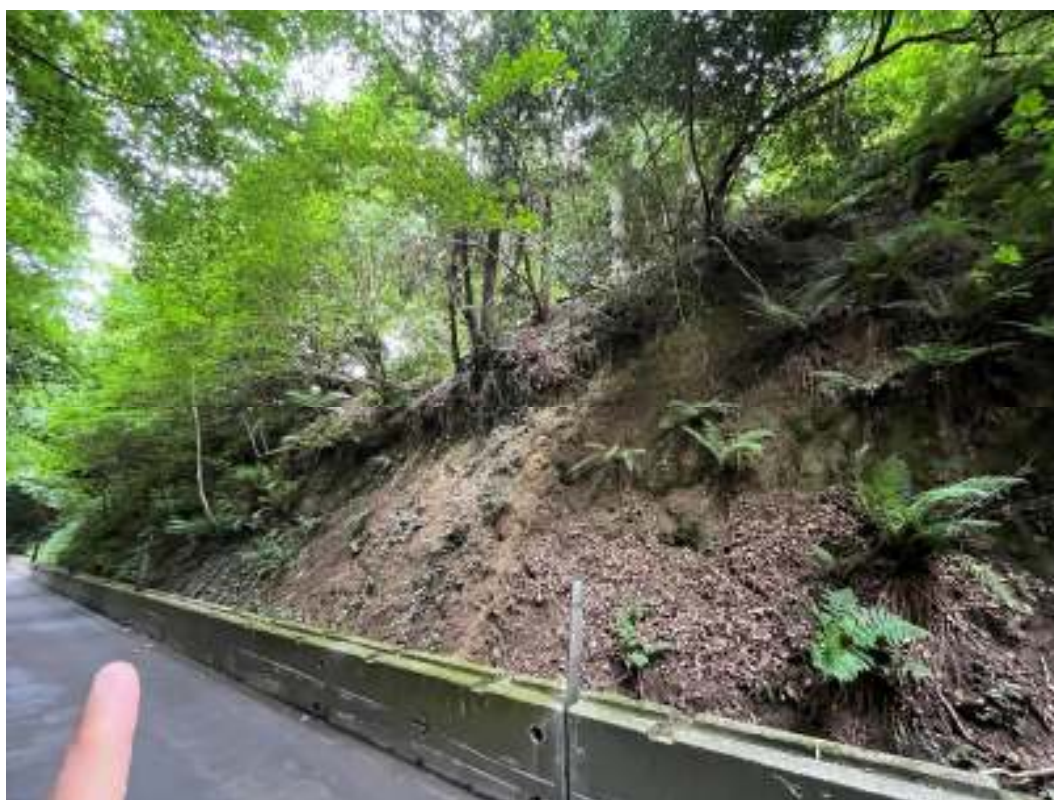
*Figure 6 Possible indication of recent slope movement - limited vegetation and exposed tree roots.*

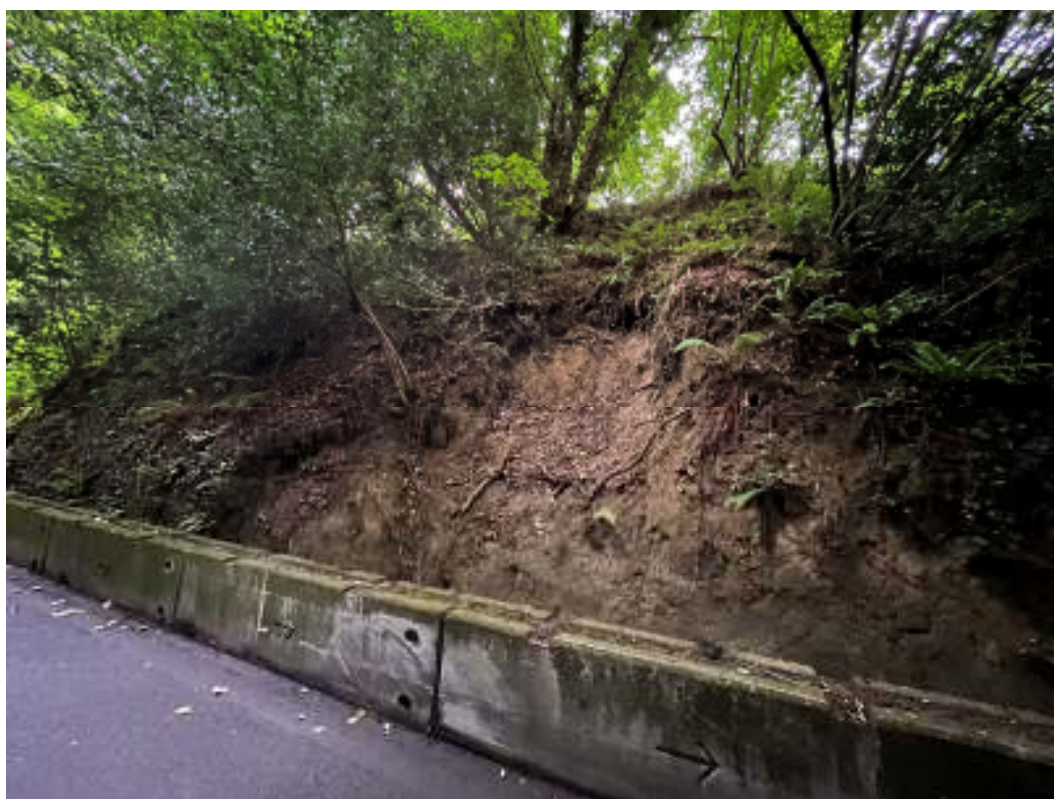
*Figure 9. Evidence of recent slope movement, eastern bank*

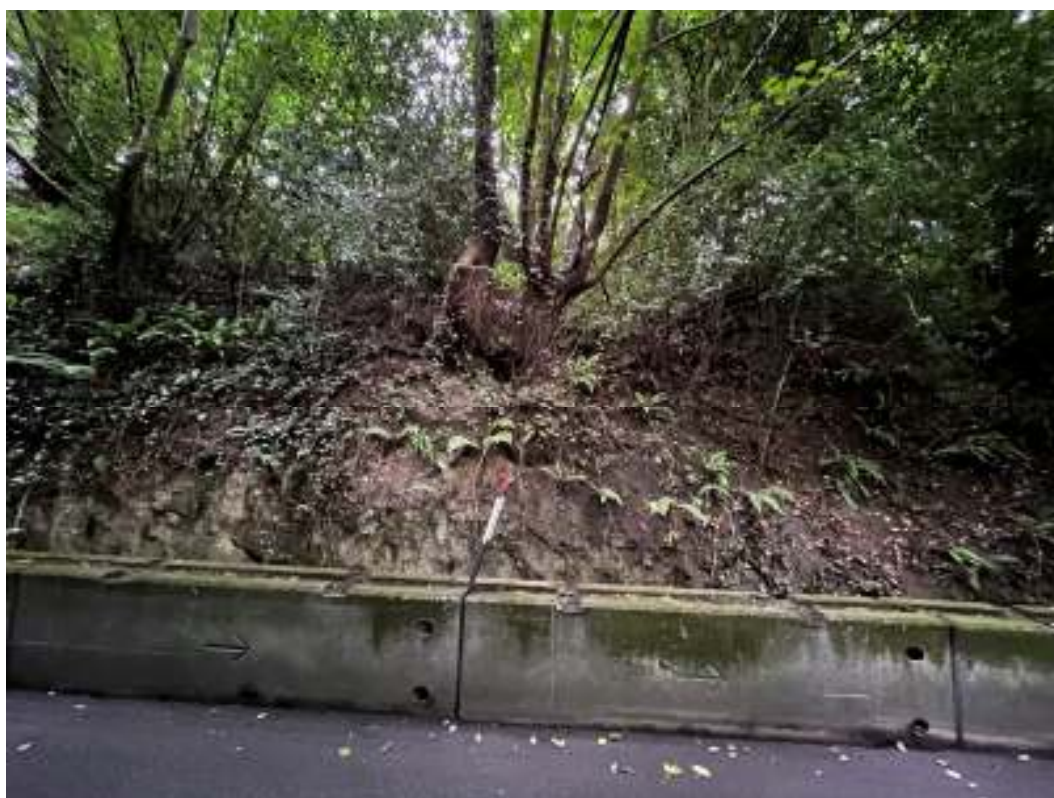
*Figure 10 Eastern bank with some evidence of back scar formation.*
