# MEMO

**SUBJECT:** Dinah's Hollow update March 2016

**DATE:** 17 March 2016

A landslide occurred at Dinah's Hollow on 9<sup>th</sup> March 2016. The site was consequently inspected on Friday 11<sup>th</sup> March by Ian King and Alexis Rose of WSP | Parsons Brinckerhoff to assess the landslide and surrounding ground conditions. This report summarises the background and the site visit.

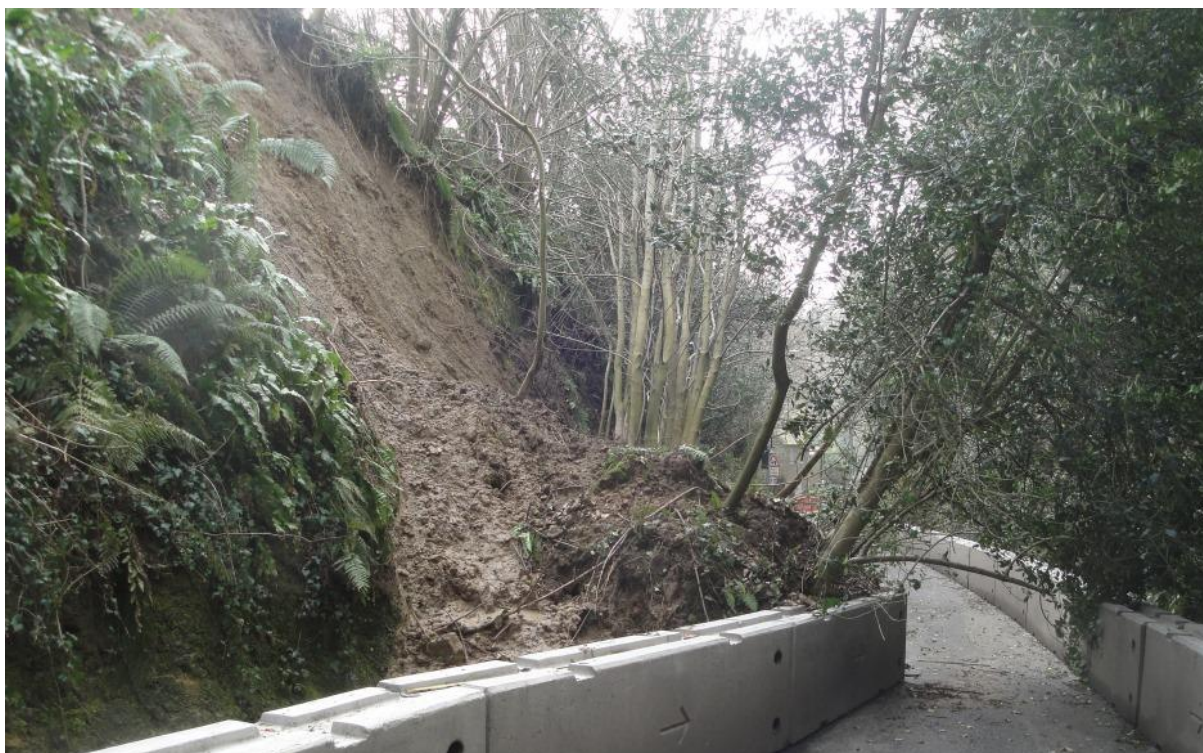
The main area of displaced material measured approximately 9m in length, up to 2.5m width and between 1m and 2m high (Figures 1 and 2). The volume of material is predicted to be about 20m<sup>3</sup> and therefore approximately 350kN, or 35 tonnes. The landslide is on the Eastern bank and is estimated to extend between 'local chainage' 130 and 140m. The detailed survey undertaken in February 2015 (Figure 3), shows the location of this recent landslide is coincident with the location of a historic slip.

**Figure 1: Landslip – viewing South**

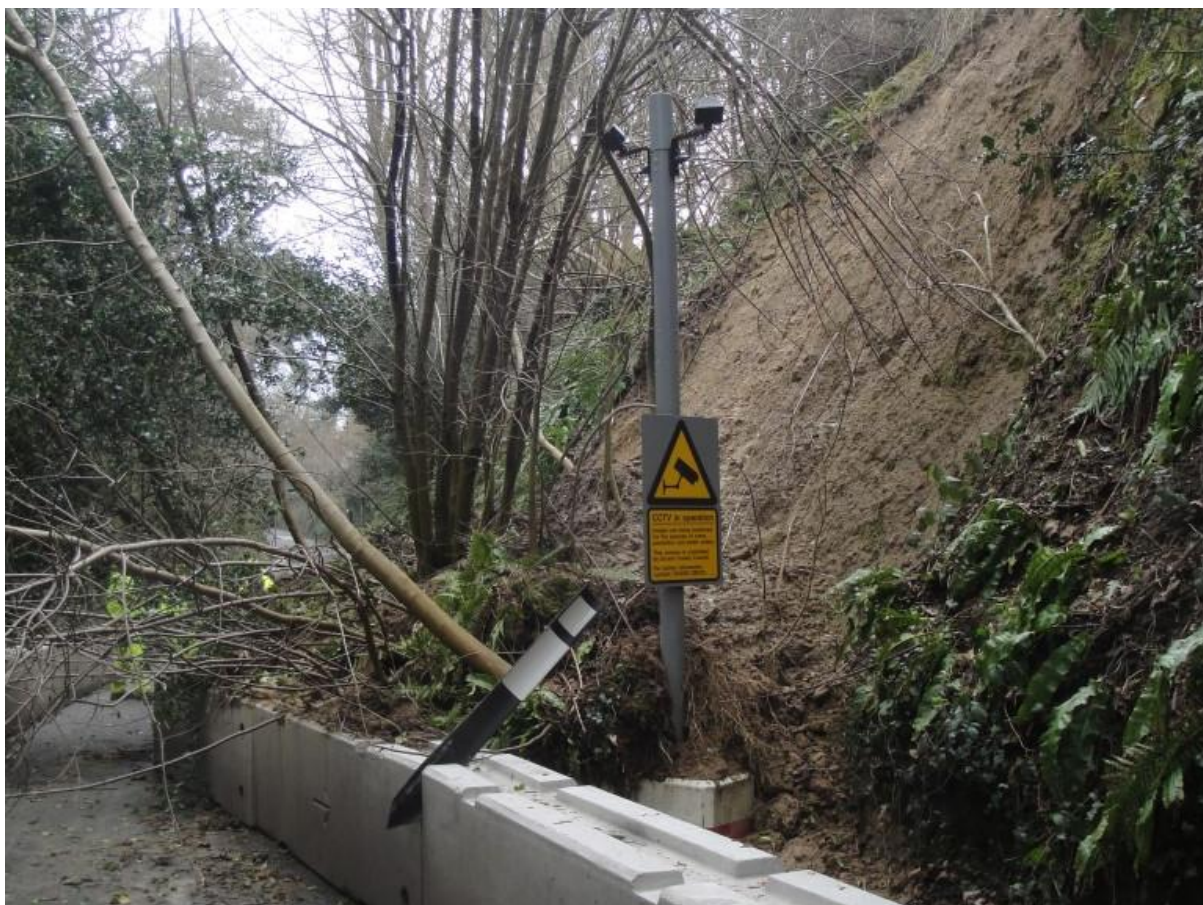
**Figure 2: Landslip – viewing North**

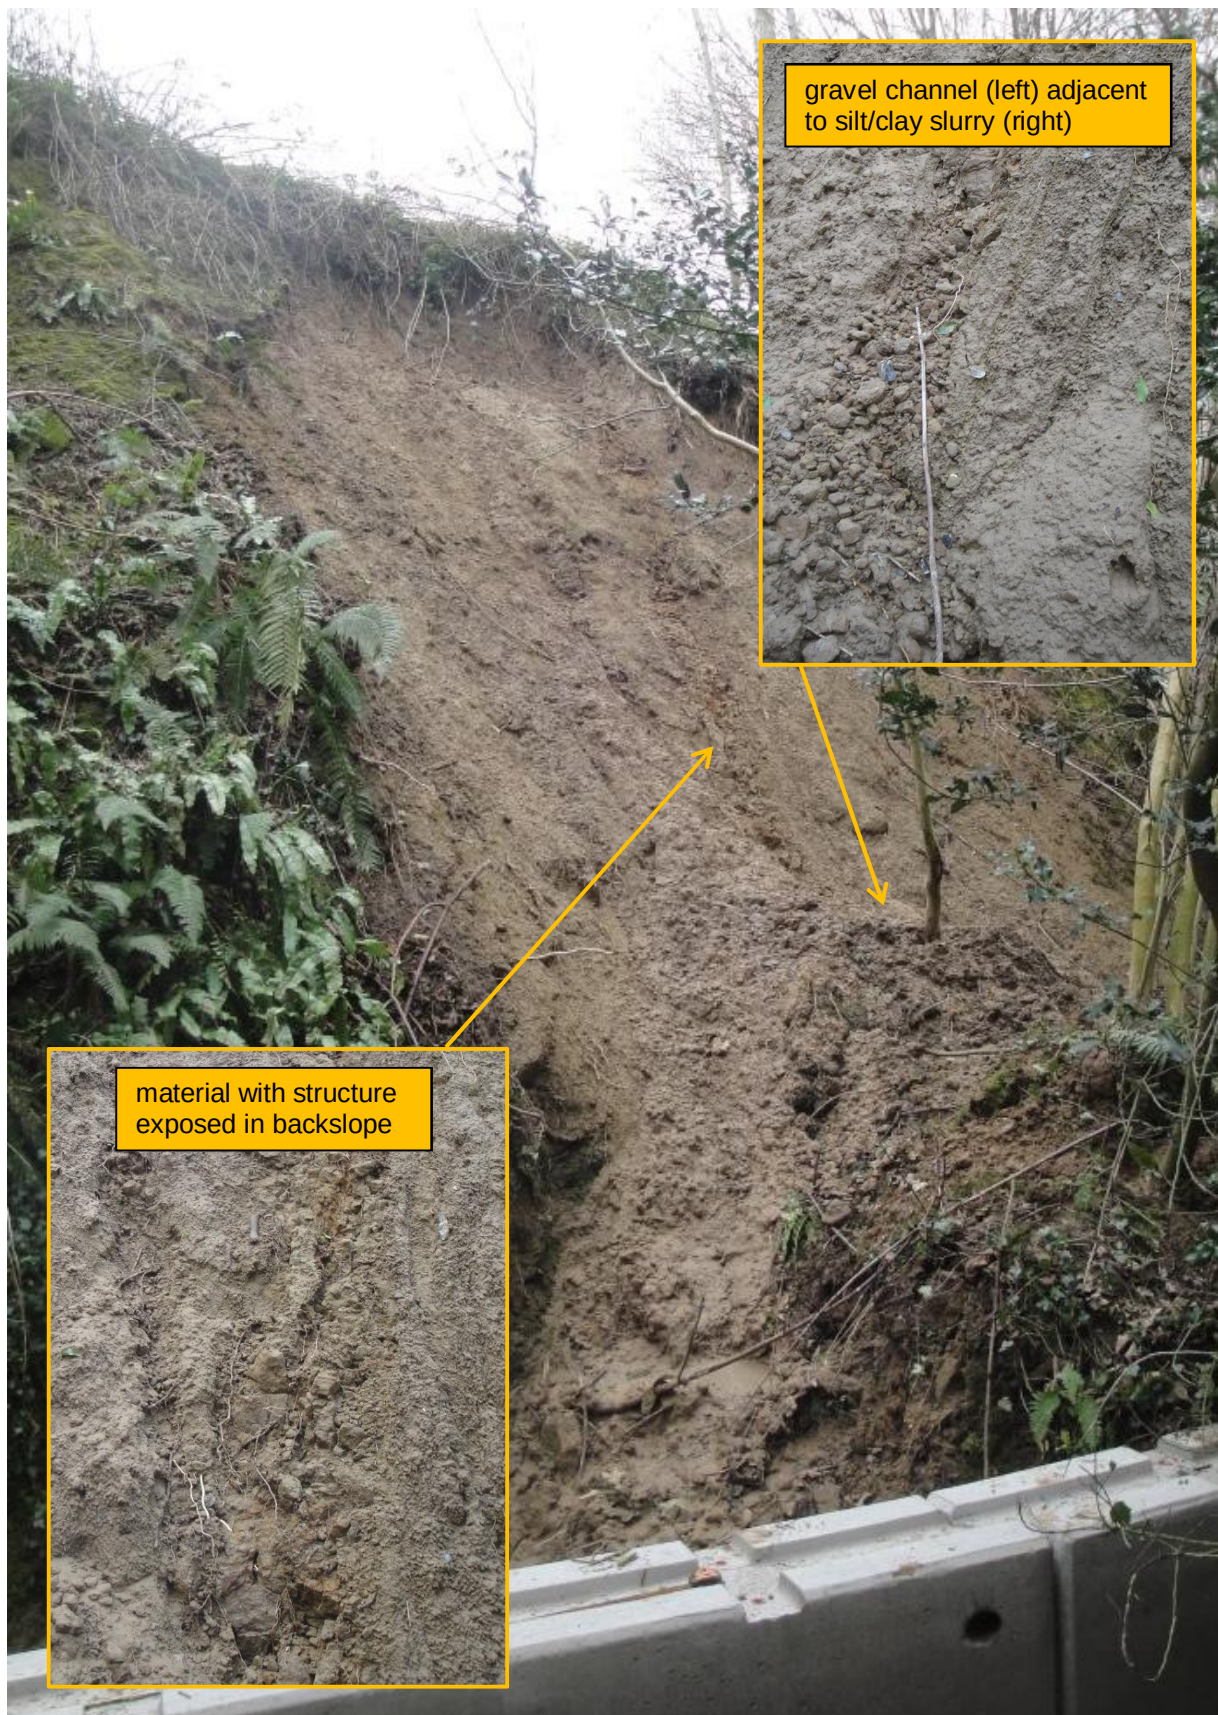
There are areas of structured material in the current back scar, indicating a relatively more competent material (rock or weathered rock, see Figure 4). This supports the idea that superficial deposits have become saturated and flowed down the face of the slope on the surface of this better quality material. The majority of the landslide material appeared to be heavily saturated silty clayey sand, with

occasional gravels and cobbles of sandstone. The material generally has a high silt content, which liquefies when disturbed. The landslide can be classified as a flow landslide.

The backslope has an approximate angle of between 60° (lower slope with higher clay content) and 80° (upper slope with lower clay content).

**Figure 4: Backslope of landslide with features highlighted**

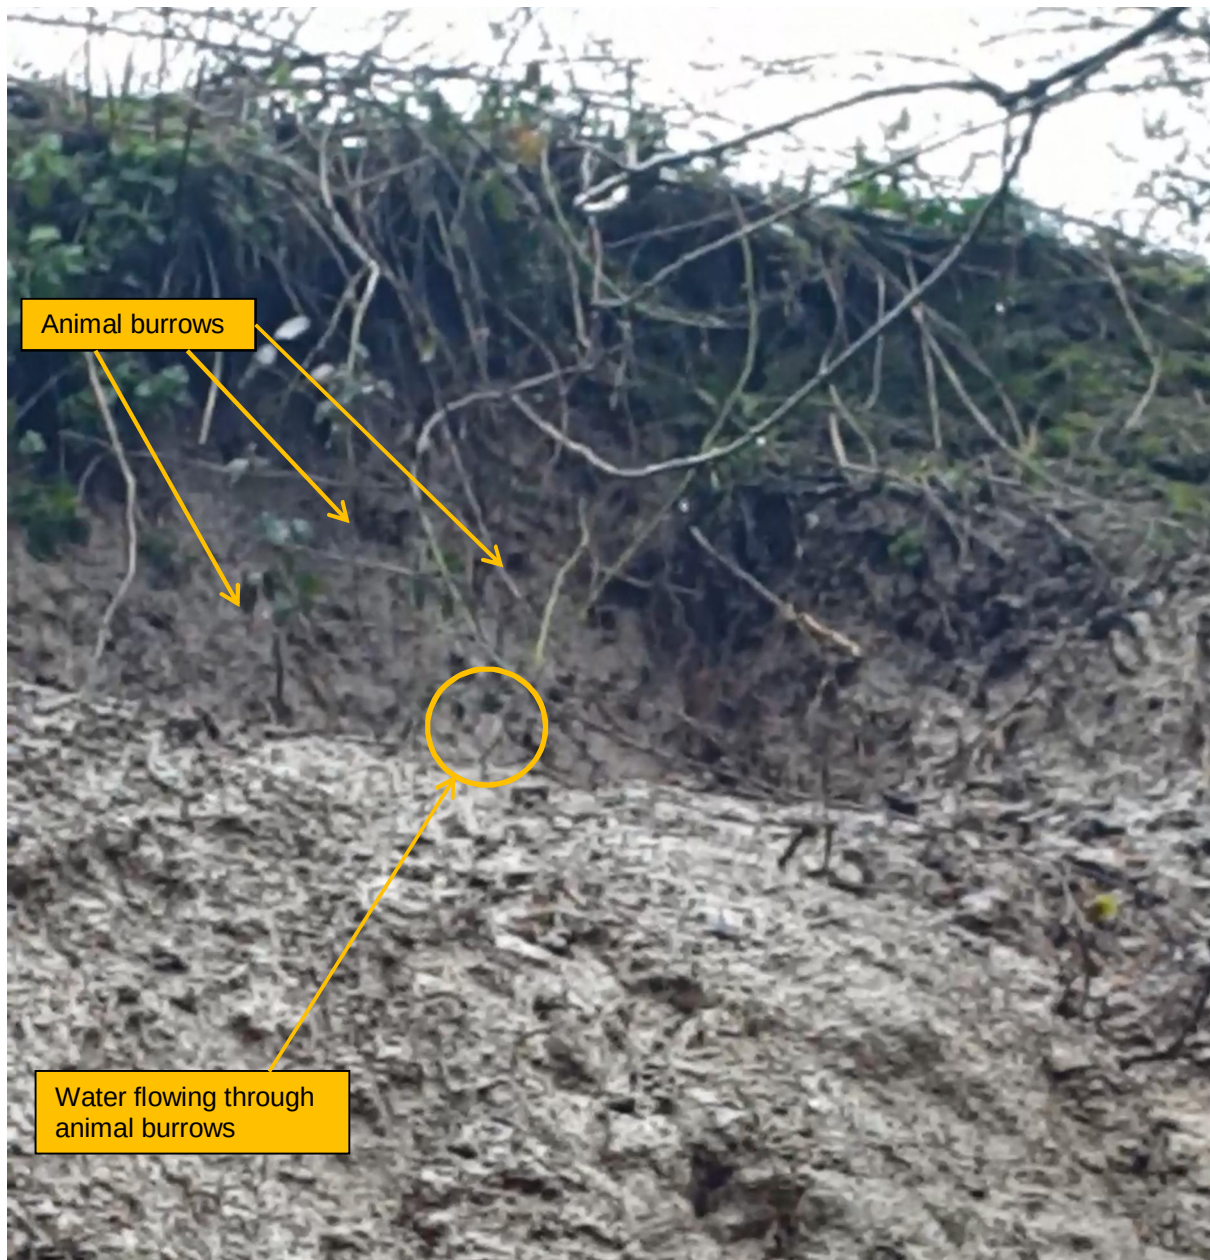
There was no sign of seepage during the site visit. However, a video made available by DCC, which was filmed on the morning of 9<sup>th</sup> March, shows seepage at the top of the back slope as well as the steady continuous movement of material down the slope. The most noticeable seepage observed in the video is a very heavy seepage flowing from what appears to be an animal burrow within the backscarp (see Figure 5). Seepage was also observed by DCC as a 'steady stream' of water flowing over the top of the bank.

**Figure 5: Extract from video with features highlighted**

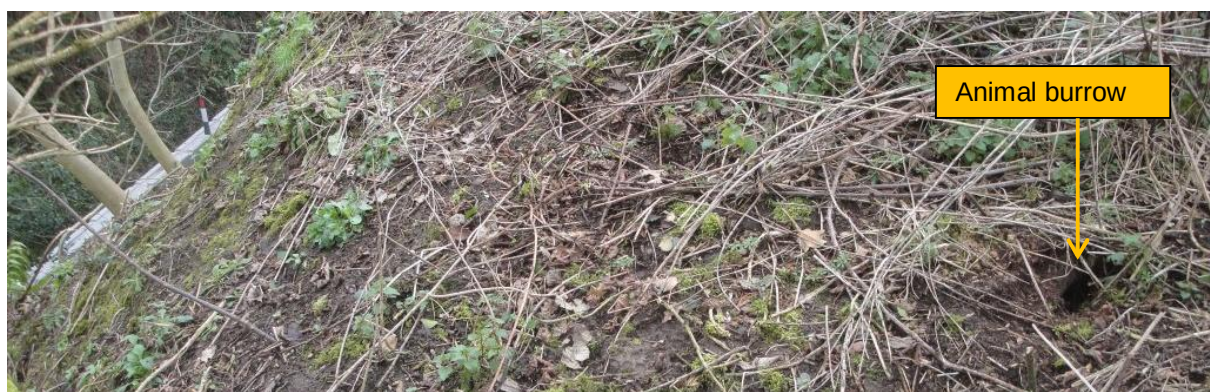
On inspection of the ground above the landslide (Figures 6 and 7), wet and spongy ground was discovered immediately above the backscarp along with a network of animal burrows. This observation ties in with the video evidence that water was flowing through the network of animal burrows. It has been noted on numerous previous site visits that silt and ponding occurs in the corner of the field close to the top of the landslide area (see Figure 8). Flattened grass was also observed, which may have been caused by flowing water (see Figure 9).

**Figure 6: Ground above landslip**

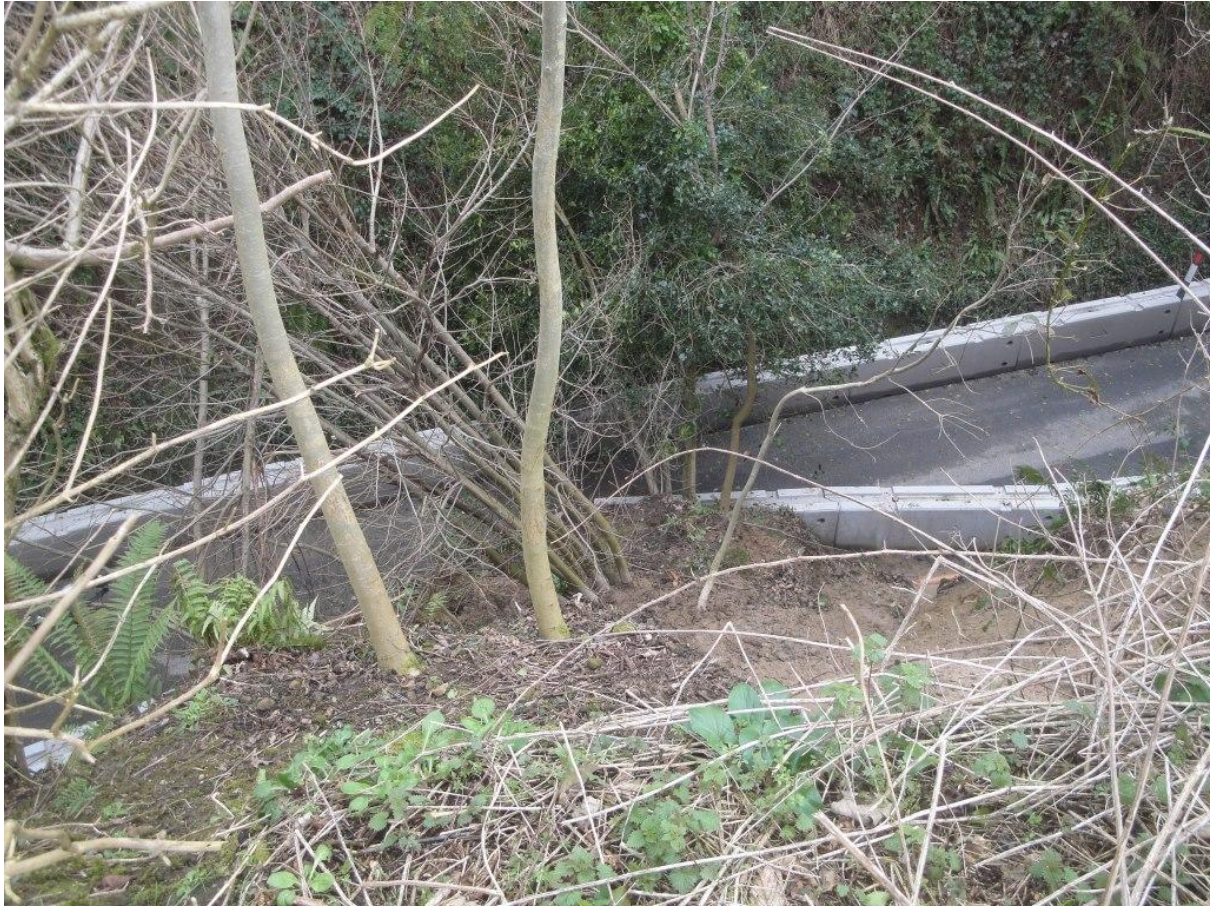
**Figure 7: View from top of landslip**

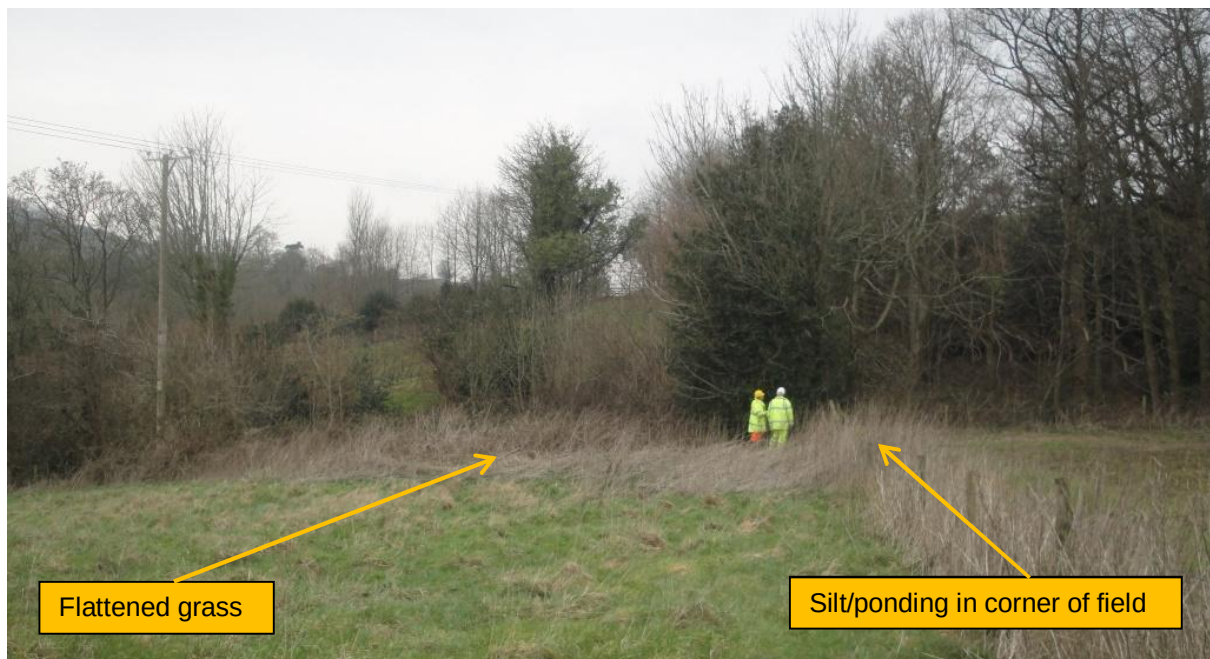
**Figure 8: Fields above landslip – viewing West**

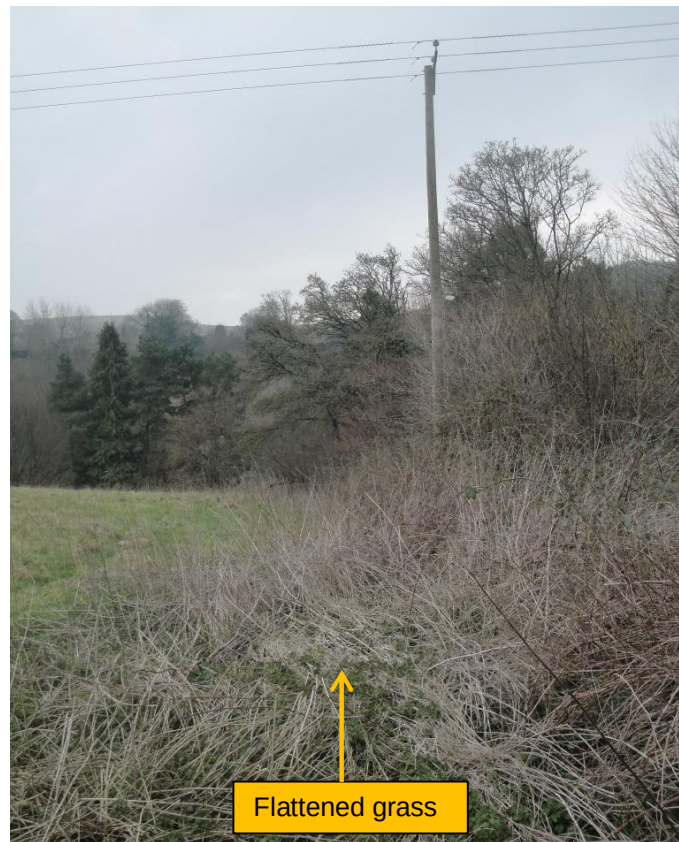
**Figure 9: Viewing South from field above landslip**

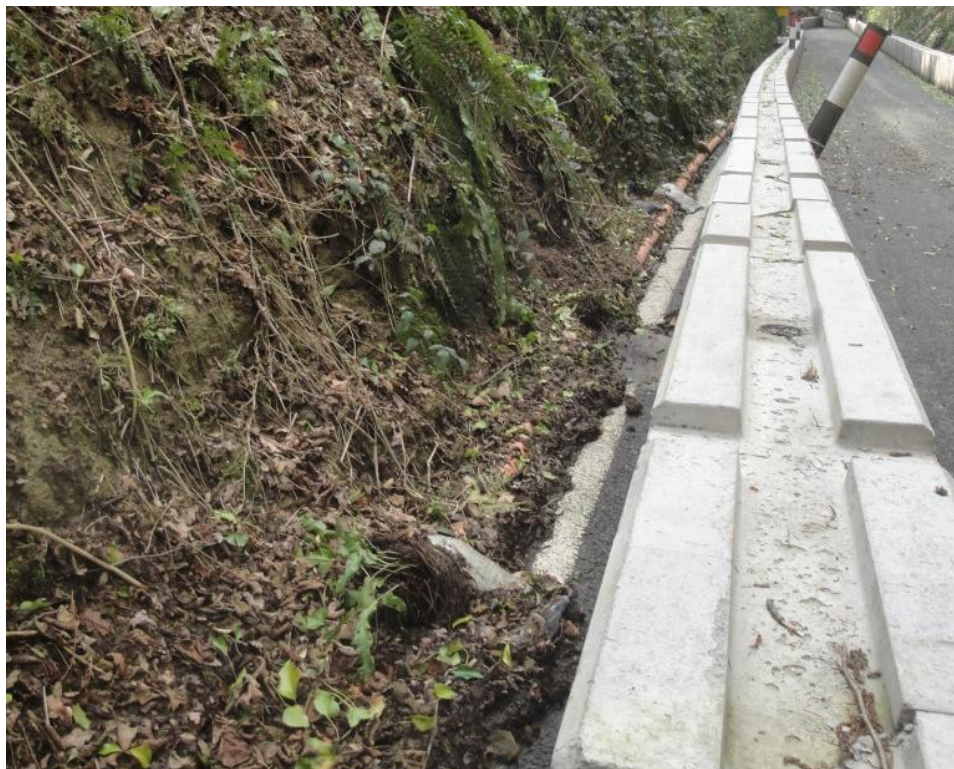
With the presence of the concrete barriers, very little removal of material at the toe of the banks has occurred (either naturally or otherwise). Figure 10 shows how material has built up, which is a combination of leaves and topsoil as well as superficial deposits and indicates that the slopes are likely to be undergoing gradual steady movements.

**Figure 10: Material collecting at toe of slope (approx. chainage 180, East)**

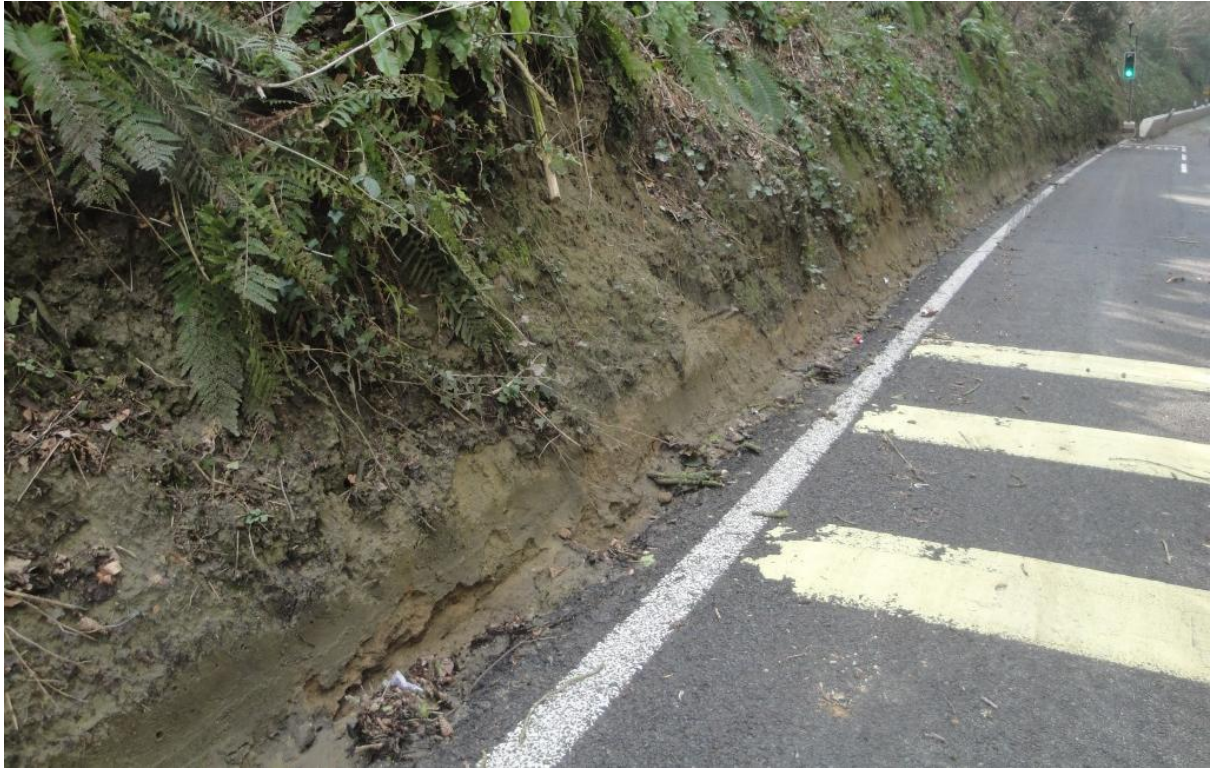
Fresh vehicle tyre marks were observed on both banks (Figures 11 and 12), which emphasise the presence of heavily saturated sand and soft material at the toe. Some vegetation trimming had taken place relatively recently, by Mr Phillips on the West bank, and by DCC on the East bank.

**Figure 11: Wheel marks exposing fresh saturated sand (approx. chainage 250, East)**

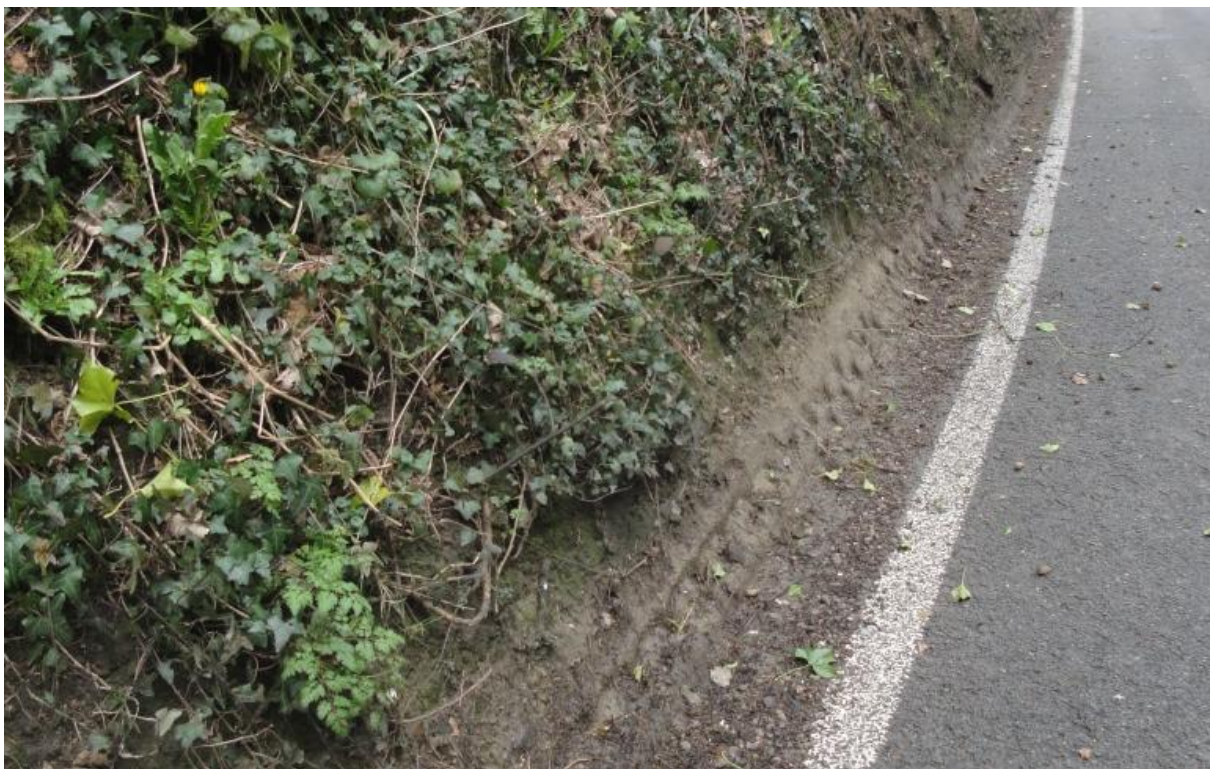
**Figure 12: Tyre marks exposing soft material (approx. chainage 250, West)**

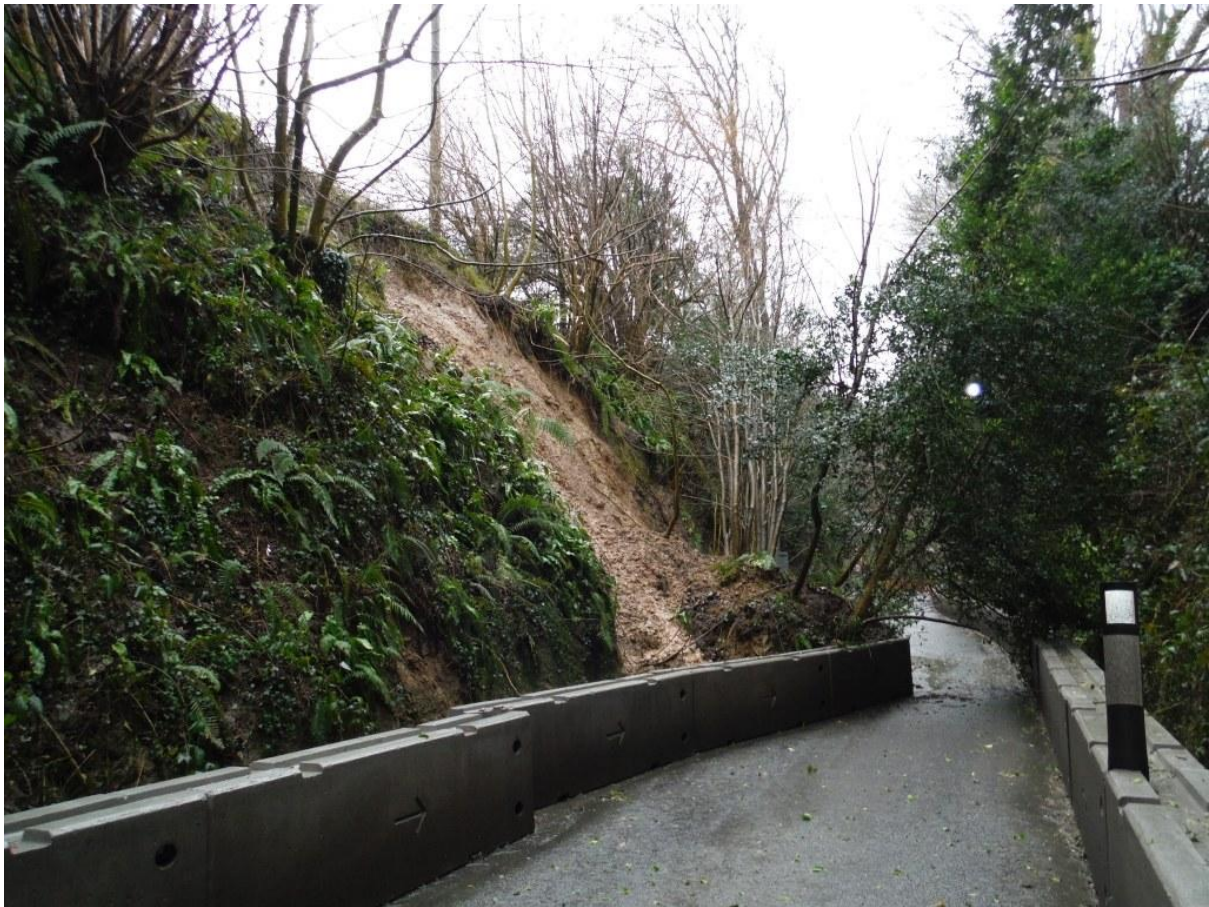
It has been noted that the photos taken by DCC on 9<sup>th</sup> March appear to be very similar to the photos taken by WSP | Parsons Brinckerhoff on 11<sup>th</sup> March. The shape of the landslide and arrangement of the landslide debris appear to be unchanged and the only notable difference is the water present on the 9<sup>th</sup> March (see Figure 13), which has clearly dried out by 11<sup>th</sup> March.

**Figure 13: Photo taken by DCC on morning of 9<sup>th</sup> March**
