Christchurch Bay and Harbour Flood and
Coastal Erosion Risk Management Study
**Technical Annex 7: Condition Assessment & Beach Profile
Analysis**

Prepared by
New Forest District Council

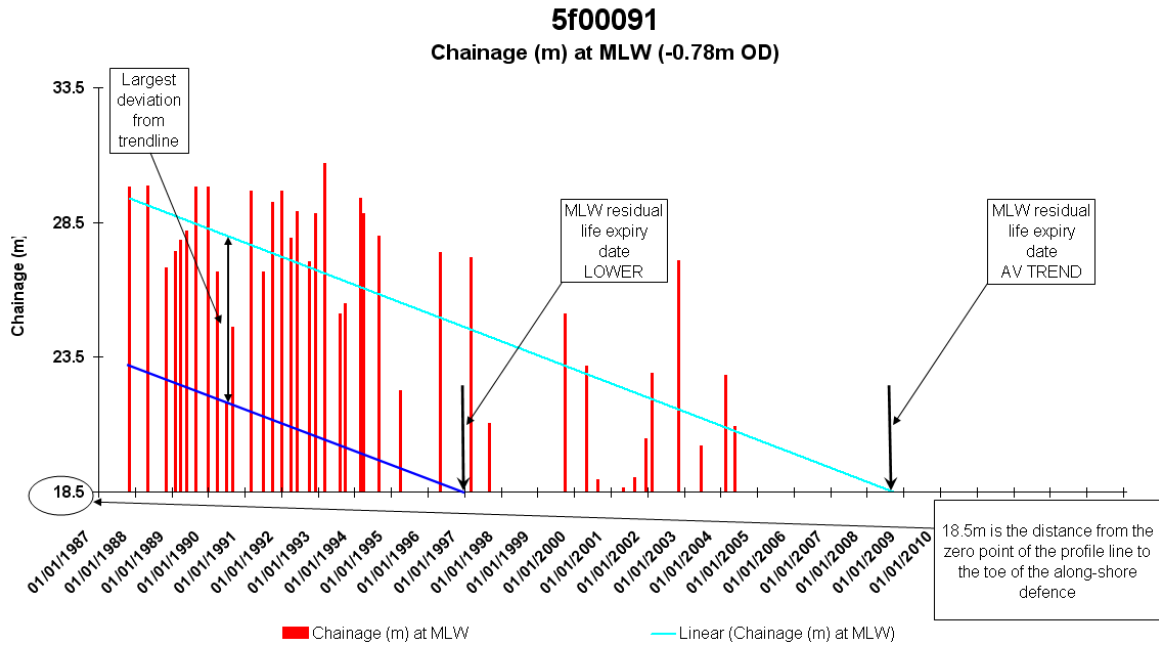
Figure 3.4 MLW expiry date forecast (lower & average trend) for profile location 5f00091

Figure 3.4 indicates the trendline for the lower and average trend expiry date. The average trend expiry date is generated by extending the average (regression) trendline (coloured light blue in figure 3.4) into the future until it meets the defence toe chainage position (i.e. the point in the future when MLW coincides with the toe of the defence). The lower trend expiry date has been generated to take into account the contribution of beach draw down caused by seasonal variation or following storm events. Over the period the profile has been surveyed, there has been a significant deviation between the recorded chainage position and the average trendline position. The lower deviation is important as it represents a scenario when the MLW is significantly closer to the toe of the defence (in comparison with the average trend rate). Although the MLW position is not maintained, during these periods the risk of structural failure is considerably increased. Therefore in order to take the lower deviation into account the lowest recorded deviation is selected and the trendline applied to this lower level (coloured dark blue in figure 3.4). The lower trend line is again projected into the future until it meets the defence toe chainage position. Lower and average trend expiry dates have been calculated at all profile locations where regression has been identified and the complete results are presented in Appendix E (Table E.1). A summary of the results is presented in Table 3.2 (below).

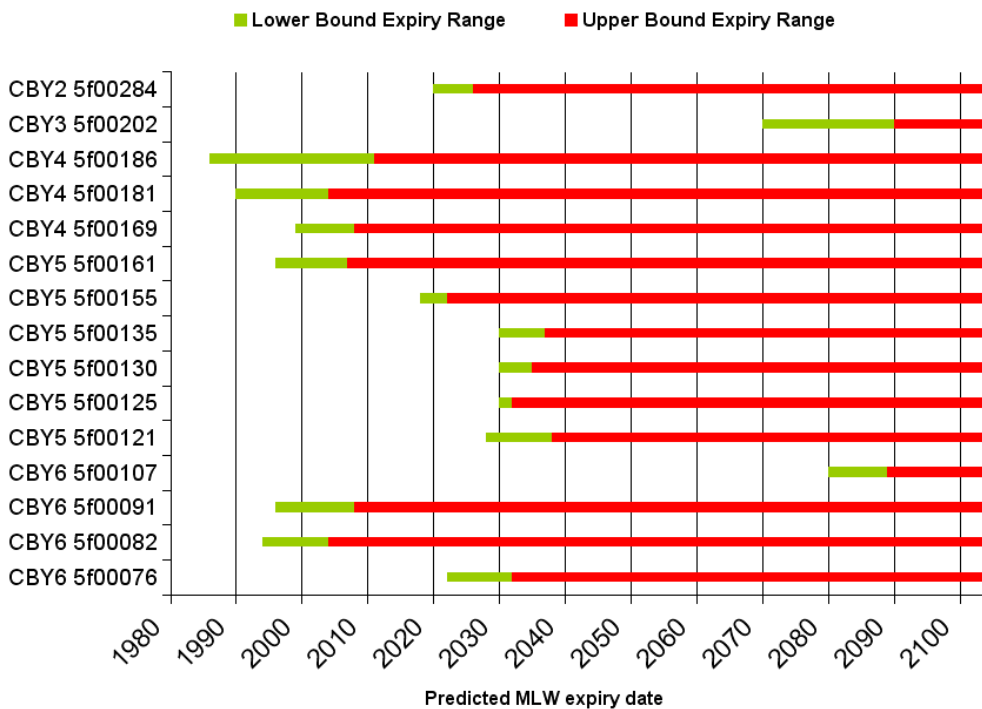
Figure 3.5 Lower and upper bound expiry dates

Figure 3.5 is a timeline which highlights when the lower and average trendlines are predicted to coincide with the toe of the defence. The start of the green bar in Figure 3.5 represents the earliest predicted date that MLW will reach the toe of the structure (taken from the lower trendline projection). The start of the red line is the predicted date when MLW will reach the toe of the structure (taken from the average trendline projection).

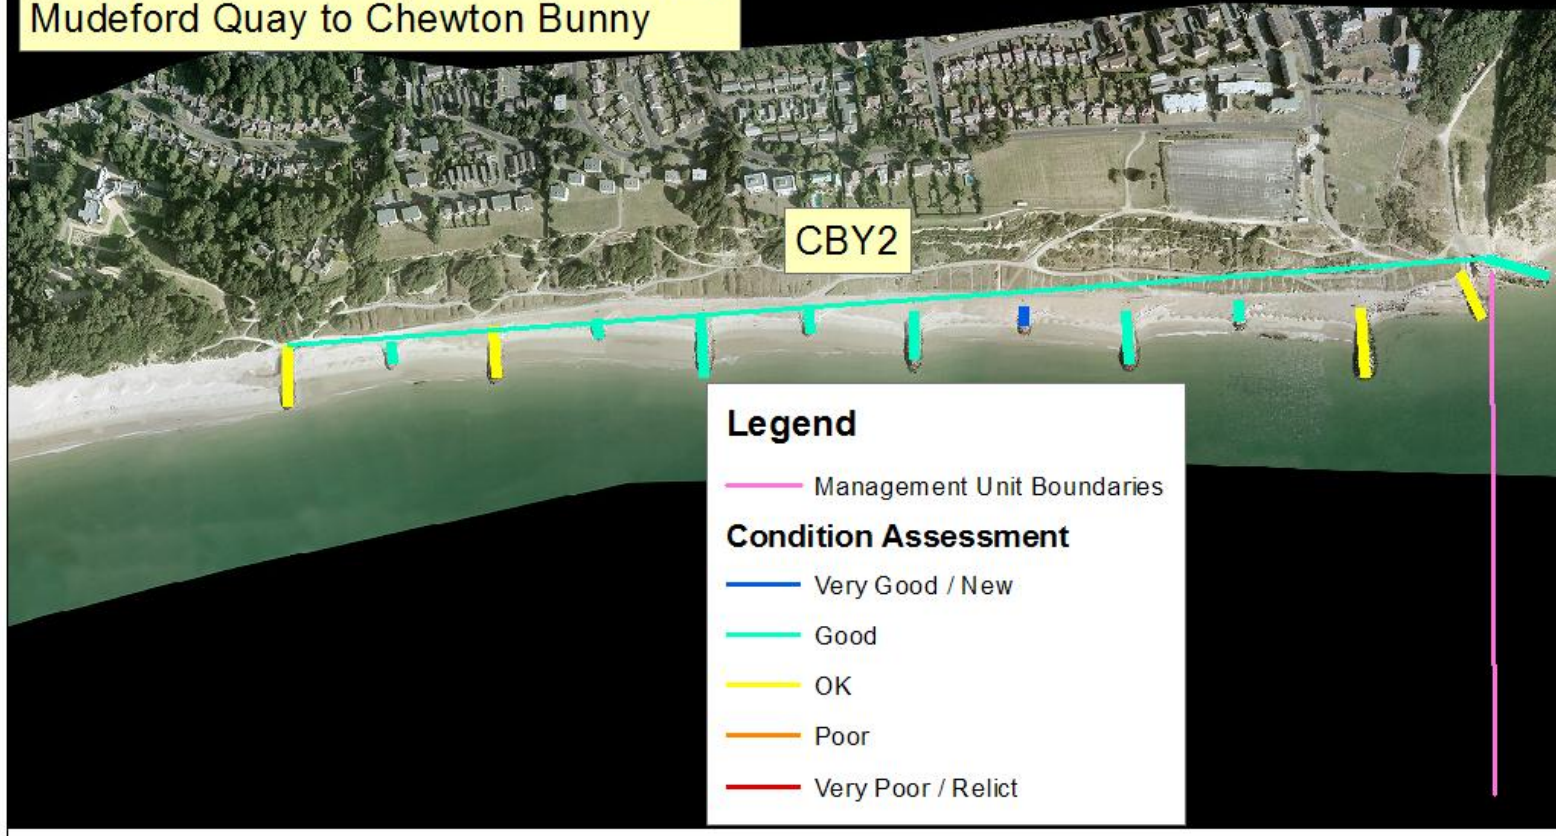
Figure B.3

Condition Assessment for CBY2 (East)
Mudeford Quay to Chewton Bunny

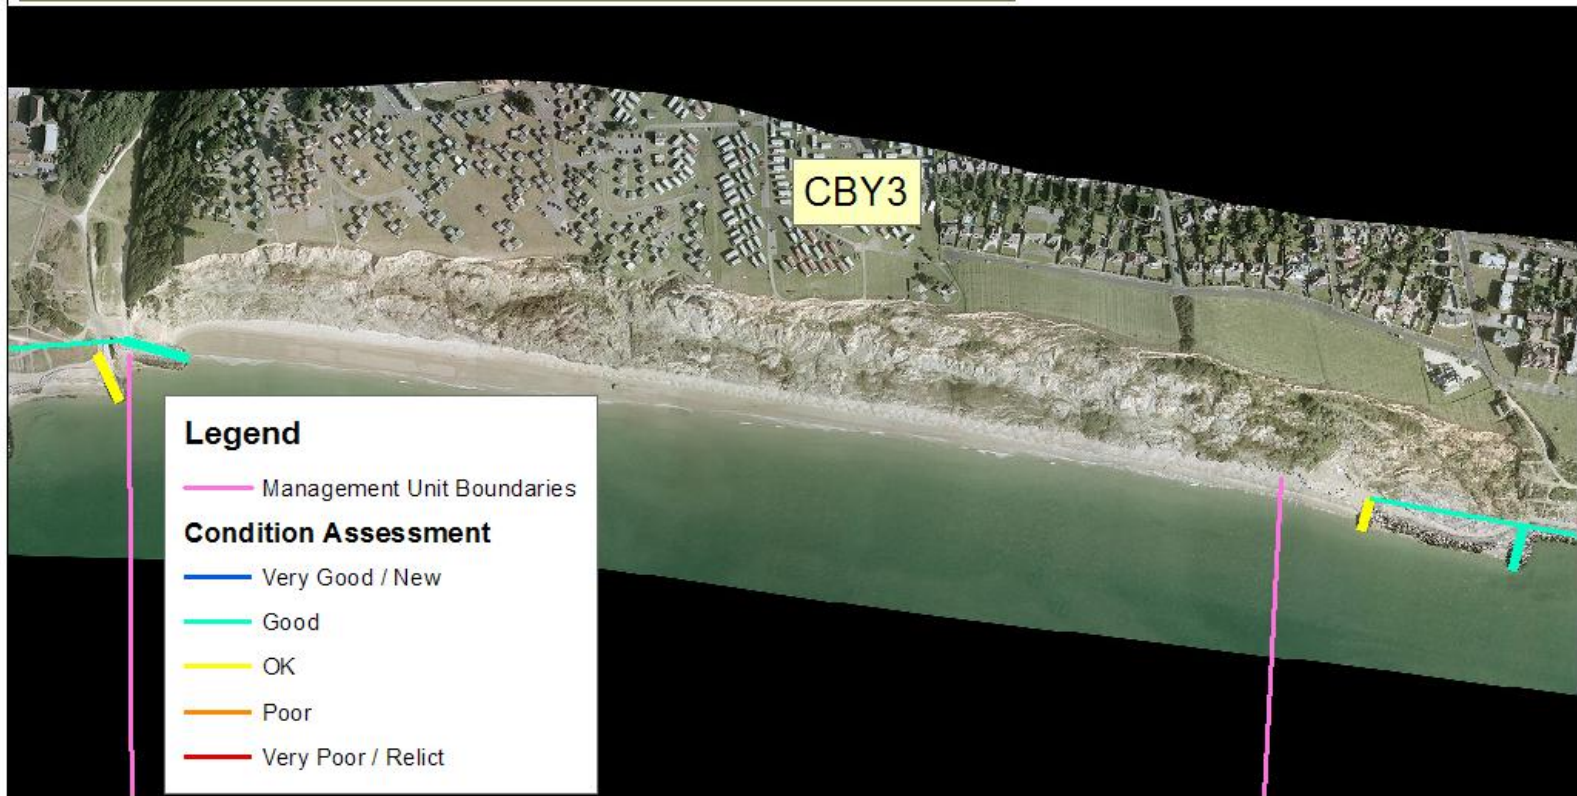
Figure B.4

Condition Assessment for CBY3
Chewton Bunny to start of defences at Barton-on-Sea

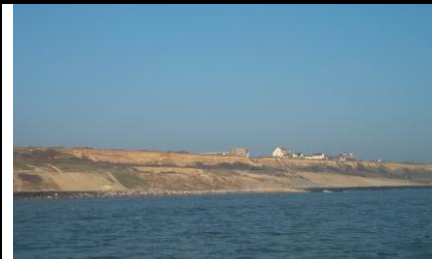
<p>Plate C4.1 Looking northeast, view of rock revetment and cliff stabilisation structures at Barton-on-Sea</p>

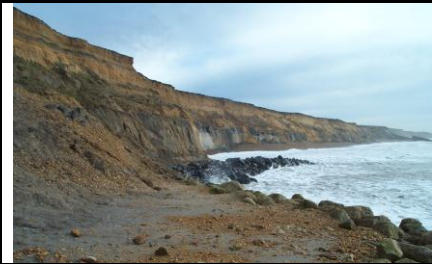
<p>Plate C5.2 Looking east, coastline to the east of Strong Point 25 at Barton-on-Sea</p>

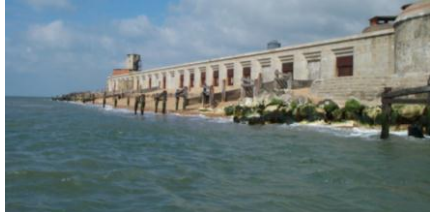
Plate C7.3 Looking northwest, view of wooden groynes and rock revetment on south side of Hurst Castle, Hurst Spit
