Christchurch Bay and Harbour Flood and
Coastal Erosion Risk Management Study
Technical Annex 8 – Assessment of Standards of Service

Prepared by
New Forest District Council

Technical Annex 8: Assessment of Standards of Service

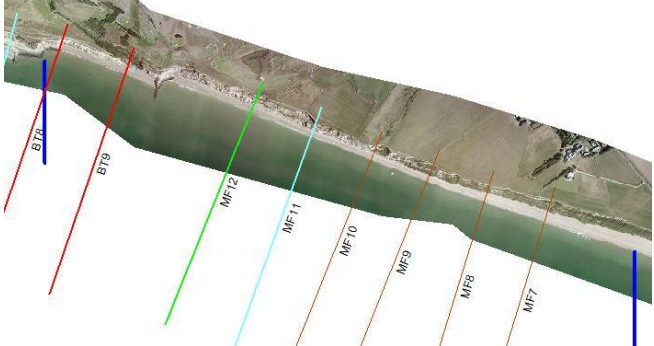
<p>The beaches in the central section of the bay from Barton (BT1) to Hordle (MF10) exhibit a narrowing trend with the MLW reaching the toe of the defences between year 1 and 20 of the strategy.</p>	
<p>CBY6</p>

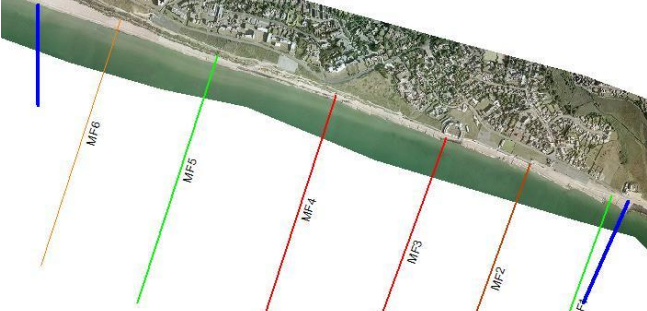
<p>The general trend of the MLW position for the Milford frontage indicates that the defences will receive a level of protection by a width of beach until between 2024 to 2053.</p>

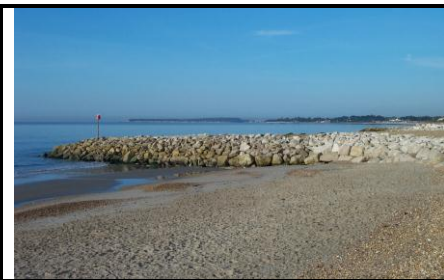
View looking approximately west of rock strong point on Highcliffe Beach.

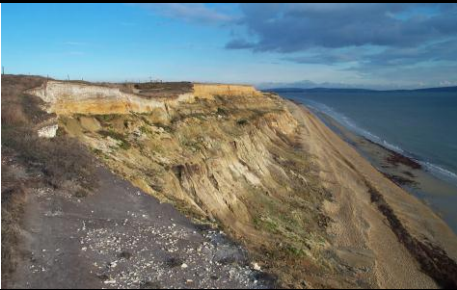
View looking approximately east of undefended frontage at Becton, east of Strong Point 25 at Barton-on-Sea.
 	View looking approximately east of Strong Point 25 at Barton-on-Sea.

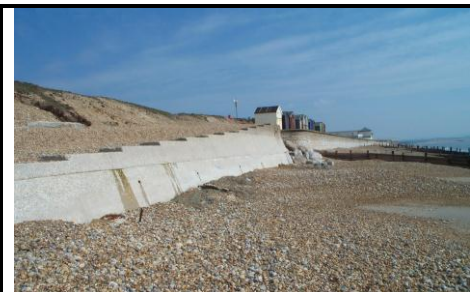
View looking approximately west of concrete seawall and wooden groynes at Milford-on-Sea, as well as timber beach huts.

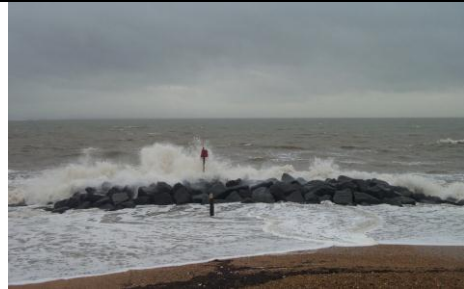
View looking approximately west of offshore rock breakwater, Hurst Spit.

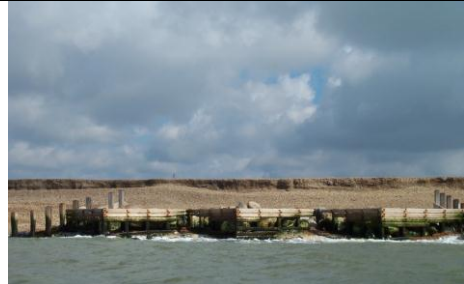
View looking approximately northeast of wooden revetment and groynes west of Hurst Castle, Hurst Spit.

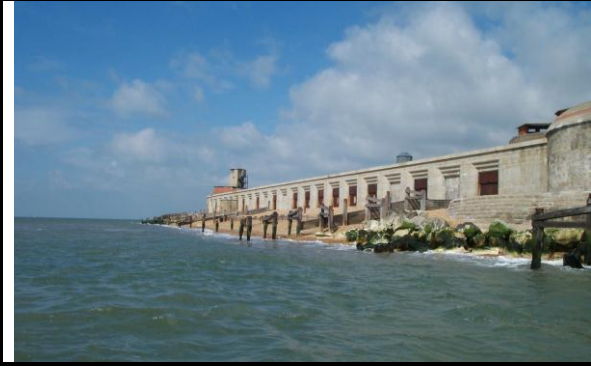
View looking approximately northwest of wooden groynes and rock revetment on south side of Hurst Castle, Hurst Spit.
