Christchurch Bay and Harbour Flood and
Coastal Erosion Risk Management Study
Technical Annex 10: SSSI Condition Assessment

Provided by
Natural England

Technical Annex 10: SSSI Condition Assessment

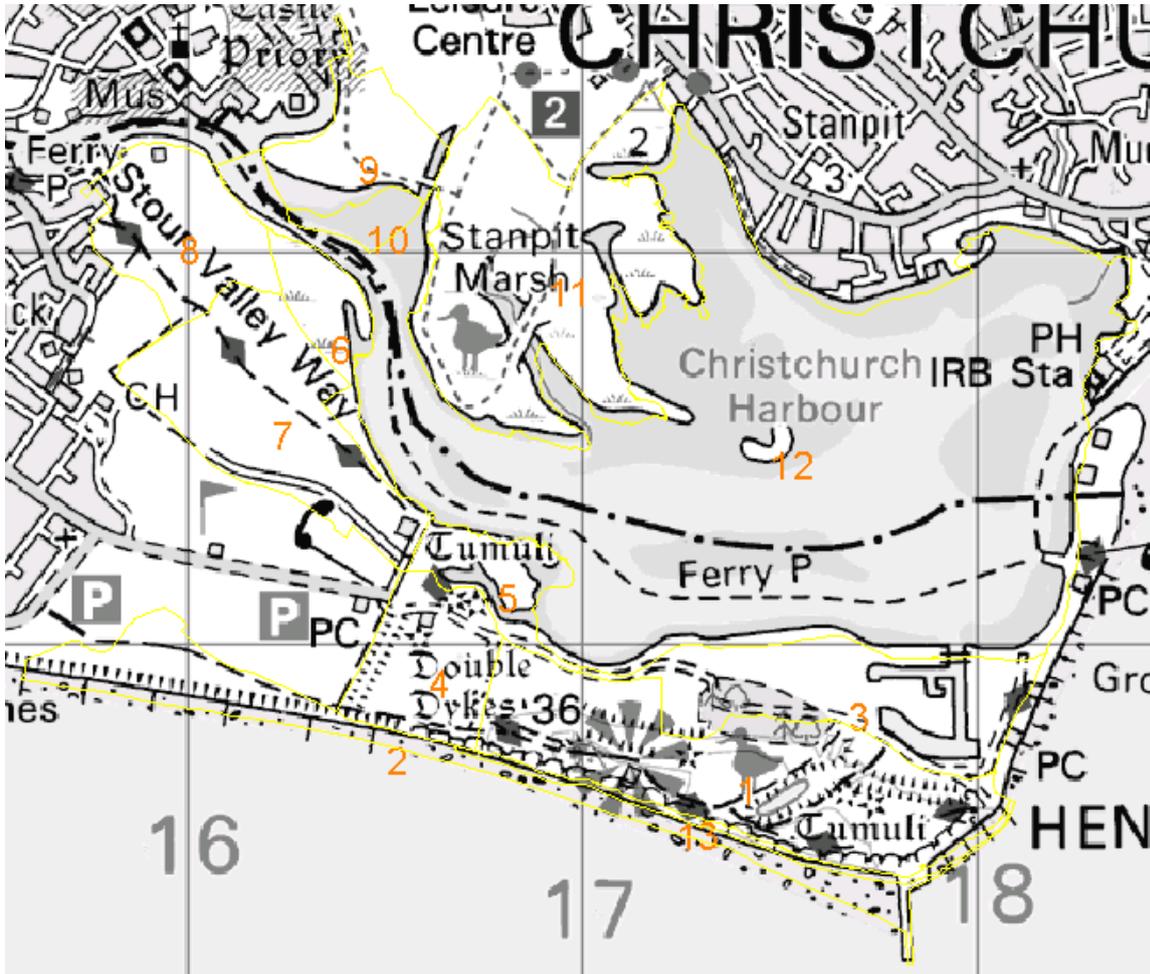
Christchurch Harbour SSSI

MANAGEMENT UNIT	CHB1 to 5
COASTAL DEFENCES	seawall & timber groynes
SSSI UNIT REF. UNIT LENGTH	Units 1 to 13
SSSI TYPE / HABITAT	Earth Heritage, shrub and grassland lowland, supra-littoral rock, and littoral sediment
DATE OF LAST INSPECTION	Sept 1997 to Sept 2000
SSSI CONDITION	Various
COMMENTS (Nov 2002)	Harbour mainly Favourable, although sub-units also unfavourable declining and no change

Main habitat	Unit No.	Unit area (ha)	Latest assessment date	Condition	Reason for adverse condition
Dwarf shrub heath - lowland	1	36.14	03/11/04	Favourable	
Supralittoral rock	2	20.30	03/11/04	Unfavourable declining	Inappropriate weed control
Supralittoral rock	2	20.30	03/11/04	Unfavourable declining	Undergrazing
Littoral sediment	3	21.16	03/11/04	Favourable	
Acid grassland - lowland	4	12.4	03/11/04	Unfavourable no change	
Littoral sediment	5	6.83	03/11/04	Unfavourable declining	
Littoral sediment	6	6.9	10/02/2000	Favourable	
Acid grassland - lowland	7	24.60	03/11/04	Favourable	
Neutral grassland - lowland	8	13.93	03/11/04	Favourable	
Neutral grassland - lowland	9	10.52	26/08/03	Favourable	
Littoral sediment	10	2.61	10/02/2000	Favourable	
Littoral sediment	11	41.60	03/11/04	Favourable	
Littoral sediment	12	152.55	26/03/04	Favourable	
Earth heritage	13	2.98	26/09/2000	Favourable

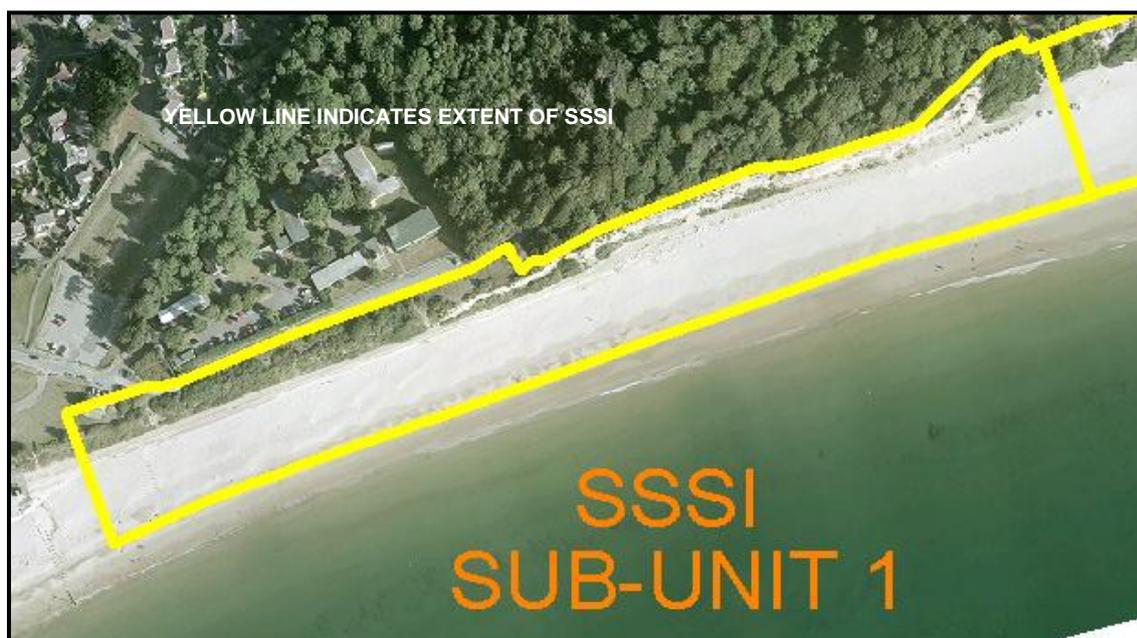
MANAGEMENT UNIT	CBY2
COASTAL DEFENCES	Seawall & timber groynes / undefended cliffs
SSSI UNIT REF.	SSSI Sub Unit 1
LENGTH / AREA	505 metres / 3.3 ha
SSSI TYPE / HABITAT	Earth Heritage
DATE OF LAST INSPECTION	1 st February 2001
SSSI CONDITION	Favourable
COMMENTS (FEB 2002)	Cliff with good exposures although minor build up of material at foot of cliff masks some of the lower exposures. Some Holm Oak present.

CHRISTCHURCH BAY STRATEGY OPTIONS		LIKELY IMPACT ON SSSI WITH RESPECT TO FEB 2001 CONDITION			
		Decline	Maintain	Improve	
1	Do Nothing (cliff erosion following seawall failure)			•	
2	Hold the line (replace seawall following failure)		•		
3	Hold the line (recharge beach to west & maintain seawall) *		•		* Preferred option

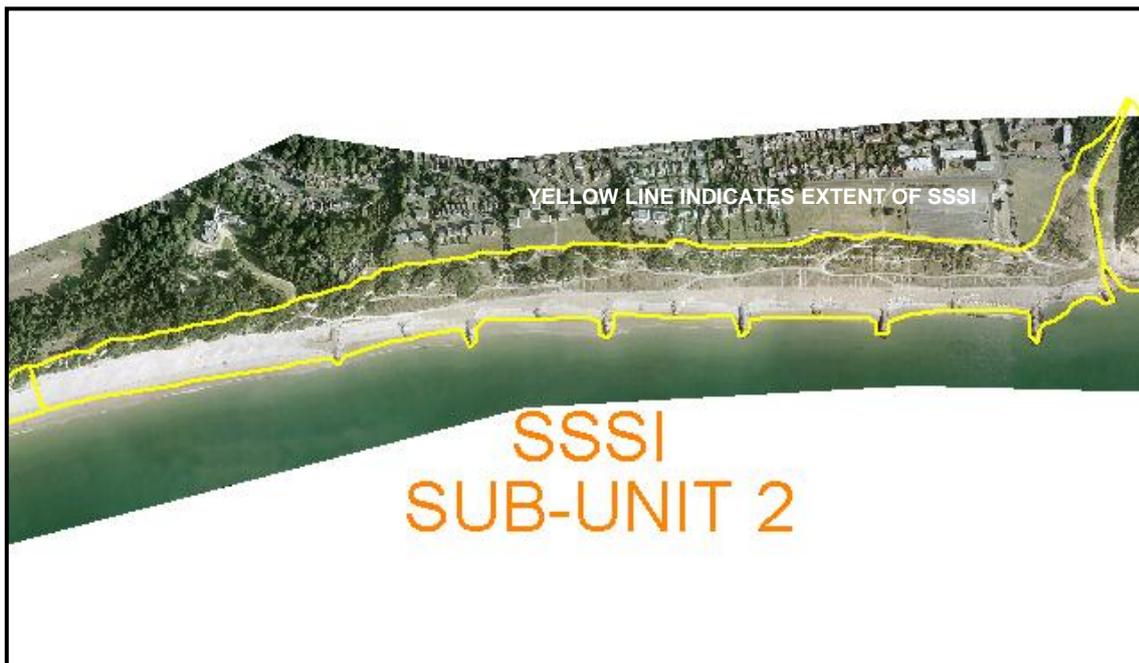
MANAGEMENT UNIT	CBY2
COASTAL DEFENCES	undefended cliffs / rock groyne, rock revetment, cliff stabilisation (including slope re-profiling)
SSSI UNIT REF.	SSSI Sub Unit 2
LENGTH / AREA	1842 metres / 26.51 ha
SSSI TYPE / HABITAT	Earth Heritage
DATE OF LAST INSPECTION	14 th June 2000
SSSI CONDITION	Unfavourable – no change
COMMENTS (June 2000)	Inappropriate coast-defence works, effectively obscuring interest and preventing further erosion of cliff face.

CHRISTCHURCH BAY STRATEGY OPTIONS		LIKELY IMPACT ON SSSI WITH RESPECT TO JUNE 2000 CONDITION			
		Decline	Maintain	Improve	
1	Do Nothing			●	
2	Managed retreat (reduce length or remove strongpoints)			●	
3	Hold the line (recharge beach & maintain strongpoints) *		●		<i>*preferred option</i>

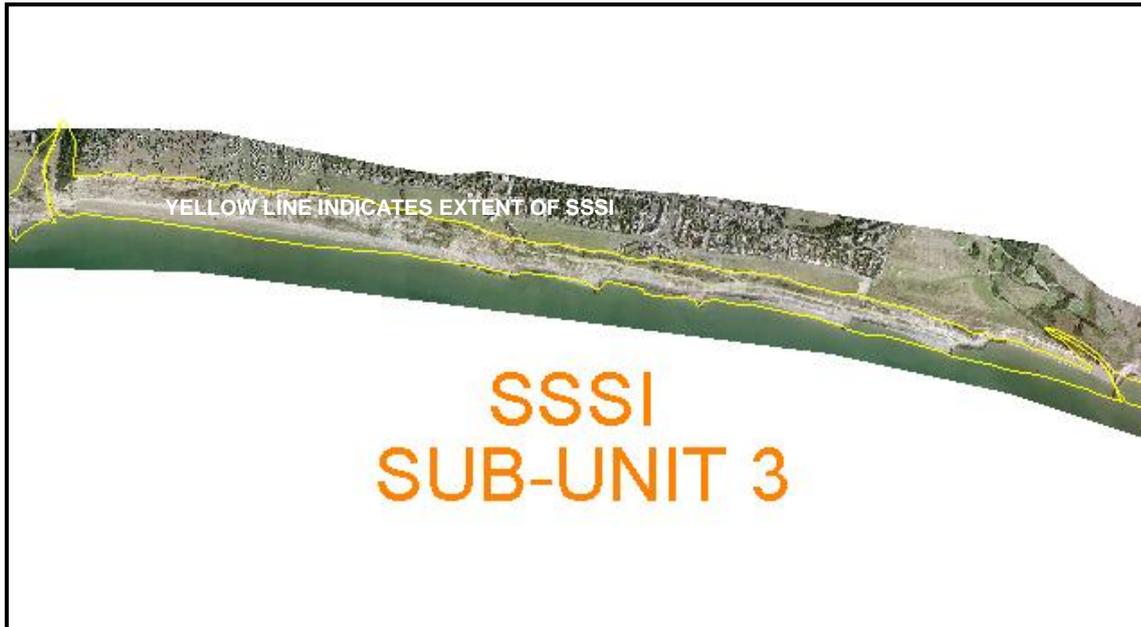
MANAGEMENT UNIT CBY3 / CBY4

SSSI CONDITION Unfavourable – No change

(Western section (undefended Naish Cliffs) - Favourable
Eastern section (defended cliffs) : Unfavourable – no change)

COMMENTS May 2001 & additional unofficial inspection Nov 2002 Earth science feature obstructed. Presence of beach huts and inappropriate drainage / stabilisation works in central section at Barton have obscured much of the lower exposures in cliff.

(Western section (undefended cliffs): Freely slumping cliff profile providing partial exposures of A2 and extensive exposures of A3 – F of the Barton Formation. Units above F poorly exposed. Note that the foreshore exposures were covered in a thick layer of sand.
Eastern section (defended cliffs): Re-graded cliffs and weighted toe obscure exposure throughout unit. D-H of Barton Clay Formation obscured. Small exposures of unit H present at the eastern extremity of defences and in number of fresh scars generated by recent small-scale slips.)

CHRISTCHURCH BAY STRATEGY OPTIONS		LIKELY IMPACT ON SSSI WITH RESPECT TO MAY 2001 CONDITION			
		Decline	Maintain	Improve	
1	CBY3 Do Nothing (cliff continues to erode)		•		
2	CBY4 Managed retreat (remove strongpoints & revetments)			•	
3	CBY4 Hold the line (maintain existing coastal defences)		•		
4	CBY4 Hold the line (maintain existing coastal defences, recharge beach, cliff drainage scheme) *		•		<i>*preferred option</i>

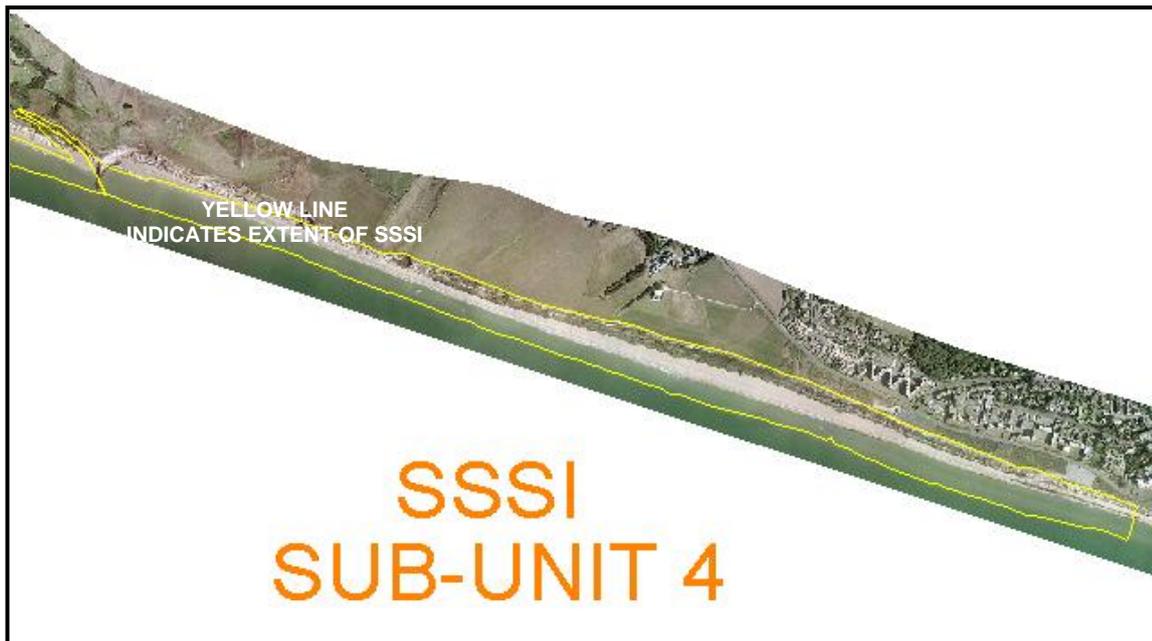
MANAGEMENT UNIT	CBY5 / CBY6
COASTAL DEFENCES	Undefended cliffs (CBY5) / defeneded cliffs (CBY6) : seawall, timber groyne, rock revetment
SSSI UNIT REF. LENGTH / AREA	SSSI Sub Unit 4 3109 metres / x 38.49 ha
SSSI TYPE / HABITAT	Earth Heritage
DATE OF LAST INSPECTION	12 December 2001 (An additional unofficial inspection was undertaken in Nov 2002, these comments are highlighted in dark red)
SSSI CONDITION	Unfavourable – no change (Western section (Becton Bunny to Parish Boundary): favourable, Eastern section (Parish Boundary to Milford): unfavourable – declining?)
COMMENTS Dec 2001 & additional unofficial inspection Nov 2002	Earth Science feature obstructed. Eastern third of this unit (Hordle & Rook Cliffs) are fronted by a double row of beach huts and the lower slopes immediately behind have slumped and are densely vegetated to within 10-20 ft from the cliff top - only the very upper section is visible. (Western section: Coastal processes active and providing continuously renewed exposure. Although the outfall at Becton Bunny is messy, it does not impact on the succession. This might change if a new outfall is installed. Units I - K of the Barton Clay Formation and lower part of Headon Formation well exposed. Eastern section: Increasingly wide beach eastwards (beach feeding?) with little toe erosion to the cliffs. Therefore the cliffs are vegetating up. Beach huts in front of cliffs and concrete promenade in extreme east of unit. Upper part of Headon Formation intermittently exposed.)

CHRISTCHURCH BAY STRATEGY OPTIONS		LIKELY IMPACT ON SSSI WITH RESPECT TO DEC 2001 CONDITION			
		Decline	Maintain	Improve	
1	CBY5 - Do nothing (cliff will continue to erode) *			●	<i>*preferred option</i>
2	CBY6 - Do nothing (increase in cliff erosion following revetment / seawall / groyne failure)			●	
3	CBY6 - Hold the line (maintain defences & beach recharge)*		●		<i>*preferred option</i>

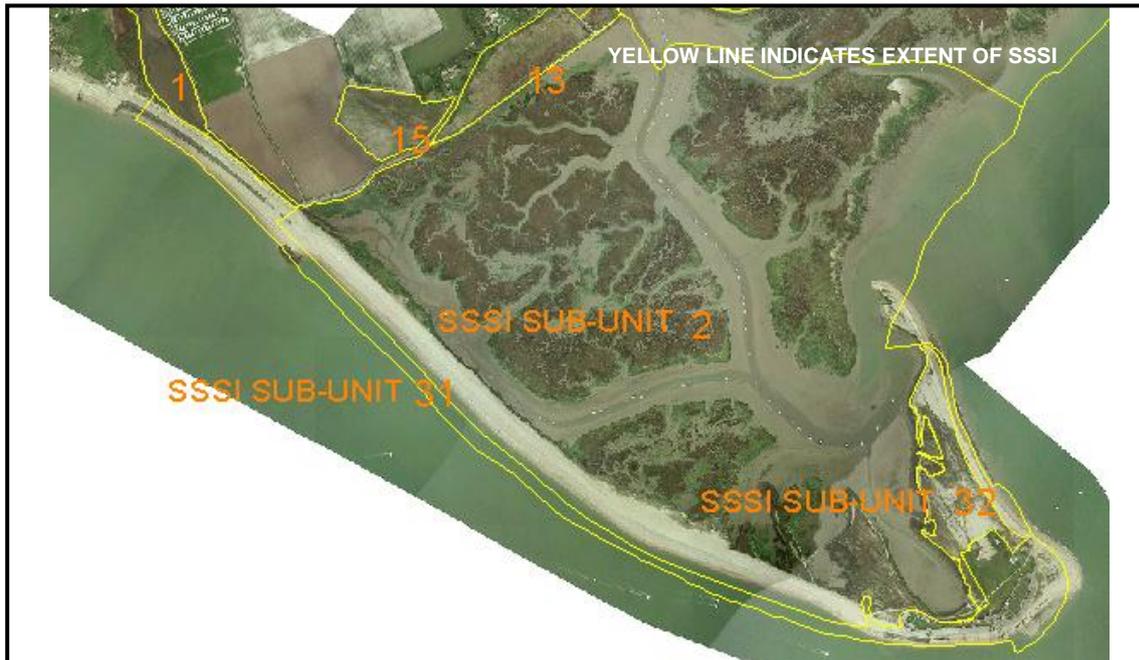
MANAGEMENT UNIT	CBY7
COASTAL DEFENCES	Seawall, timber groynes rock revetment
SSSI UNIT REF. AREA	SSSI Sub Unit 2 171.32 ha
SSSI TYPE / HABITAT	Littoral sediment
DATE OF LAST INSPECTION	27 th August 2003
SSSI CONDITION	Unfavourable - declining
COMMENTS (AUG 2003)	This unit, which is backed by a sea wall, is showing signs of extensive saltmarsh erosion indicative coastal squeeze. There are significant losses of lower saltmarsh and reversed succession where mid and upper marsh areas are being invaded by lower marsh species. There are undoubtedly also signs of Spartina die-back and this is contributing to the erosion rates.

CHRISTCHURCH BAY STRATEGY OPTIONS		LIKELY IMPACT ON SSSI WITH RESPECT TO PRESENT CONDITION			
		Decline	Maintain	Improve	
1	Do Nothing	●			
2	Hold the line (extend rock revetment)		●		
3	Hold the line (recharge beach/beach management plan) *		●		<i>*preferred option</i>
