**Southampton City Council  
Archaeology Unit  
Report 583**

**Roman Town House, Mosaics Conservation Study,  
Colliton Park, Dorchester**

**ROMAN TOWN HOUSE, COLLITON PARK, DORCHESTER**  
**MOSAICS CONSERVATION STUDY**  
**Report 583**

April 2003

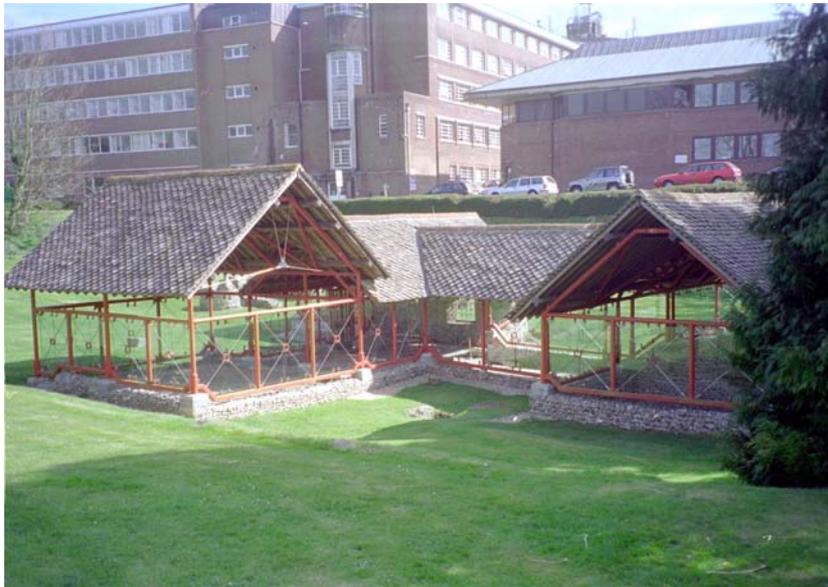
Plate 1. Roman Town House Cover Building and Dorset County Hall

1.2. A new cover building was designed, by John Stark and Crickmay Partnership, and erected in 1996-99 to display the mosaics and protect the exposed and deteriorating walls of the west wing, (The Roman Town House at Dorchester, Puttnam), (Plate 1). The Dorset County Archaeological Officer at the time was Laurence Keen and AC Archaeology excavated the mosaics and other buried archaeological features. A programme of mosaic conservation was undertaken by the Cliveden Conservation Workshop (CCW).

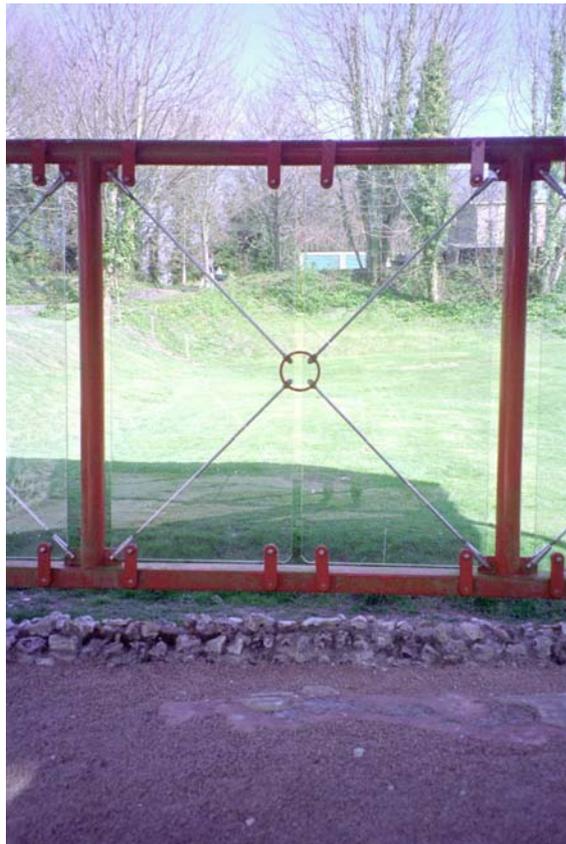
3.1.1. The mosaics and surviving walls and archaeological features of the West Range were covered by a steel-framed structure that was set in concrete blocks on the surviving Roman walls. The steel frames supported glass panels. There were gaps between each panel and also between the glass panels and the frame to allow for air-flow. There were also spaces between the steel frame and the tops of the walls, (Plate 2). The building's gable-ends were open, (Plate 3), except for room 10 which was in-filled with wooden boards to prevent entry of wind-blown rain that was causing a damp problem. The roof was constructed of an oak frame supporting a Purbeck stone tile roof.

Plate 2. Room 15. Steel-framed glass panel

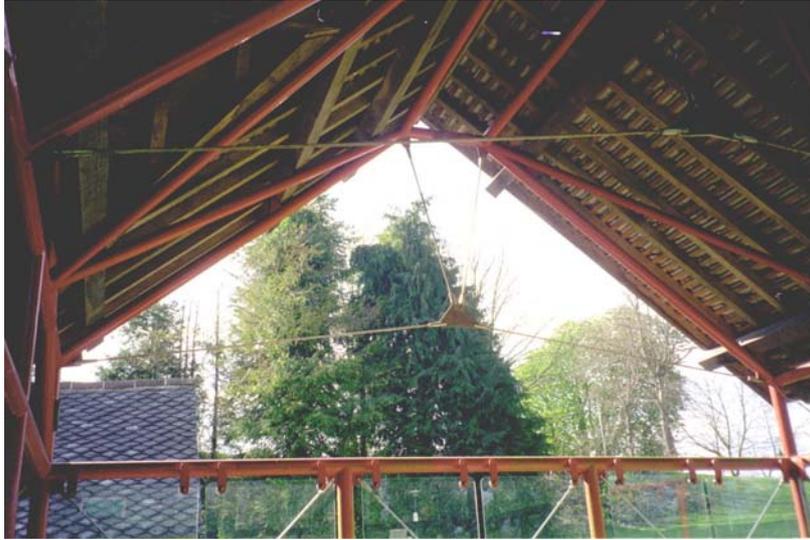
Plate 3. Room 15. West, open gable-end.

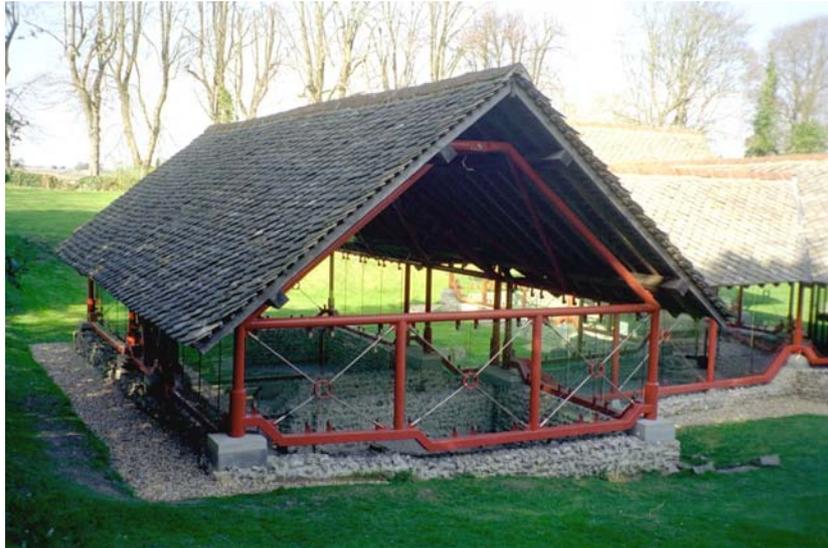
4.1. The monument and cover building is situated in a grass bowl with surrounding banks and in the proximity of the town walls and ramparts, (Plate 4). The underlying geology is chalk.

Plate 4. West end of cover building

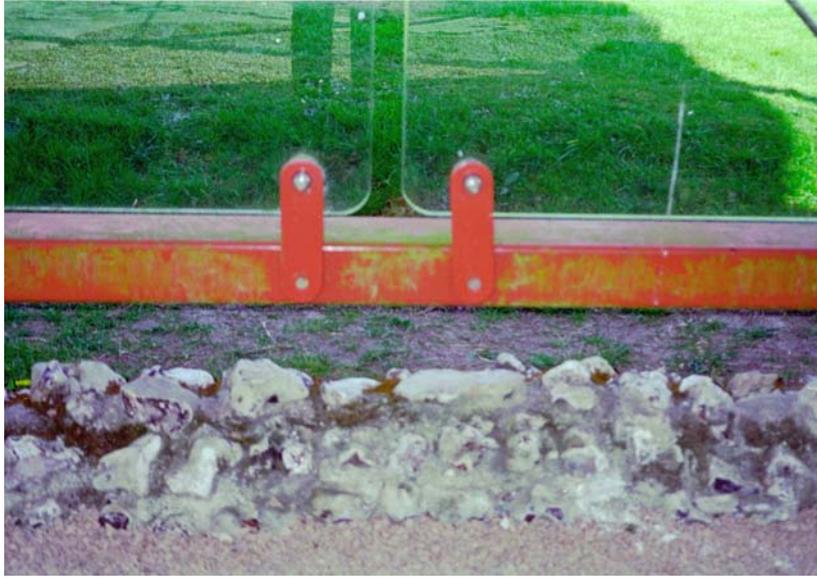
At the base of some of the steel frame supports on beams running parallel to the tops of the walls, algae were forming where rivulets of water had run down the steel beam and onto the tops of the walls, (Plate 5).

Plate 5. Room 15. Steel-frame structure with glass panels. Note: algae on horizontal frame and the gap between frame and wall.

The spaces and gaps between the glass panels, the steel frame and the walls are sufficiently large to allow leaves, litter, animals and birds to enter the building. Children are known to enter the building through these gaps including through the stoke hole to the hypocaust of room 17. Whilst working in the villa later in the afternoon of 7 April 2003 a child was seen in room 16 and as CE was working in room 10 at the time the child could not have entered via the doorway entrance. The child, (whose parent was outside and the family were playing football), was asked to leave via the door.

7.3.3. To install gauze or mesh or alternative into the gaps and spaces between the steel frame and glass panels of a size suitable to stop litter and plant debris blowing into the cover building. The mesh or material selected should not corrode or cause staining on the walls or mosaics in wet conditions.

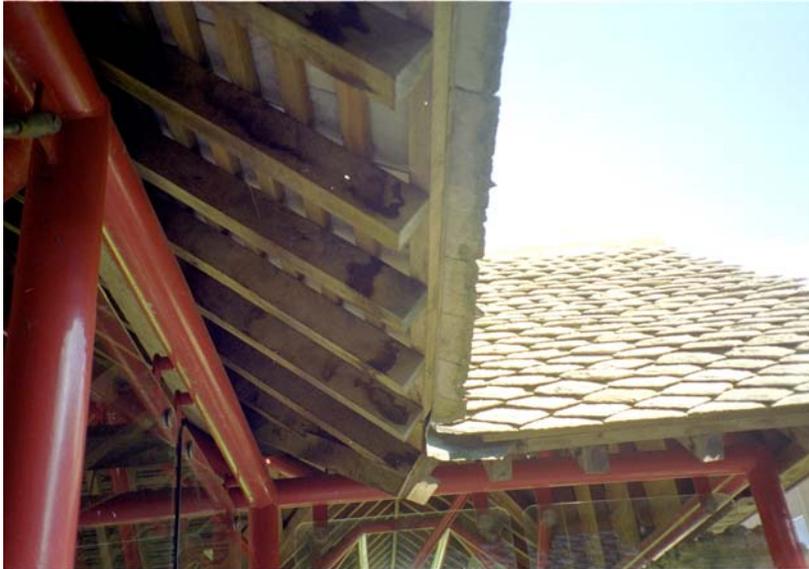
4.4. Externally on the south side, under the eaves, there were stains on the wooden roof supports suggesting water movement or penetration, (Plate 6). There were no gutters and in the roof valleys a channel was situated directing the flow of rain water down-wards onto the gravel pathway.

Plate 6. Cover building, South side, under eaves,. Note: stains on wooden roof supports

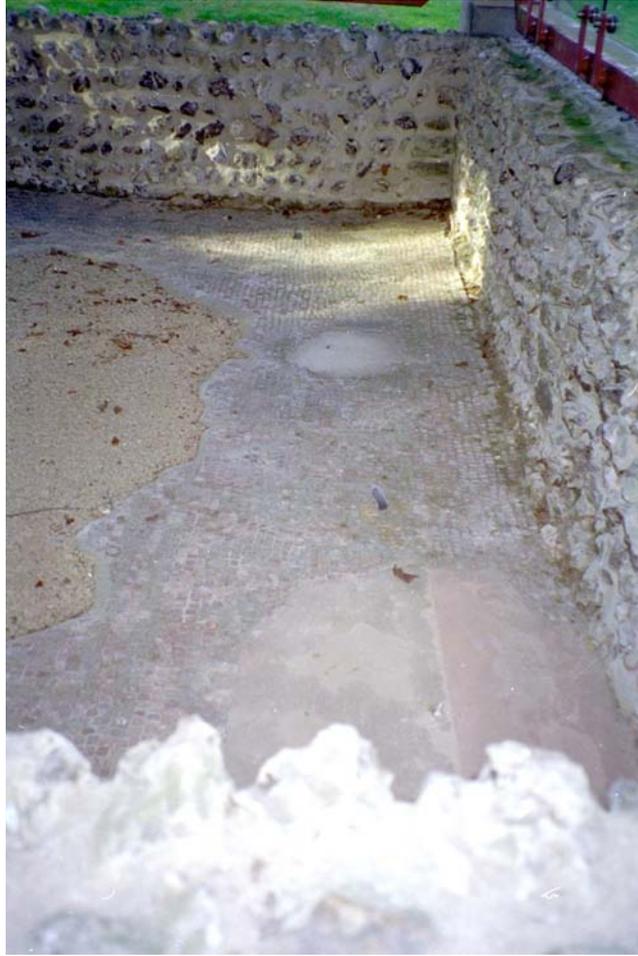
Plate 7. Room 18. Note: Debris on floor surface and algae at base of wall.

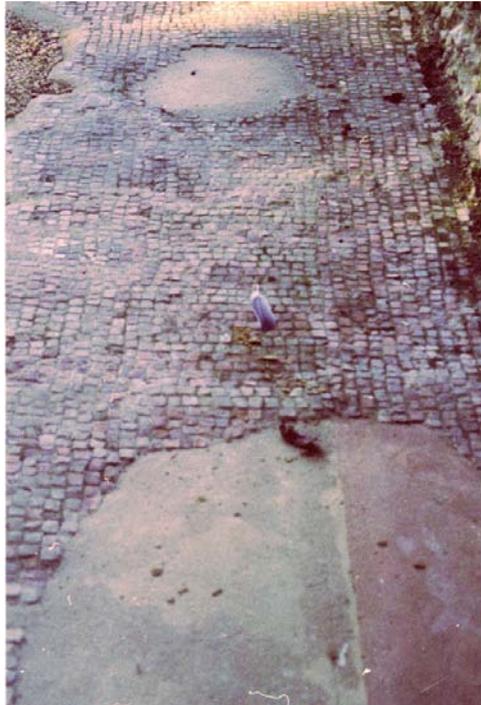
Plate 8. Room 18. Note feather and debris on mosaic surface.

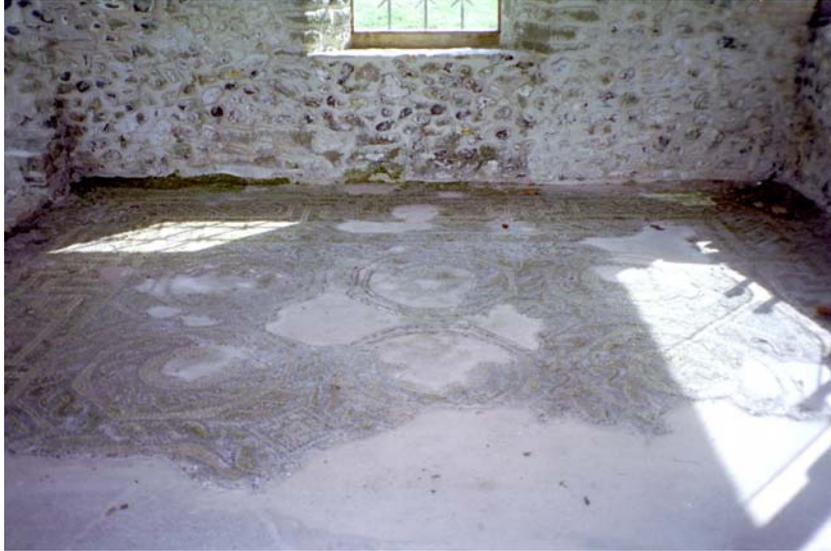
5.2. All the mosaics were in a dusty and dirty condition with leaves lying on the mosaic floors, mortar and gravelled areas. The mosaic in Room 10 was especially dirty with debris collecting on the mosaic surface and in the corners of the room, (Plates 9-11).

Plate 9. Room 10. Note: debris and algae on the surface and sunlight through the windows

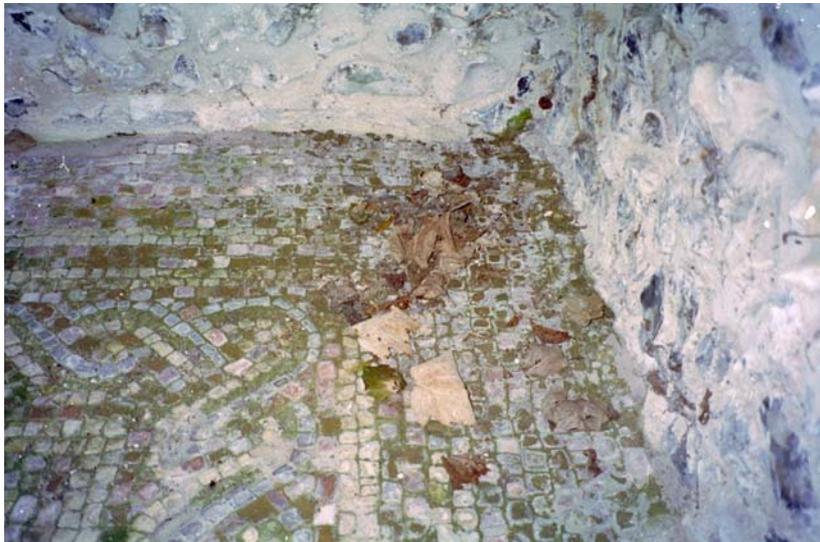
Plate 10. Room 10. Note: algae on the mosaic surface and leaves collecting in the corner.

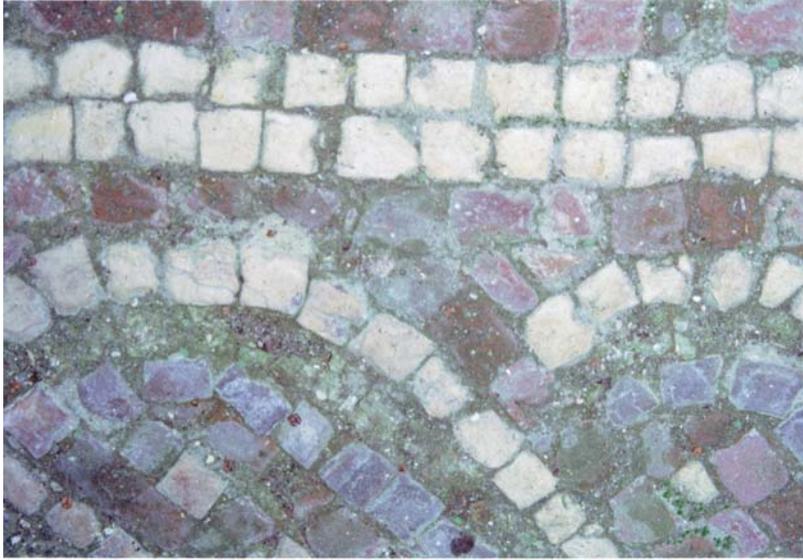
Plate 11. Room 10. Note: dirt and salt efflorescence on tesserae

7.1.6. Check and remove white, dry, powdery crystals of salt efflorescence by gently brushing with natural hair or bristle brushes. Wipe the surface with a barely damp (use de-ionised water) small sponge swab. Water should be kept to a minimum to prevent movement of salts. Absorb excess moisture from the surface using good quality absorbent paper rolls. Salt crystals require removal as they can gradually break up the tesserae surface. It is less damaging for the salts to form on the outside of the tesserae than inside in the internal pores(Woolfitt, 2000) . Salt efflorescence will be minimised if the movement of water in the mortar beds is reduced. Salts will crystallise in a low Relative Humidity environment.

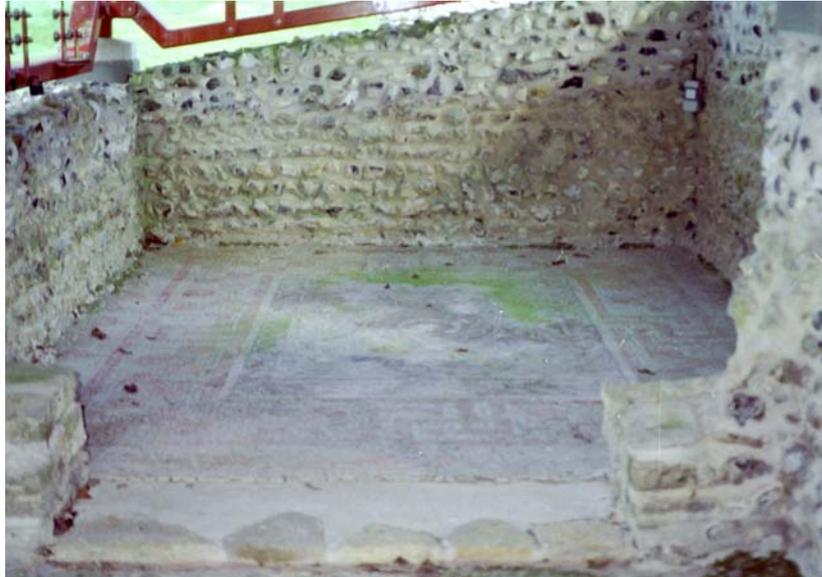
Plate 12. Room 8. Geometric mosaic. Note: algae, salt efflorescence and residues of mortar on tesserae surface.

It is not advisable that wax or lacquer coatings are applied to the tesserae surface in room 8 as this will cause other problems for example, sealing crystallising salts into the stones causing their disintegration or discolouration.

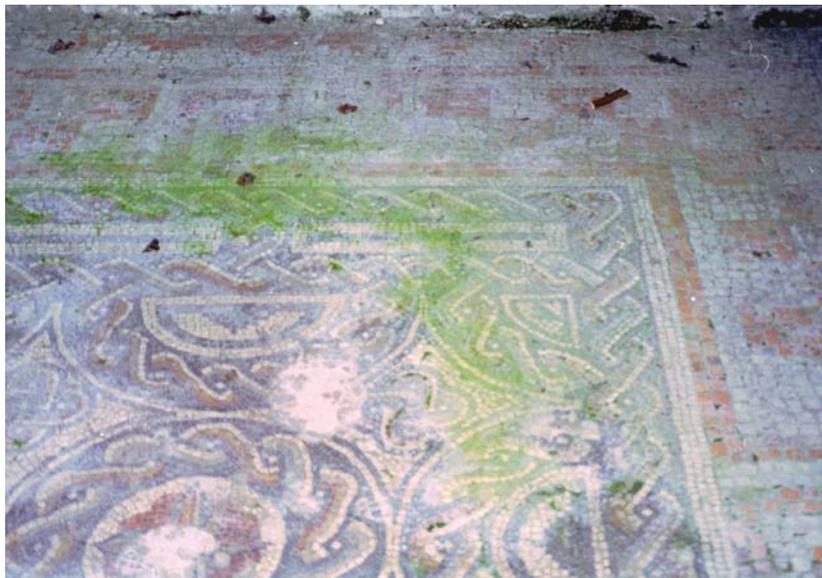
because there is a white deposit on the tesserae surface that is thought to be residue remaining after surface grouting, (Plate 13).

Plate 13. Room 8. Mosaic detail showing algae, salt efflorescence, mortar residues and repairs.

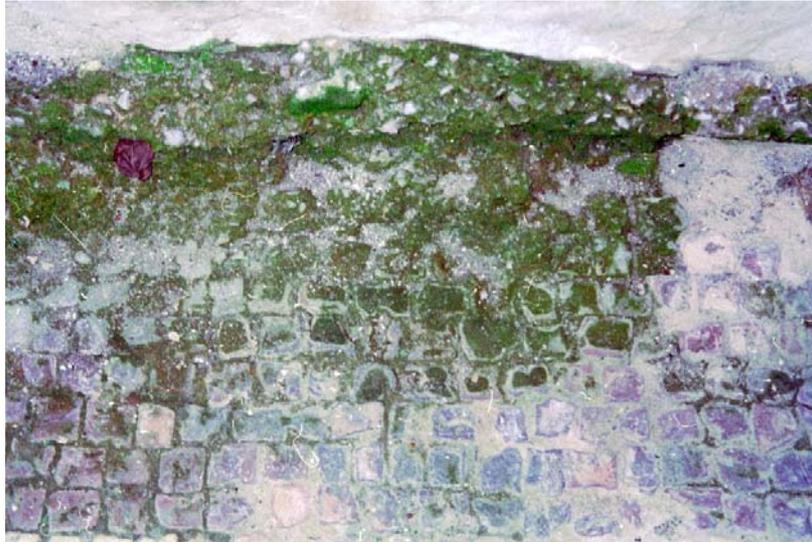
5.5. In room 10 the algae is mainly along the base of the south wall, SE corner and a small area along the base of the east wall with small areas on the mosaic surface. There was white powdery salt efflorescence mainly in the black tesserae (Plates 14-15).

Plate 14. Room 10. Detail: Algae on tesserae surface and at base of south wall

7.1.8. Check and remove algae from the mosaic using a small, damp sponge swab and small natural bristle brushes. Remove excess moisture using a good quality absorbent paper roll. Algal growth requires light, nutrients and moisture and the control of these factors will inhibit its growth. Algae can produce acidic residues on the tesserae and can cause damage to their surface both chemically and physically. (Caneva and Salvadori)

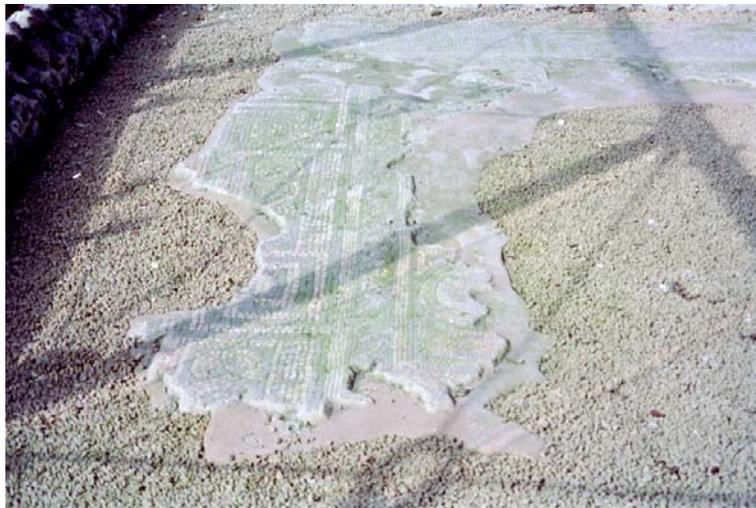
5.6. In room 15 there was intermittent algae and salt efflorescence across the tesserae of the mosaic fragment “islands” on the west and north areas. It was mainly found on the west area, (Plates 16-17). There was algal growth also on the surviving roman mortar areas and the north wall. Moss was growing on the external and top of the east wall. On the east tessellated area small plants were beginning to grow in the lime mortar bedding and in the gravel.

Plate 16. Room 15. West side of mosaic. Note: sunlight, shadows and algae.

Algae were growing on the mosaics in room 15 where sunlight from the east and west falls on the mosaic. It is suggested that shutters or blinds are installed on the west and east side as mentioned previously for the south side of the cover building. Removing dirt and dust via a maintenance programme and lowering the moisture levels by drainage or modification to the building should assist with limiting algal growth. Covering selective glass panels on the south, west and east sides should reduce the heat transference through the glass. Fluctuating temperatures cause expansion and contraction giving stresses across the floors. This situation should be monitored as regards the lime mortar areas laid in 1997-99 adjacent to the mosaics as they may constrict the mosaics and movement of the mosaics may occur, (Torracca, 1988).

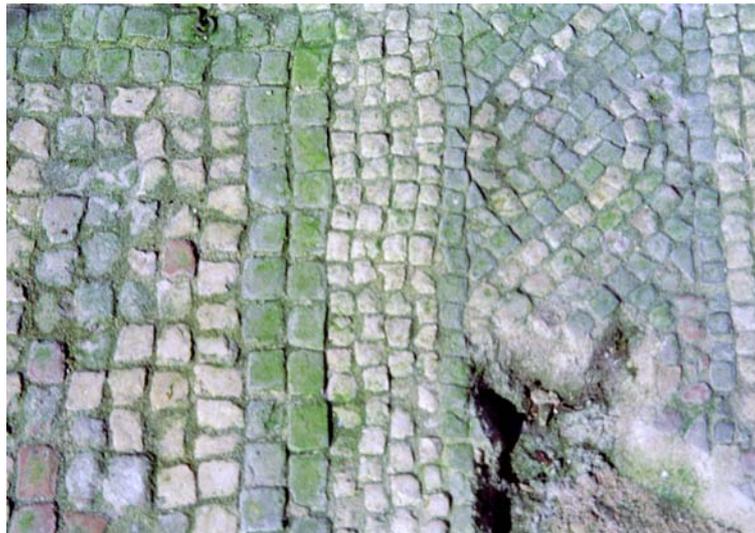
Plate 17. Room 15. Detail of algae and salt efflorescence on tesserae surface.

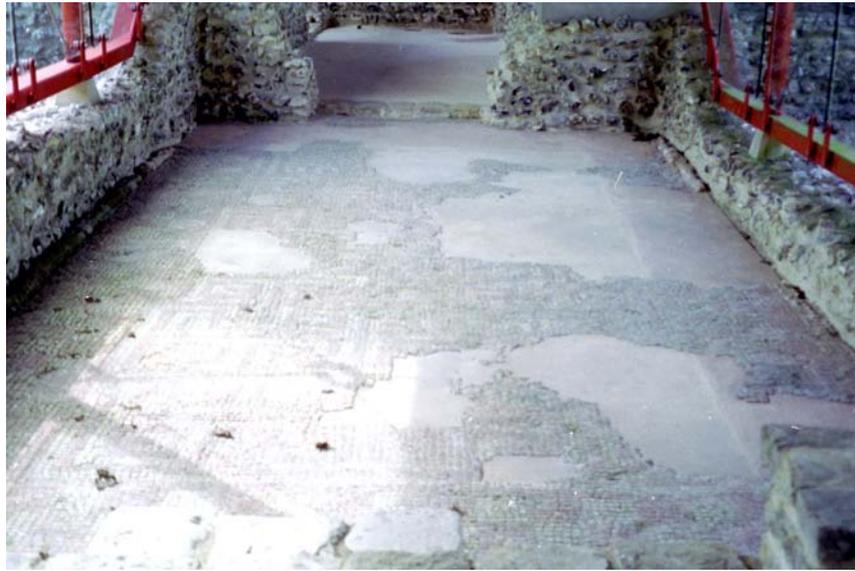
5.7. In room 13 the algal growth also ran mainly along the base of the south wall and on the adjacent tesserae and in the interstices, (Plates 18-19). There were also signs of a faint white deposit on the tesserae surface; it is thought to be areas of salt efflorescence with traces of lime mortar. Moss was starting to form in some of the interstices together with a small grass shoot.

Plate 18. Room 13. Note: sunlight, algae and leaves on mosaic surface.

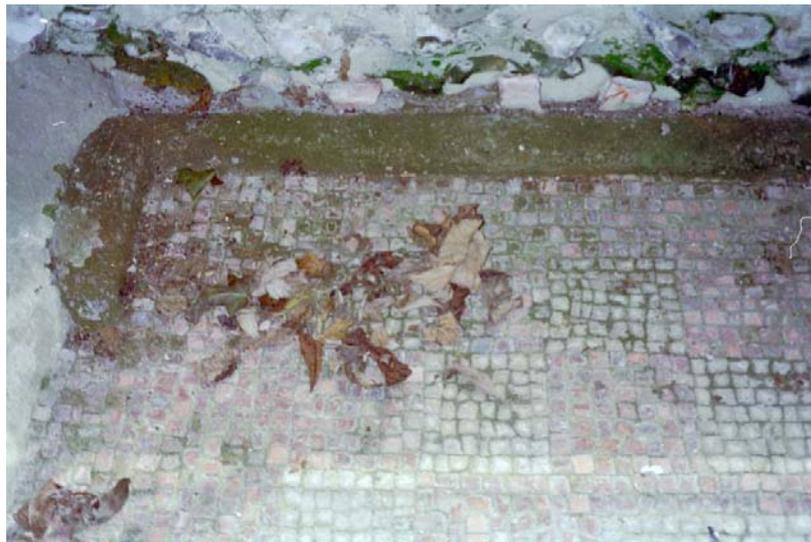
Plate 19. Room 13. Leaves in the corner and algae along base of south wall

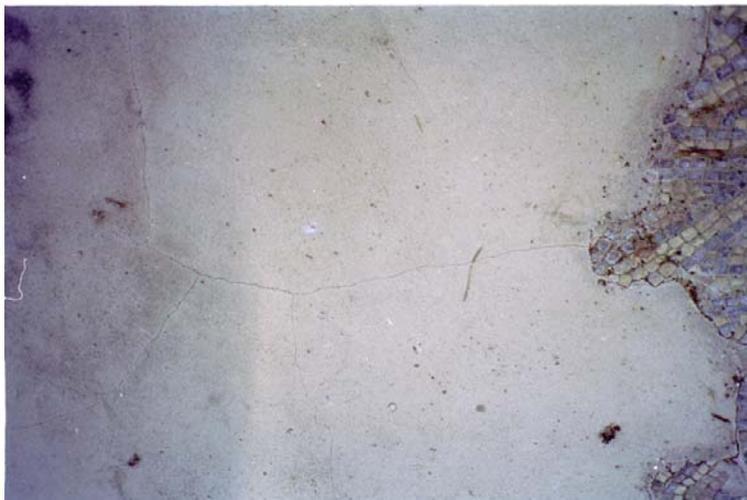
On the lime mortar floors, gauged with cement and where the visitors walk, there are cracks in the surface particularly in room 10 and room 14. The surface creaks like 'thin ice' when walked over, (Plate 20).

Plate 20. Room 10. Cracks in lime mortar surface.

The lime mortar floor in rooms 10 and 14 should be closely examined due to the cracks and 'creaking' sounds that occur as it is walked across. It should be examined to ensure it is safe for the public to walk across.

Reduced foot traffic should prevent further cracking of the lime mortars.

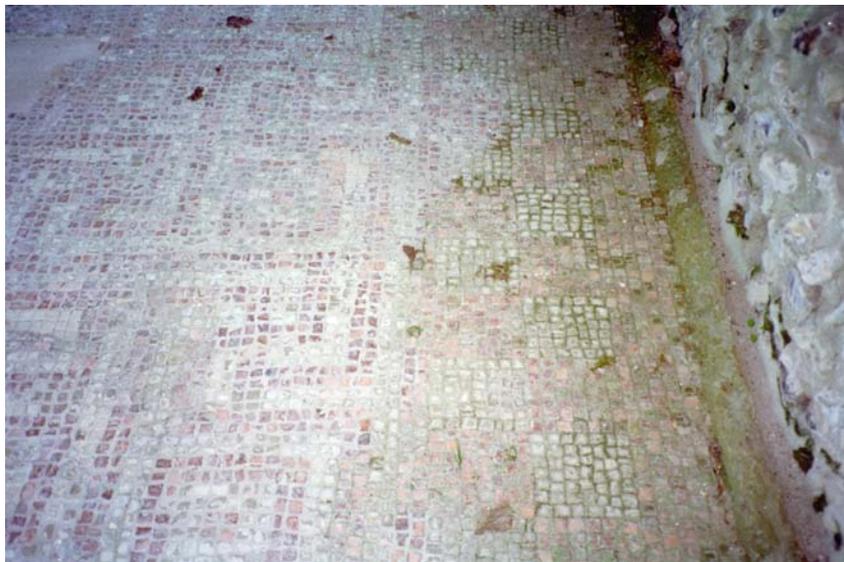
7.2.4. In room 13 there is an area of mosaic along the south side of the room adjacent to the south wall that remains as excavated and has neither been lifted, nor re-laid, nor surface grouted. The tesserae are firmly fixed with compacted soil and it is not uncommon for roman mosaics to have an earthy, mortar fill in the interstices and as long as the tesserae are held firmly they do not require surface grouting and/or lifting and/or relaying, (Plate 21). This is only necessary when tesserae are loose and becoming dislodged.

Plate 21. Room 13. Re-laid tesserae on left and original mosaic on the right adjacent to wall. Note: algae at base of wall.
