CONSERVATION AREA APPRAISAL

BERE REGIS
July 2002
BERE REGIS

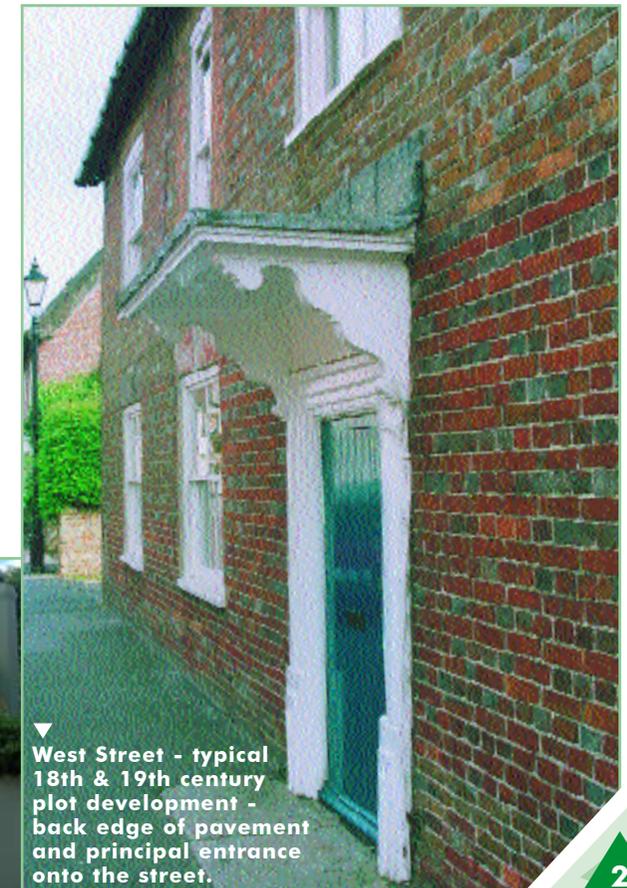
▼ West Street - typical 18th & 19th century plot development - back edge of pavement and principal entrance onto the street.

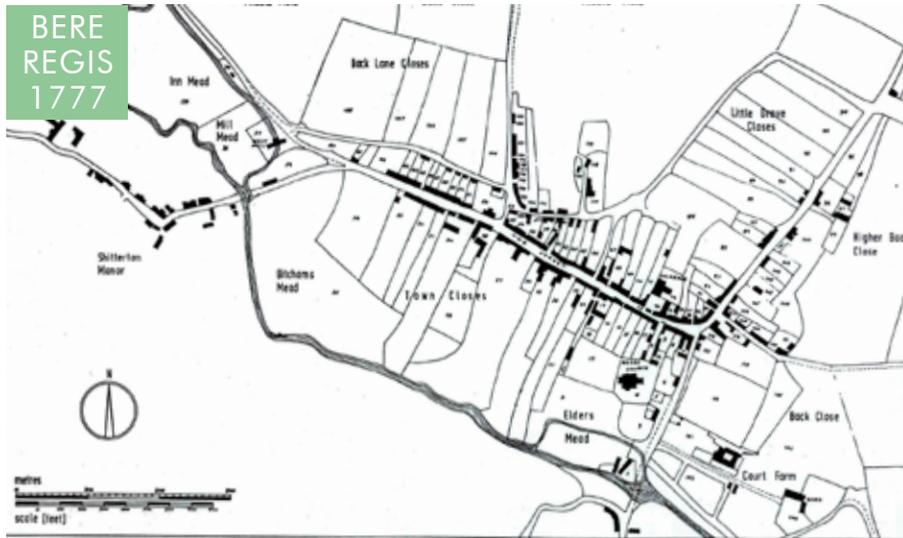
BERE
REGIS
1777

16 "THE TOWN OF BEERE REGIS" IN 1777

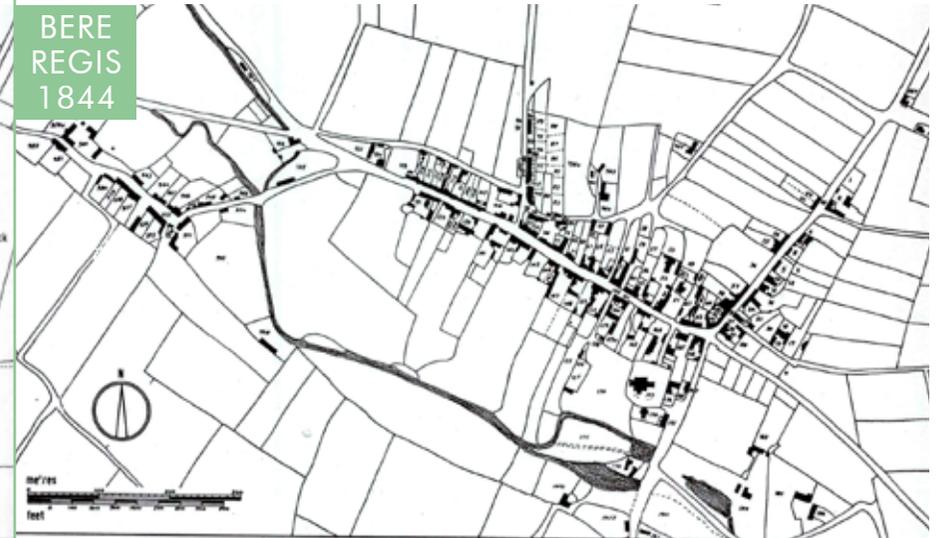
BERE
REGIS
1844

66 BERE REGIS IN 1844 SHOWING TITHE MAP NUMBERS

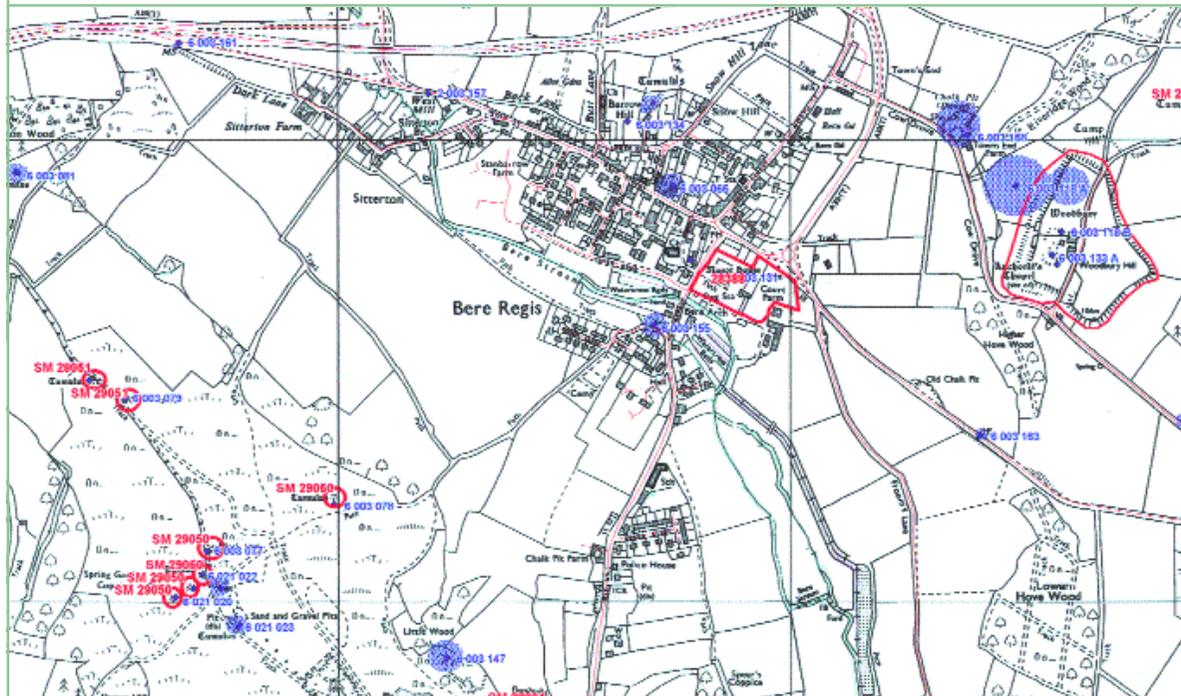
BERE REGIS ARCHAEOLOGICAL MAP

Sites delineated with a red line are protected as Scheduled Monuments.

Sites shaded in purple are other archaeological sites and find-spots that are recorded in the Dorset Sites and Monuments Record. The above are only the known archaeological sites. It is extremely likely that as yet unrecorded archaeological material extends beyond these known sites, for instance within the historic core of Bere Regis. Hence, developments away from the known sites may also have archaeological implications.

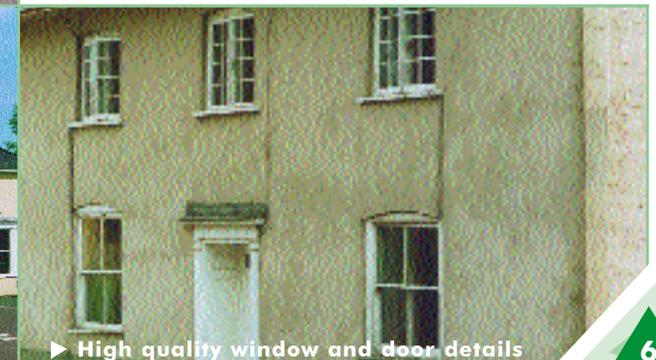
► High quality window and door details

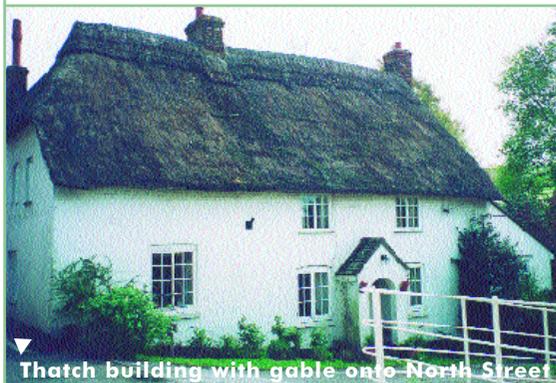
▼ Thatch building with gable onto North Street

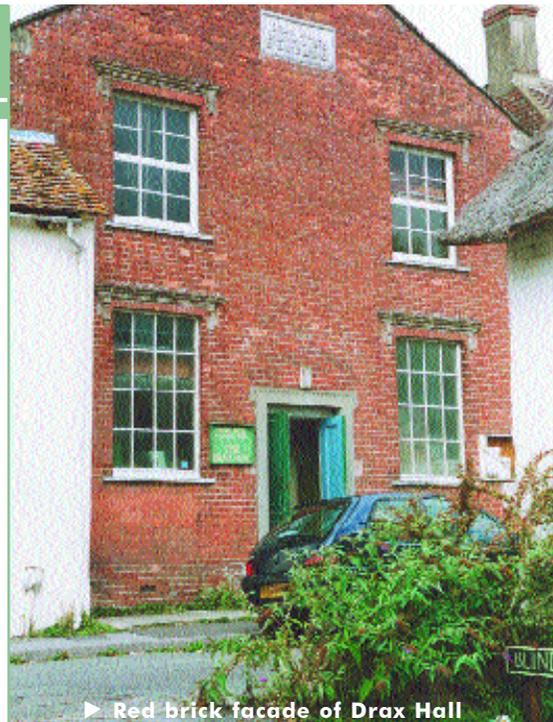
▶ Red brick facade of Drax Hall

- ◆ *The Drax Hall, which existed as a Dissenting Meeting house in the 1777 map and became a Congregational chapel before it was renovated in 1893, displays typical features of this time, including a shallow roof pitch, red brick construction, elegant sash style windows and yellow brick corbelled hood mouldings.*

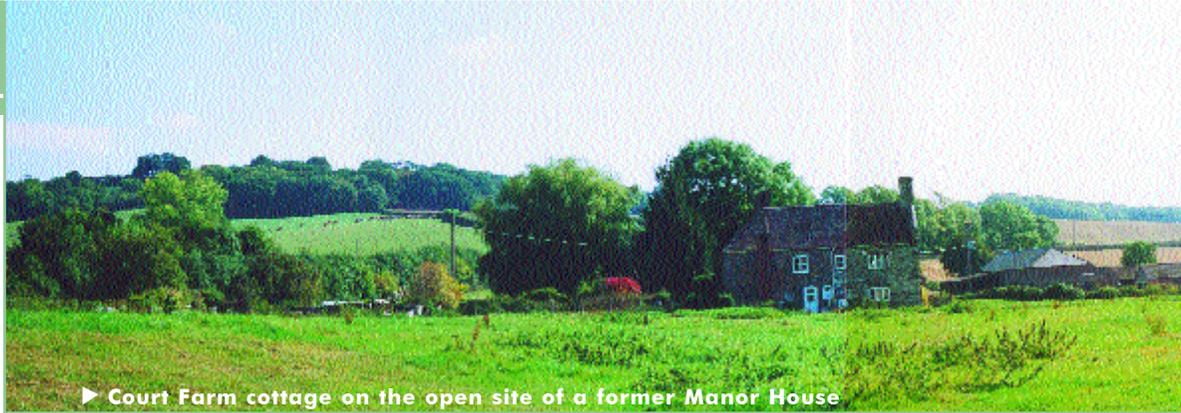
▶ Court Farm cottage on the open site of a former Manor House

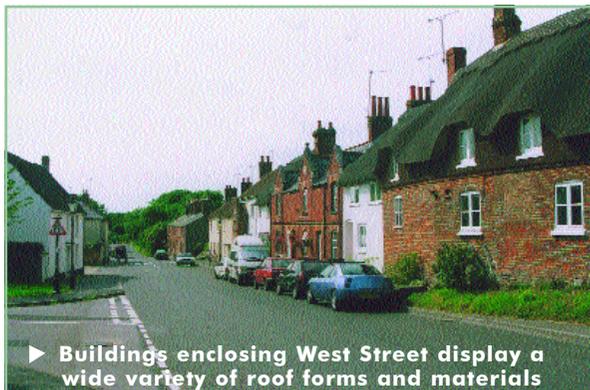
▶ Buildings enclosing West Street display a wide variety of roof forms and materials

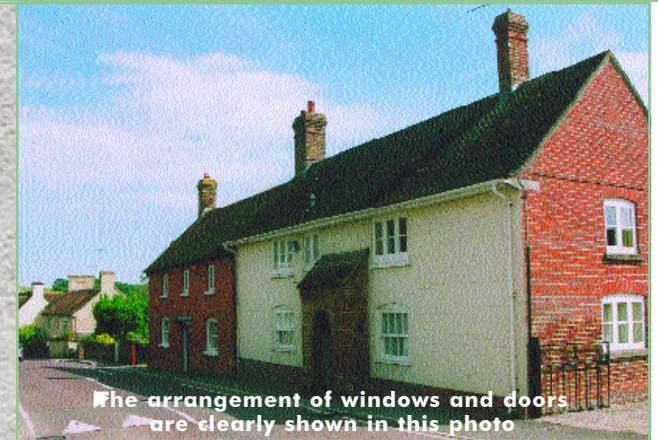
▶ The arrangement of windows and doors are clearly shown in this photo

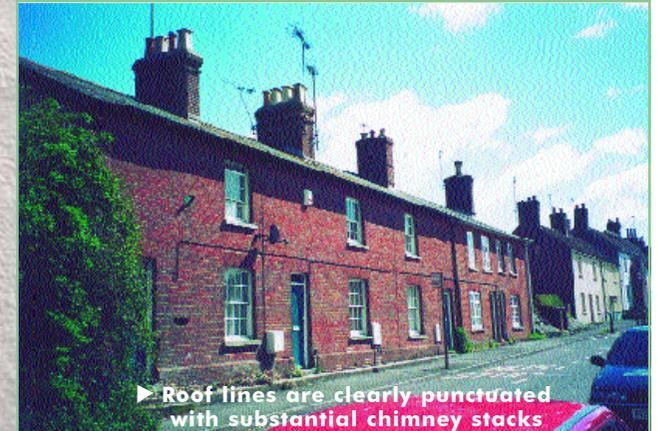
▶ Roof lines are clearly punctuated with substantial chimney stacks

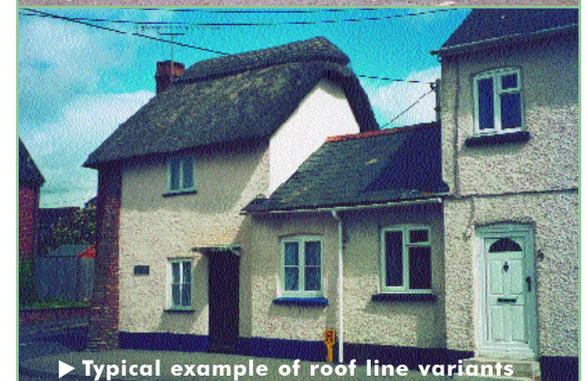
► Typical example of roof line variants

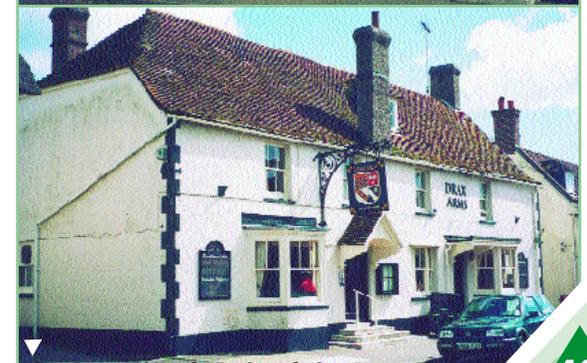
► The imposing facade of the Drax Arms

8.2.4 The Drax Arms, a 19th century public house (including an attached stable to the rear), has roughcast walls over 2 storeys, with smooth plastered quoins beneath a cropped hip tiled roof incorporating tall chimneys. There are double hung sash windows to

the 1st floor and one dormer in the roof, bay windows and main door with gabled tiled wood on brackets.
