Swanage Beach Management Plan

Swanage Beach Management Plan Update 2020

Dorset Council

25 August 2020

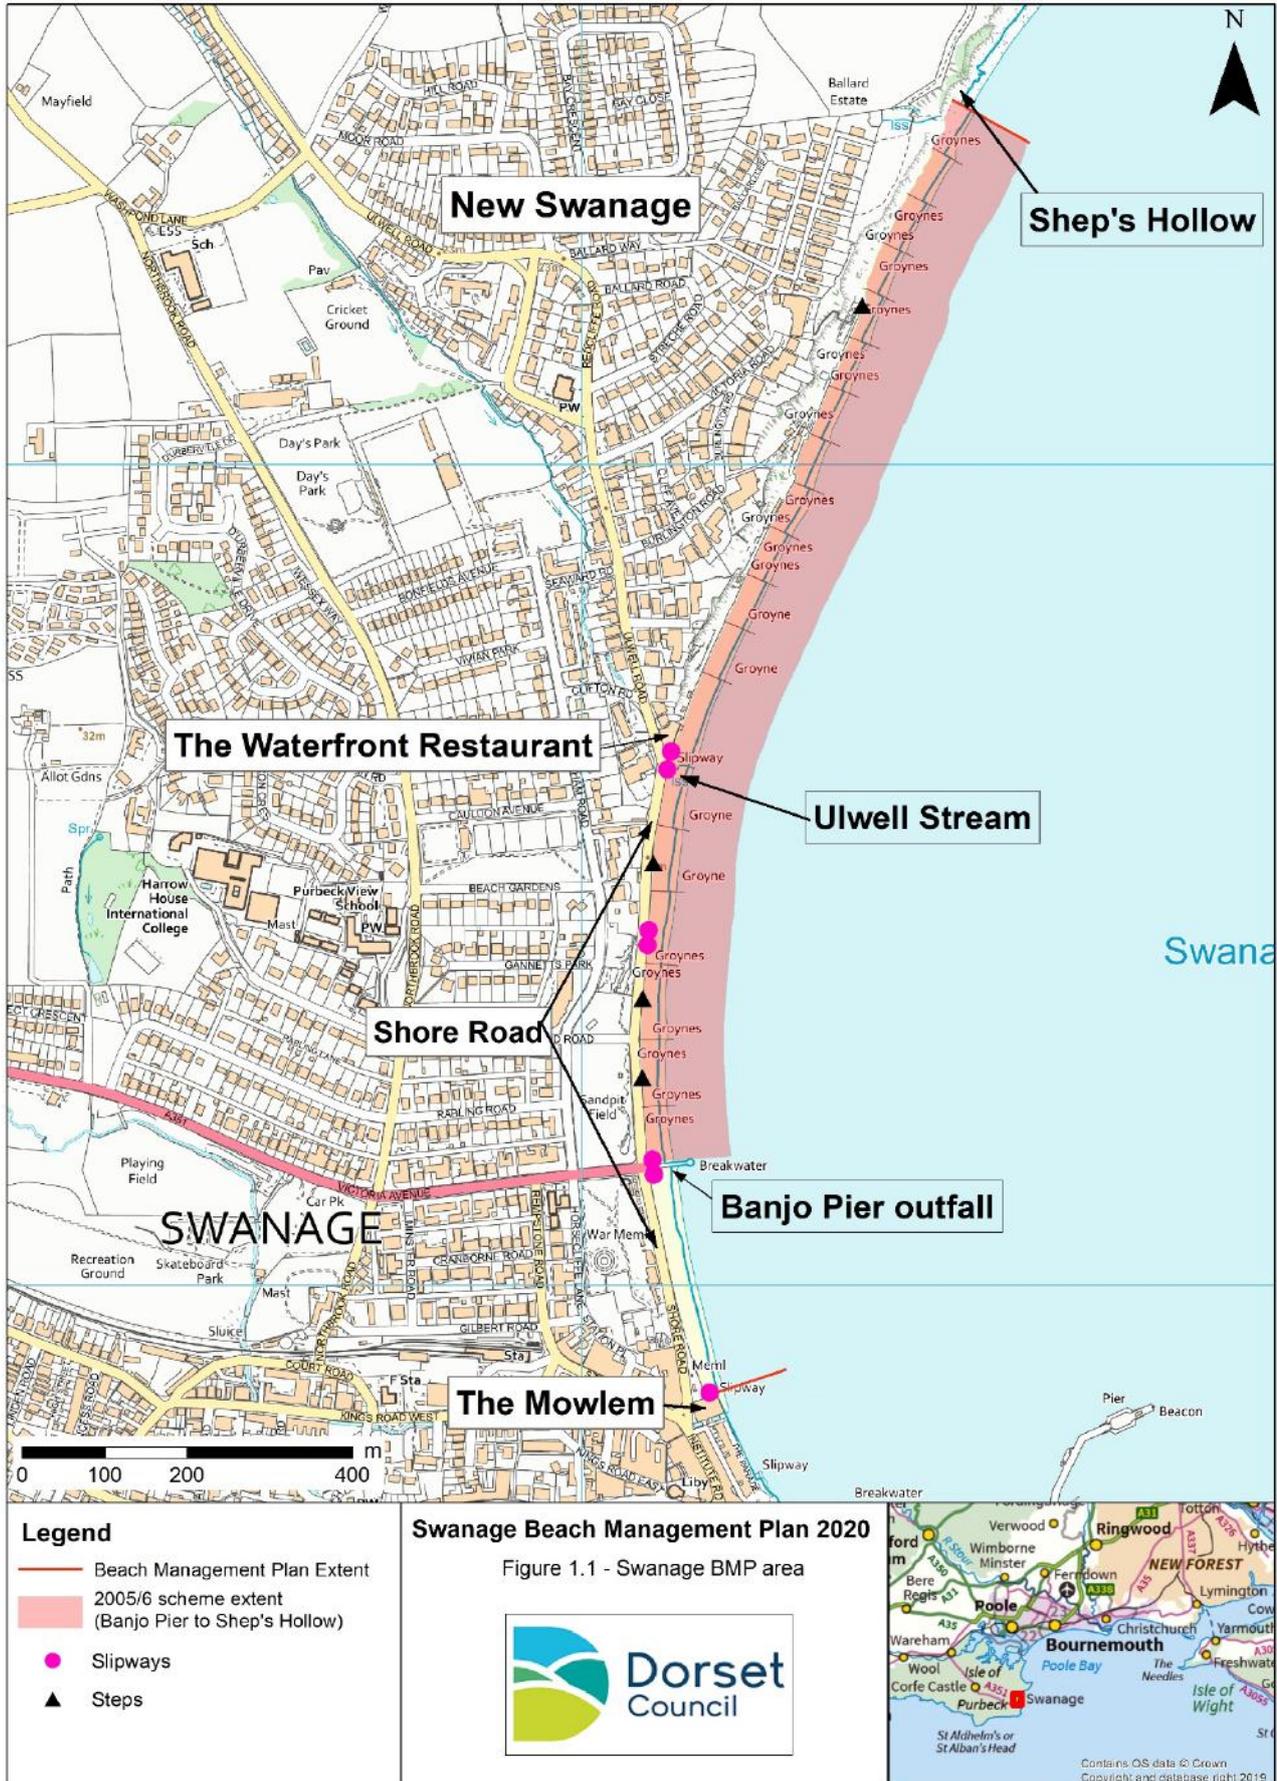
Figure 1-1 Swanage beach management plan area.

This Beach Management Plan (BMP) covers the central part of the Swanage Bay coast, extending from The Mowlem to the south, northwards to Shep's Hollow (see Figure 1-1). This BMP provides a review and update of the existing BMP first produced by Halcrow in March 2005 as part of the 2005/6 Swanage Beach Recharge Scheme (Halcrow, 2005a).

The current Shoreline Management Plan (SMP) covering the Swanage frontage was adopted in 2011 (Royal Haskoning, 2011). Table 1-2 summarises the SMP policies that apply to Swanage Bay, though only policy units SWA.N.1 and SWA.N.2 cover the BMP area from The Mowlem to Shep's Hollow (see also Figure 1-1 above).

This section provides an overview of the environmental setting and identifies key environmental features within the vicinity of study area (refer to Figure 1-1 above). The section is structured around a number of environmental topics as highlighted in the first column of Table 2-6. These follow the recommended structure contained in the Beach Management Manual (CIRIA, 2010).

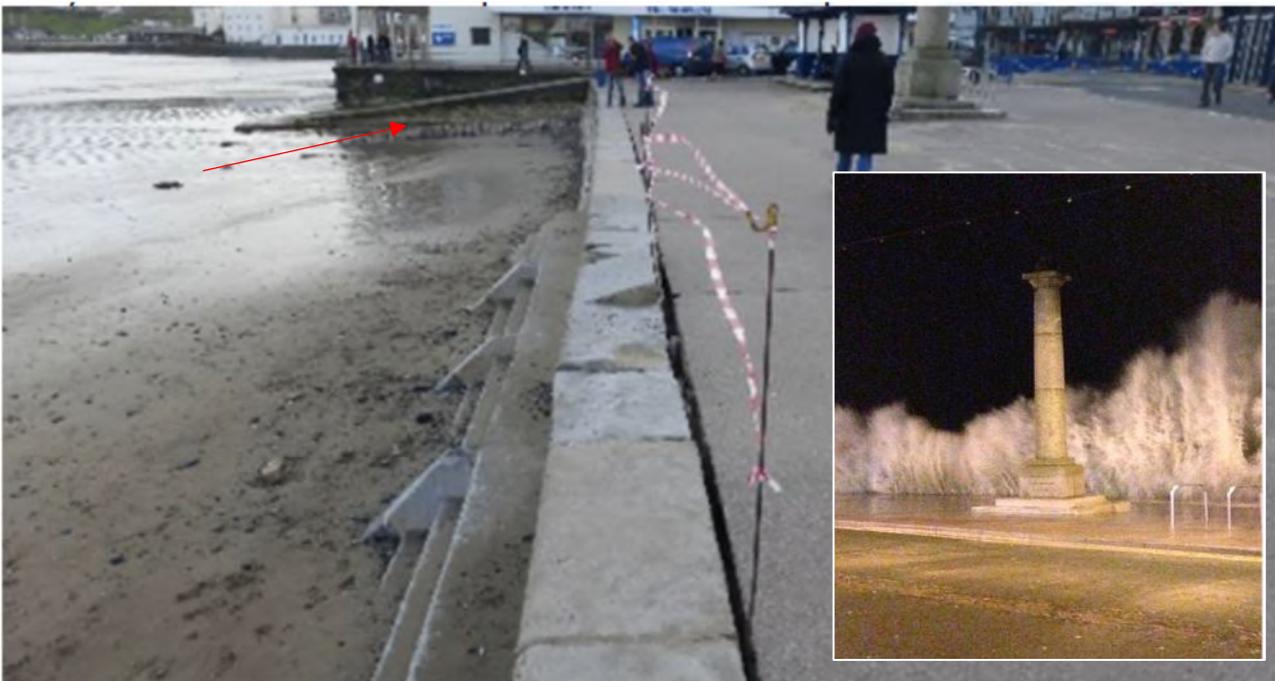
Figure 1-4 Significant damage occurred to the seawall along Swanage promenade between the Mowlem and the Banjo Pier as a result of a storm on 14th February 2014. This displaced approximately 25m of top stones (from JBA, 2020a). Note also an exposed, historic rock groyne-type structure adjacent to the slipway (marked with an arrow). Insert is a photo of waves breaking on the seawall during the same storm event (from Goater, 2014).

Whilst there is minimal direct coastal flooding from the BMP frontage, storm events do cause wave overtopping along the Shore Road section of the BMP frontage; particularly the southernmost section between the Mowlem and the Banjo Pier, especially when beach levels are low and the sea is able to attack the face of the seawall. Storm events can result in beach material and marine debris being thrown up onto the promenade along Shore Road, and cause damage to the seawall and promenade, as occurred in February 2014 (see Figure 1-4).

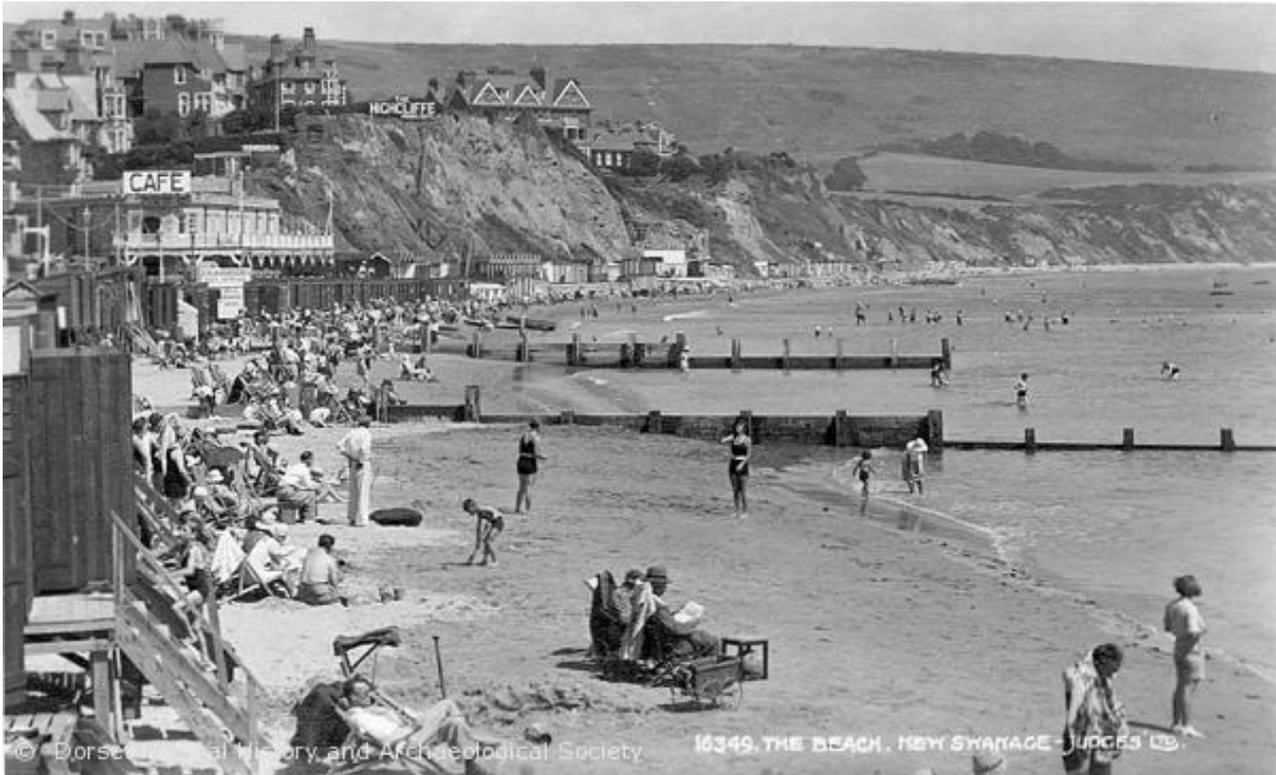
Figure 1-5 Photo showing the older timber groynes along the Shore Road part of the BMP frontage, prior to construction of additional timber groynes northwards along the New Swanage frontage. Date thought to be around 1949. Photo from Channel Coastal Observatory. Owned by Dorset County Museum. Copyright Dorset Natural History and Archaeological Society.

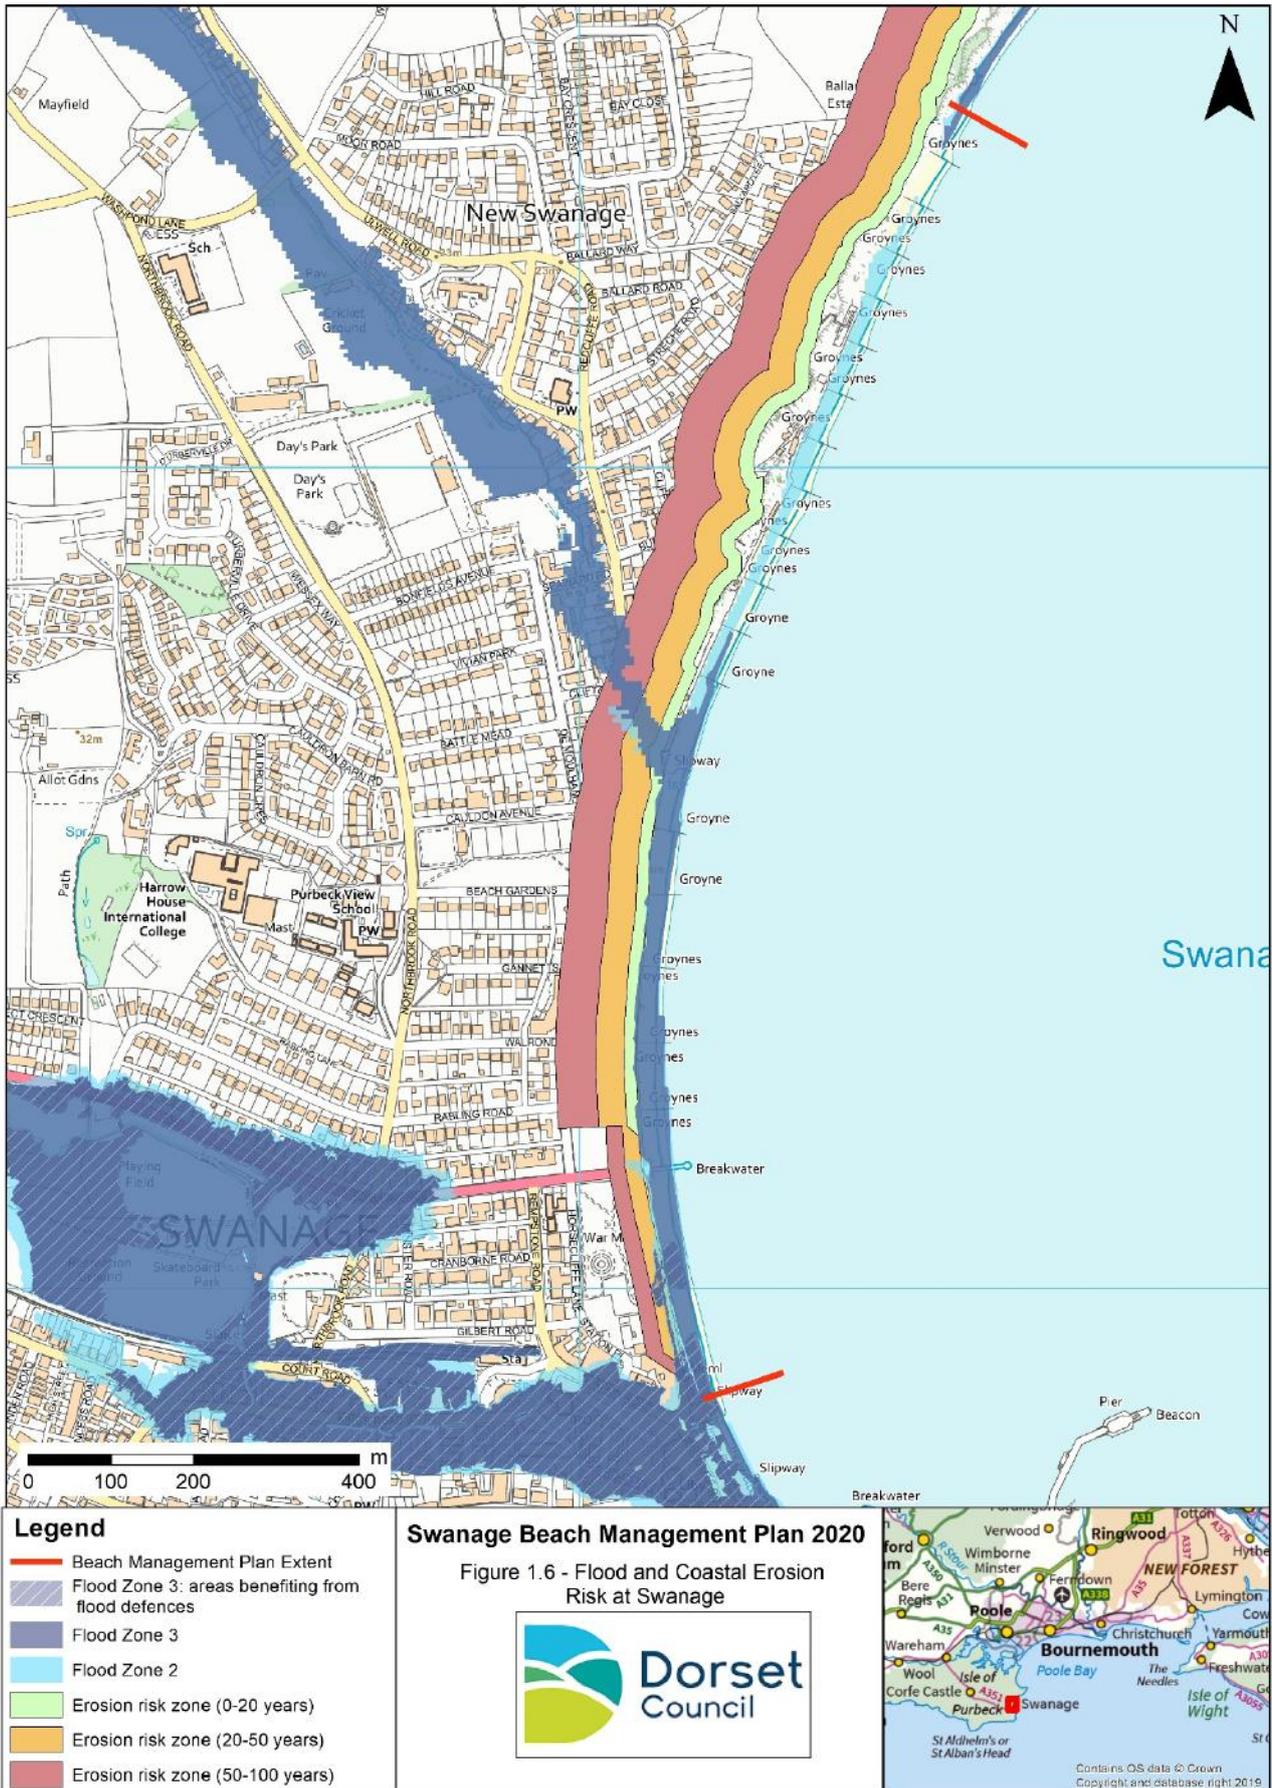
As described in Section 1.3.2, the defences along the BMP frontage primarily protect against the risk of coastal erosion and land-sliding. There is little or no risk of coastal flooding along most of the BMP frontage, except for some risk from wave overtopping during certain storm events at the southern end of the BMP area (see Figure 1-6).

Figure 1-6 Flood and coastal erosion risk at Swanage.

The preferred option may necessitate the undertaking of works within area of designated Flood Zone (refer to Figure 1-6). As a result, an Environmental Permit may be required from the Environment Agency. Flood risk modelling works may need to be undertaken in order to underpin the application for this permit. Environmental Permit applications are subject to a two-month determination period. In the event that a Marine Licence is required for the project, an Environmental Permit may not be necessary. The works proposed as part of the final option should be reviewed against the list of exclusions and exemptions that can apply to the Environmental Permitting process in order to ascertain whether such exclusions and exemptions are valid.

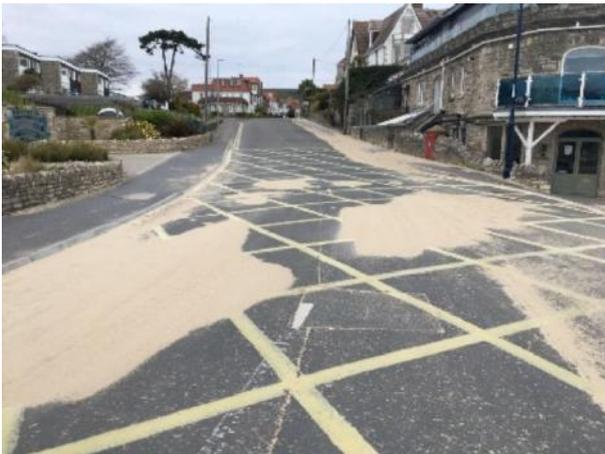
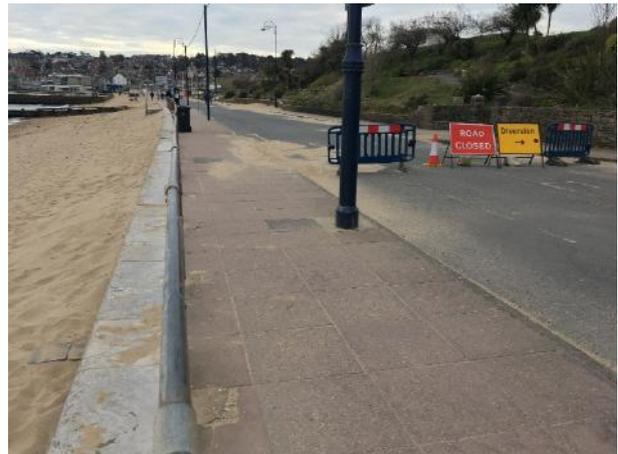
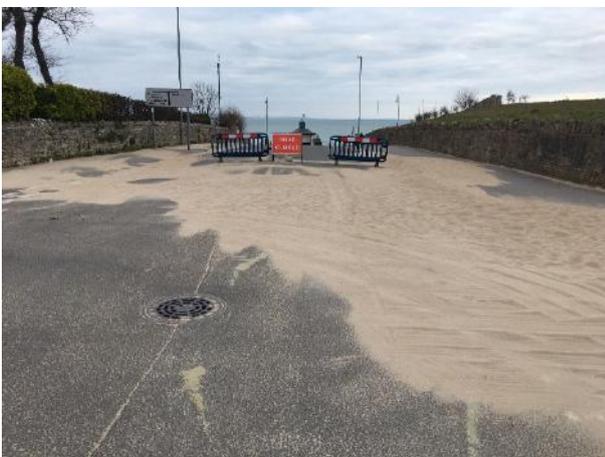
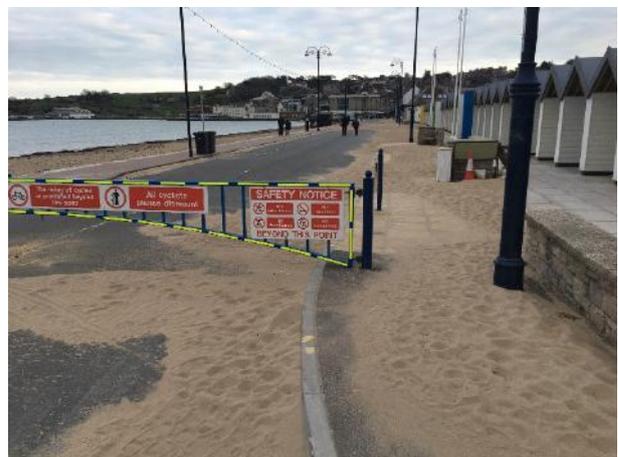
Table 1-7 Photos of wind-blown sand on the highway along Shore Road in March 2020 (photos courtesy of Dave Picksley, Environment Agency).

- The analysis of beach volume changes does not take into account of the gradual loss due to removal of wind-blown sand that encroaches onto the promenade/seawall and road behind the beach (most typically under more easterly wind patterns – see Figure 1.7) and is then removed from the system as waste as it cannot be replaced on the beach having reached the highway. There are no records of the amount of sand removed from the system as waste to indicate volumes and frequency of removal.

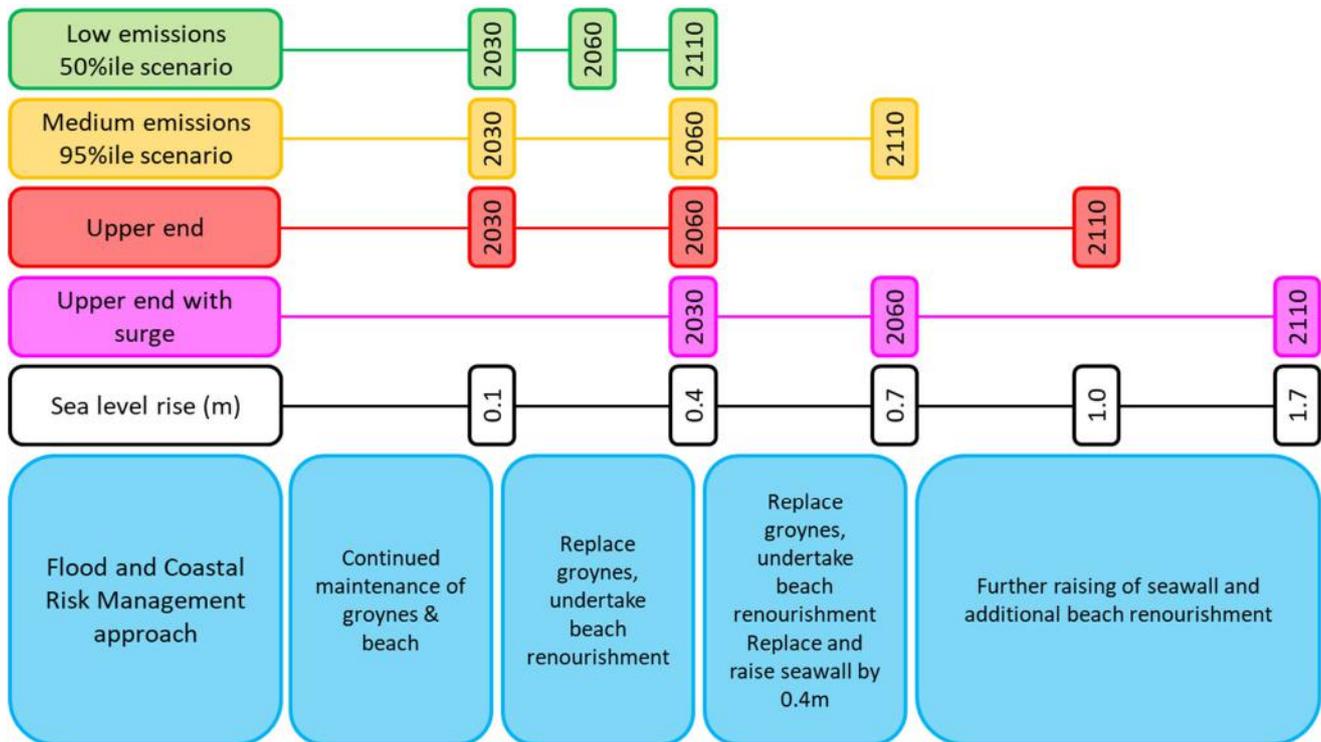
Figure 1-8 Climate change adaptive management for Swanage; NB: Medium emissions 95%ile scenario is core appraisal scenario (from Environment Agency, 2014a).

The implementation of this option, and how it may change depending on the actual rate of climate change/sea level rise experienced in the future, is summarised in Figure 1-8. Should climate change/sea level rise occur at a faster rate (i.e. upper end scenarios) then this would result in the need to raise the seawall in order to achieve the sustain approach.

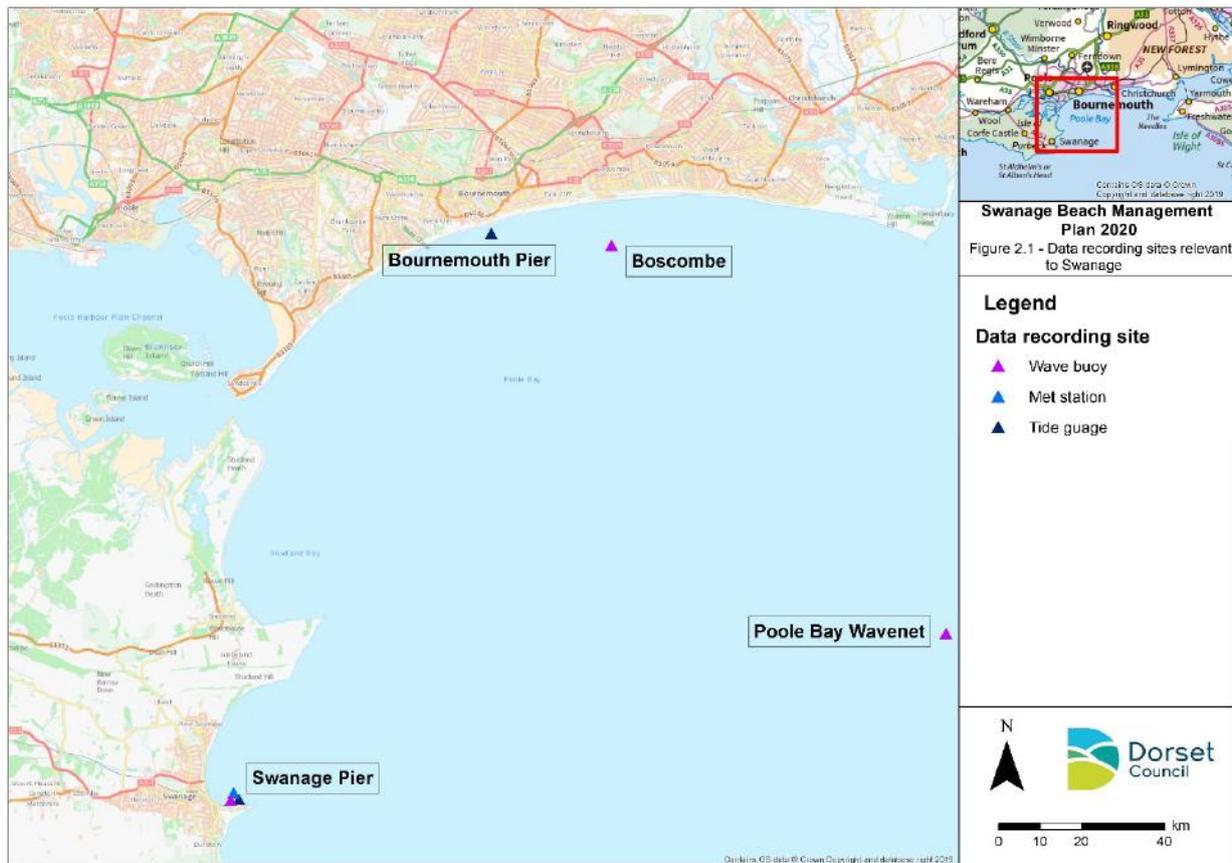
Figures 2-1 The triangles show recorders of wave data – Boscombe (CCO 2003-present) is in 10m depth, Poole Bay WaveNet (Cefas, 2003-present) is an offshore site and Swanage Pier (CCO 2008-present).

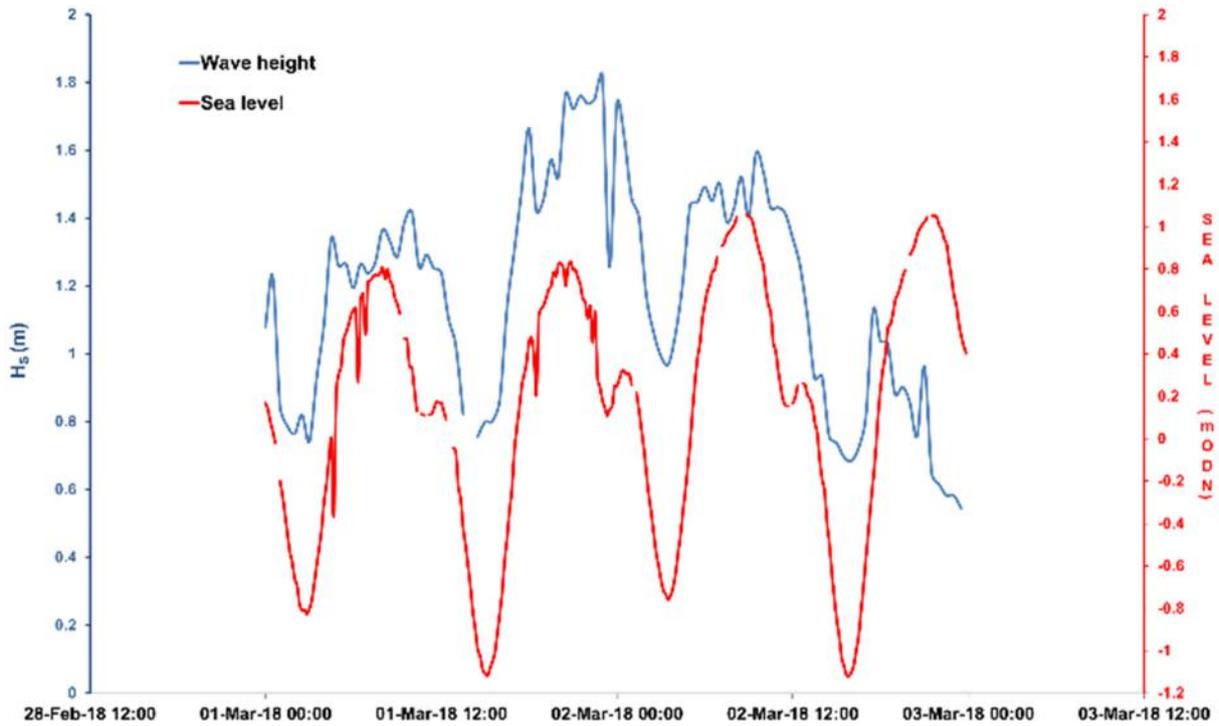
Figures 2-2a Wave times series (blue line and axis) and sea level data (red line and axis) at Swanage Pier for Storm Emma in March 2018.

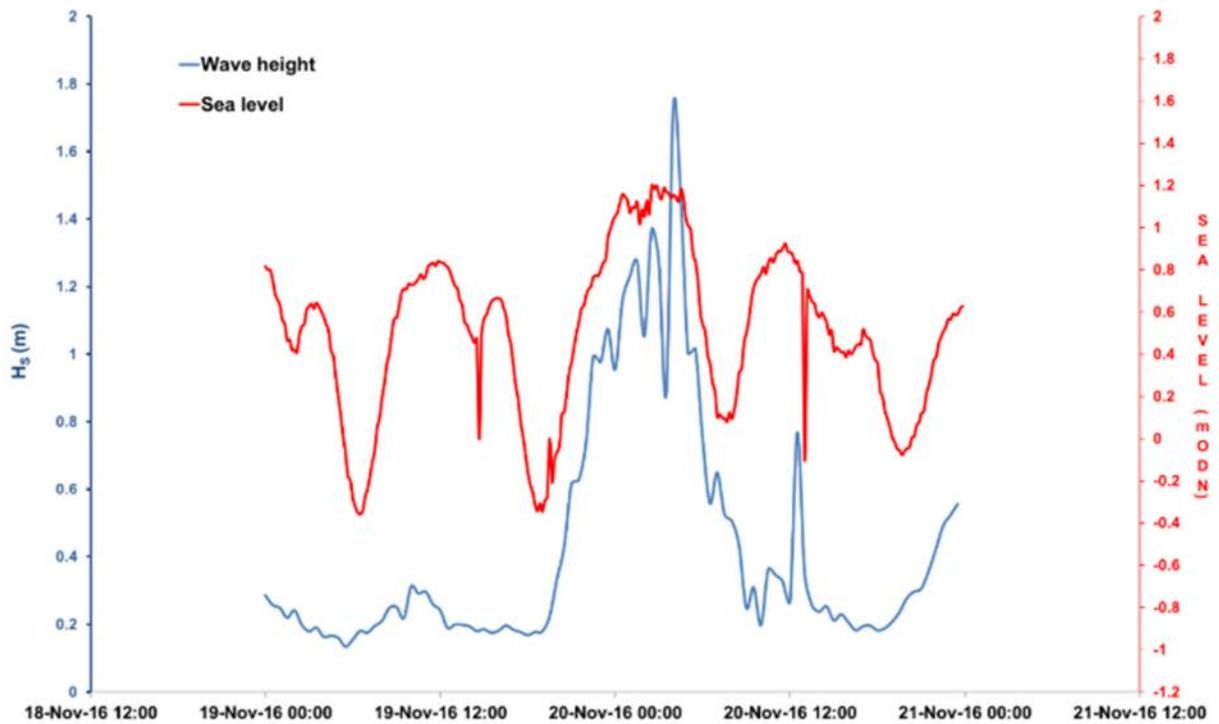
Figures 2-2b Wave times series (blue line and axis) and sea level data (red line and axis) at Swanage Pier for Storm Angus in November 2016.

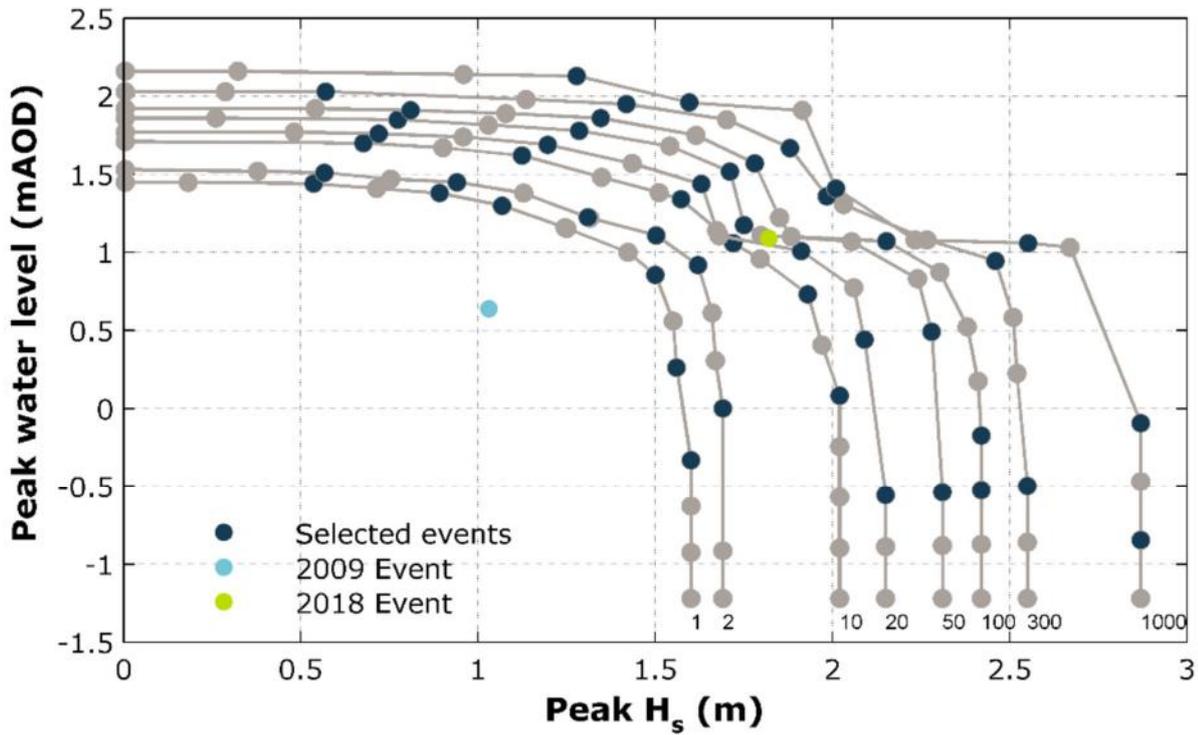
Figure 2-3 Joint probability extreme wave heights and water level curves for Swanage (JBA, 2020b). NB: “selected events” are those listed in Table 2-4.

New joint probability wave and water levels have been calculated as part of the 2020 BMP update by JBA (2020b) and are shown in Figure 2-3. From these, six wave and water level combinations were extracted for each return period to use as boundary conditions for beach response modelling (see Section 2.6.3.1); these values are provided in Table 2-4 for present day (2020) and year 2070, allowing for sea level rise (2070 values are 2020 values raised by 0.495m for water levels, and 10% for wave heights, in accordance with the UKCP09 climate change guidance – see Section 2.4).

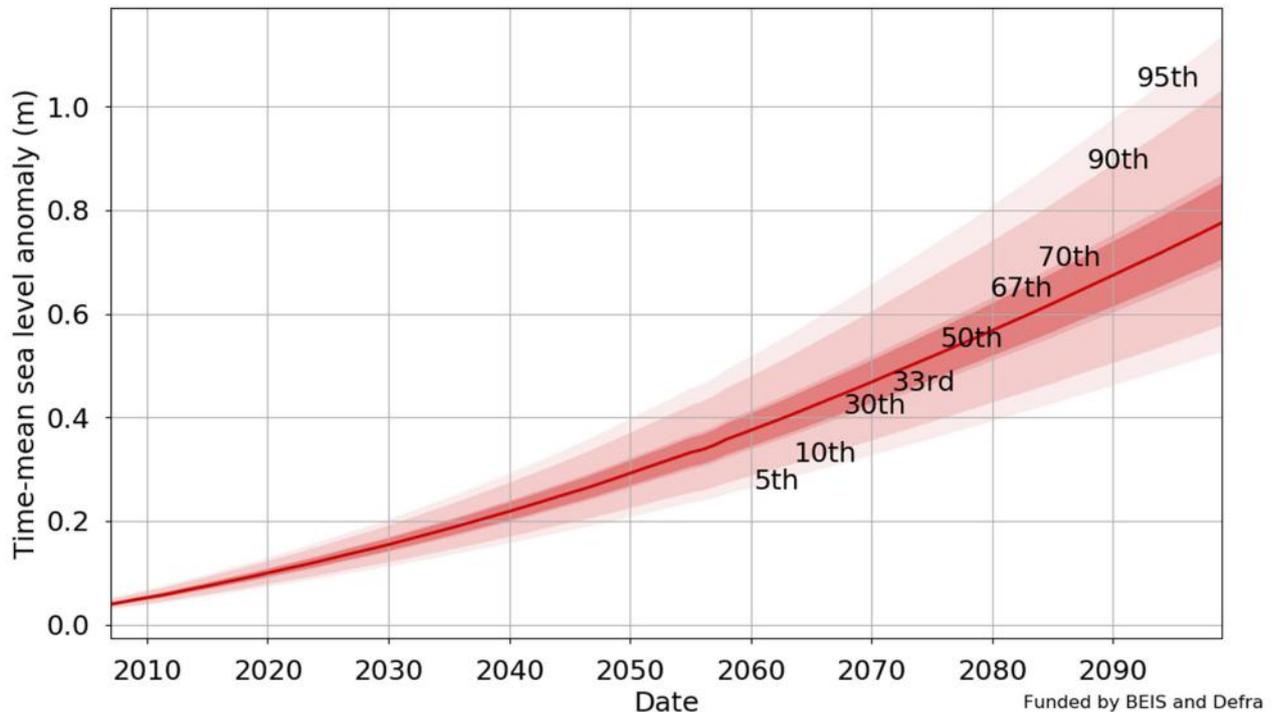
Time-mean sea level anomaly (m) for years 2007 up to and including 2099, for grid square 50.61°, -1.92°, using baseline 1981-2000, and scenario RCP 8.5, showing the 5th, 10th, 30th, 33rd, 50th, 67th, 70th, 90th and 95th percentiles

Figure 2-4 Projected change to relative sea level 2007 to 2099 for the UKCP18 RCP8.5 scenario for Swanage Bay area (source: UKCP18 website – <https://ukclimateprojections-ui.metoffice.gov.uk/ui/home>).

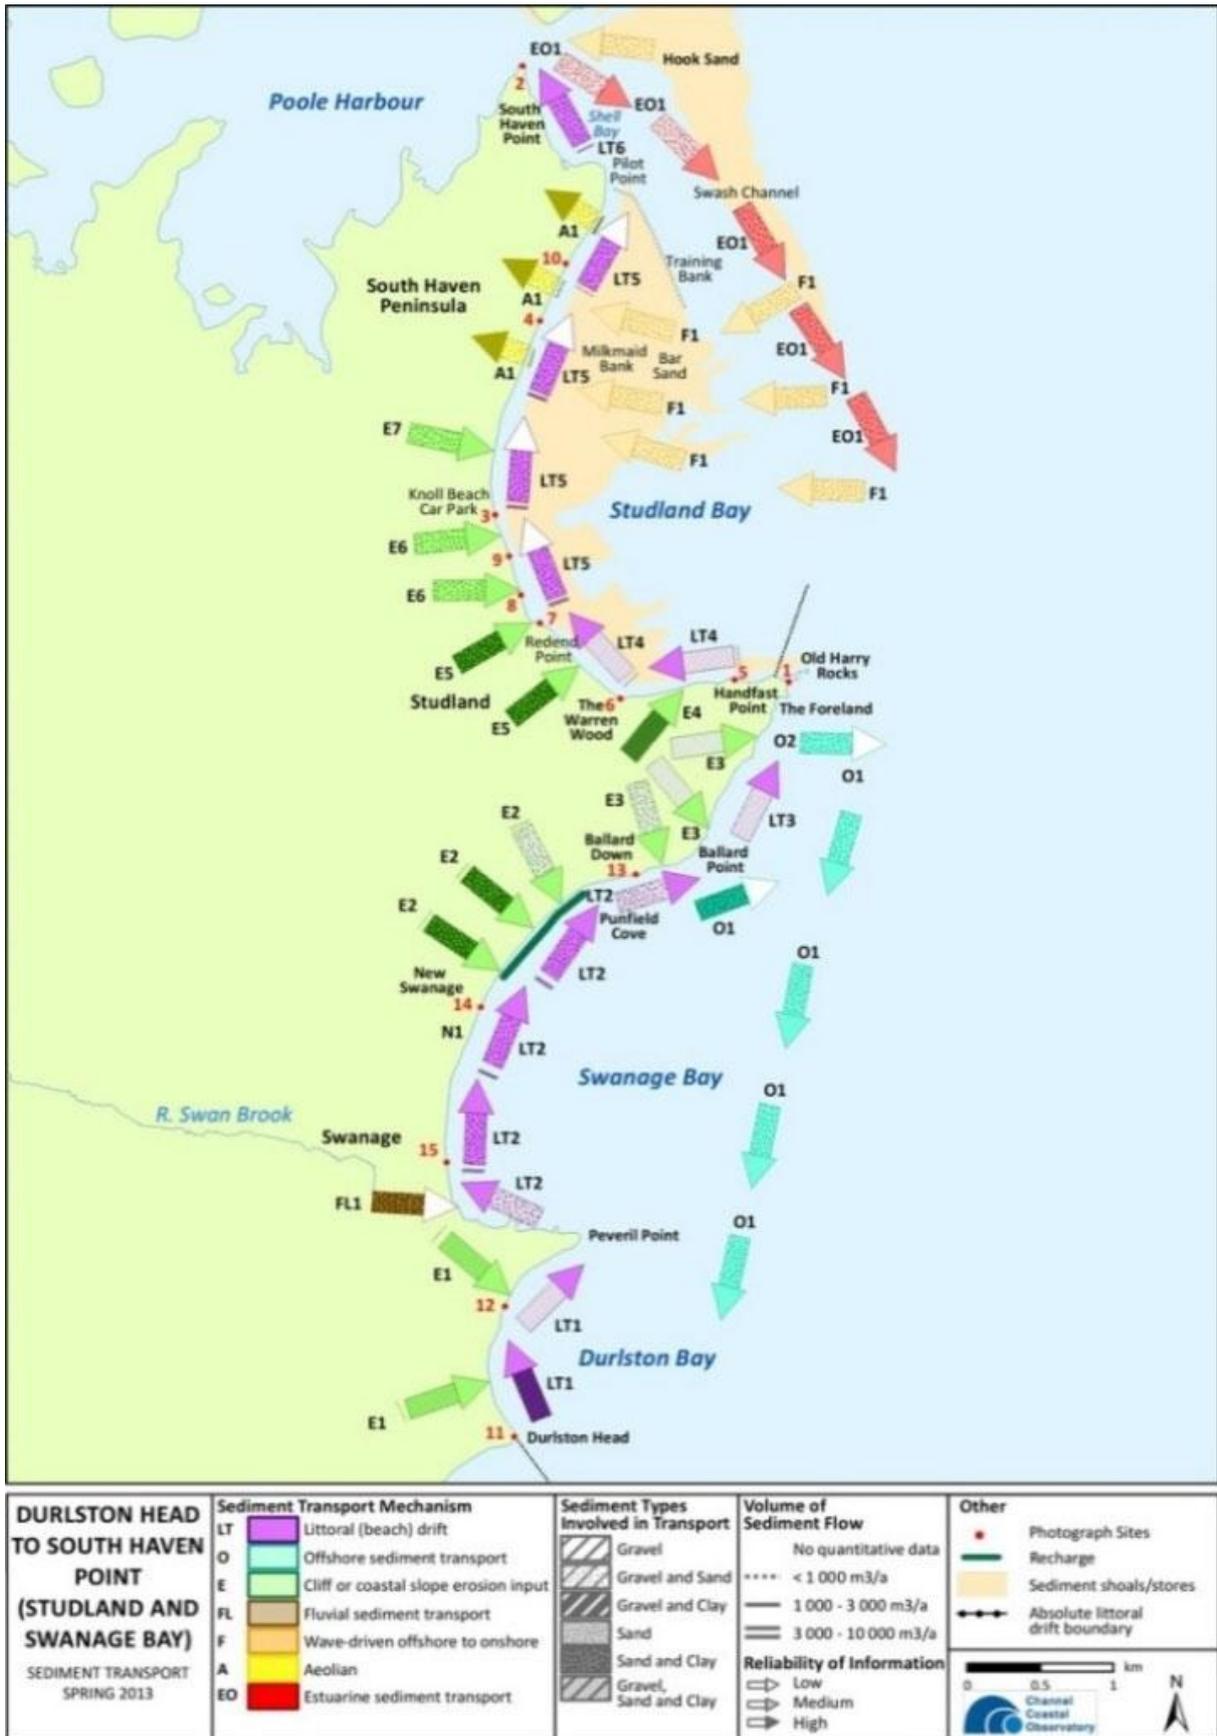
Figure 2-5 Overview of sediment transport pathways in Swanage Bay (New Forest District Council, 2017).

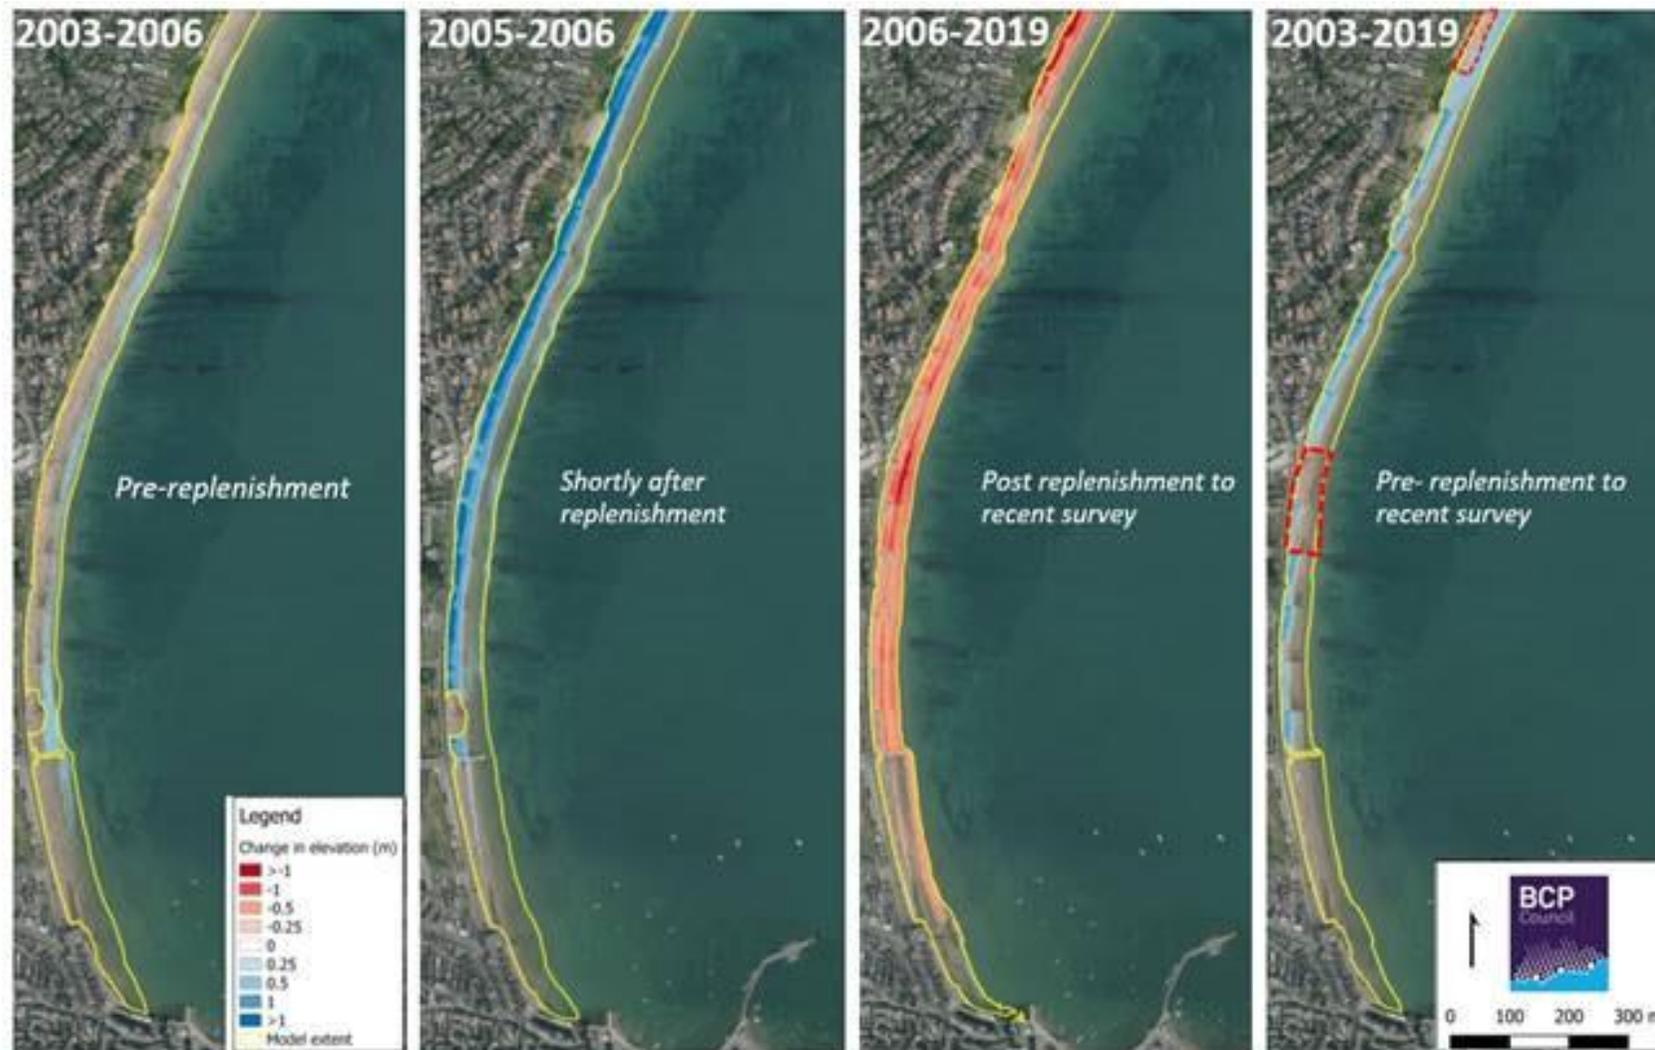
Figure 2-6 Topographic elevation difference plots 2003 until 2019 – showing pre replenishment, shortly after replenishment, change since the replenishment and change pre replenishment to recent (with the red-dashed lines highlighting erosion hotspots).

- There are a couple of areas that appear relatively more susceptible to erosion (red dashed boxes in Figure 2-6) and associated with the larger elevation changes – notably the groyne bay just south of “The Waterfront” where Ulwell Road meets Shore Road, which contains the Ulwell Outfall.
- Comparison of 2003 to 2019 (a couple of years before replenishment until February 2019) indicates that the net change is still gain in elevation across the upper foreshore.

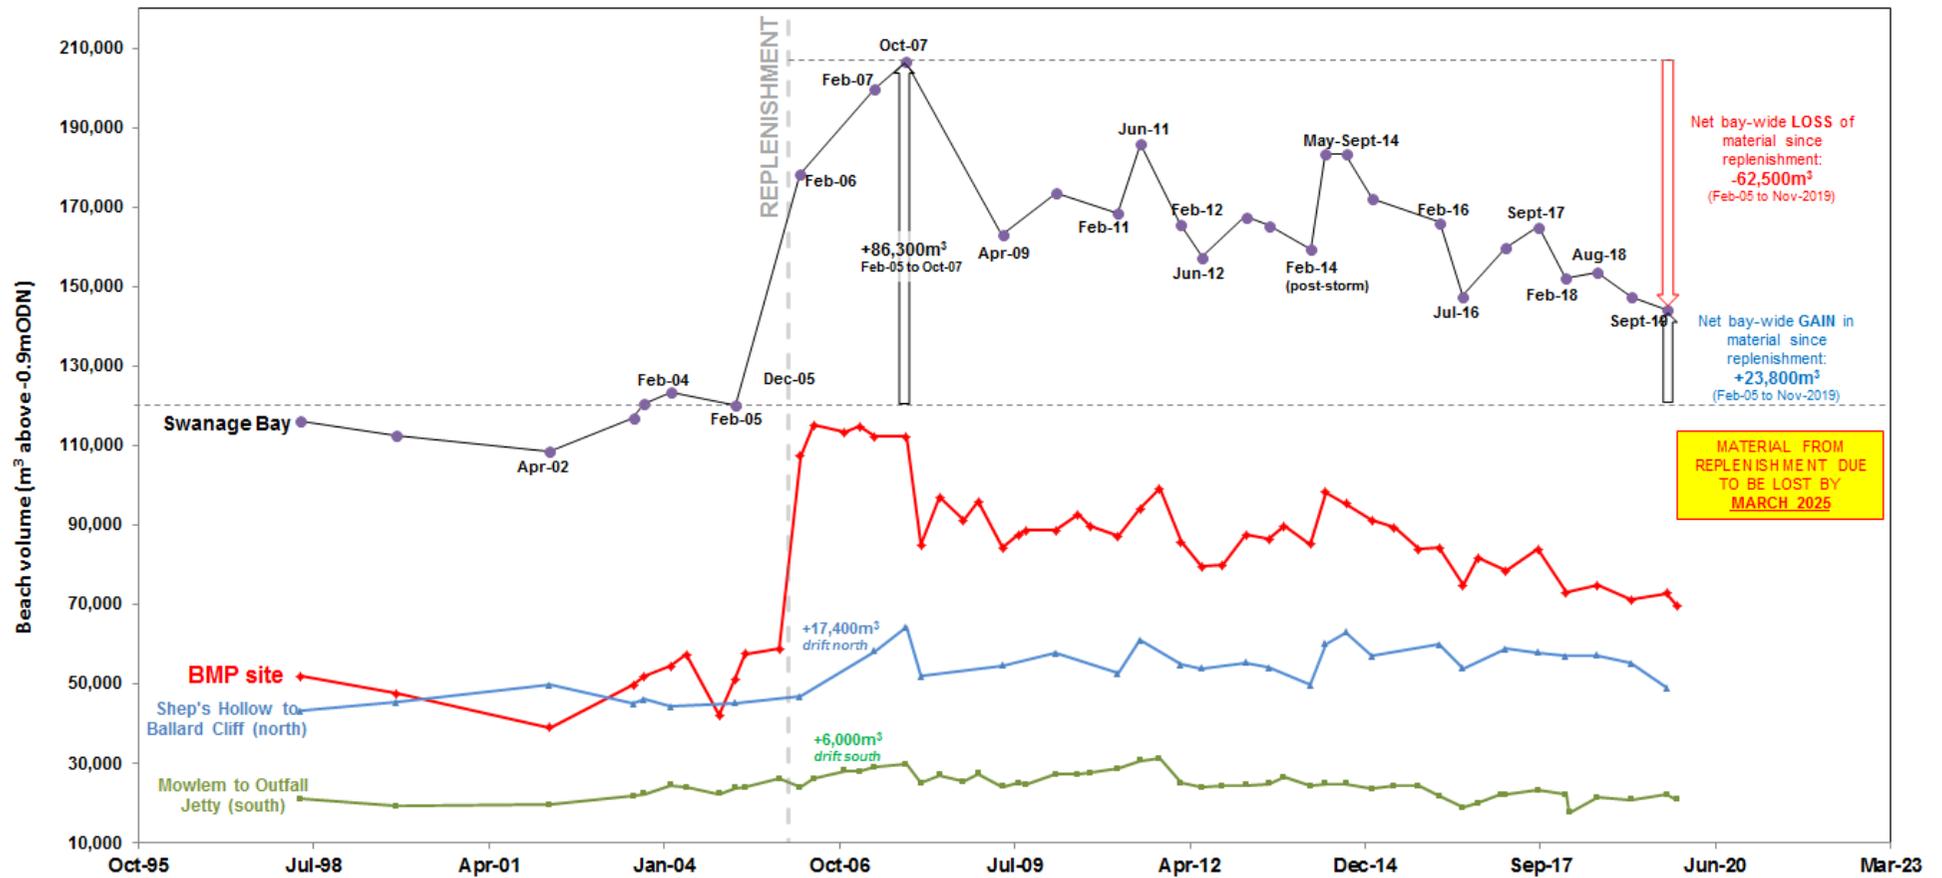
Figure 2-7 Volume change over time at Swanage Bay as interpreted by 1D profile data taken from 11/05/1998 to 08/11/2019.

Based on the averaged loss rate volume calculated from this analysis, the bay is likely to return to pre-recharge volume around spring to summer 2025; although this statement should always be caveated by (a) the uncertainties in beach volumes, (b) distinct periods of loss or inertia that may arise due to storm activity, changing this forecast estimate, and (c) this does not capture spatially where losses may be more intense over localised areas.

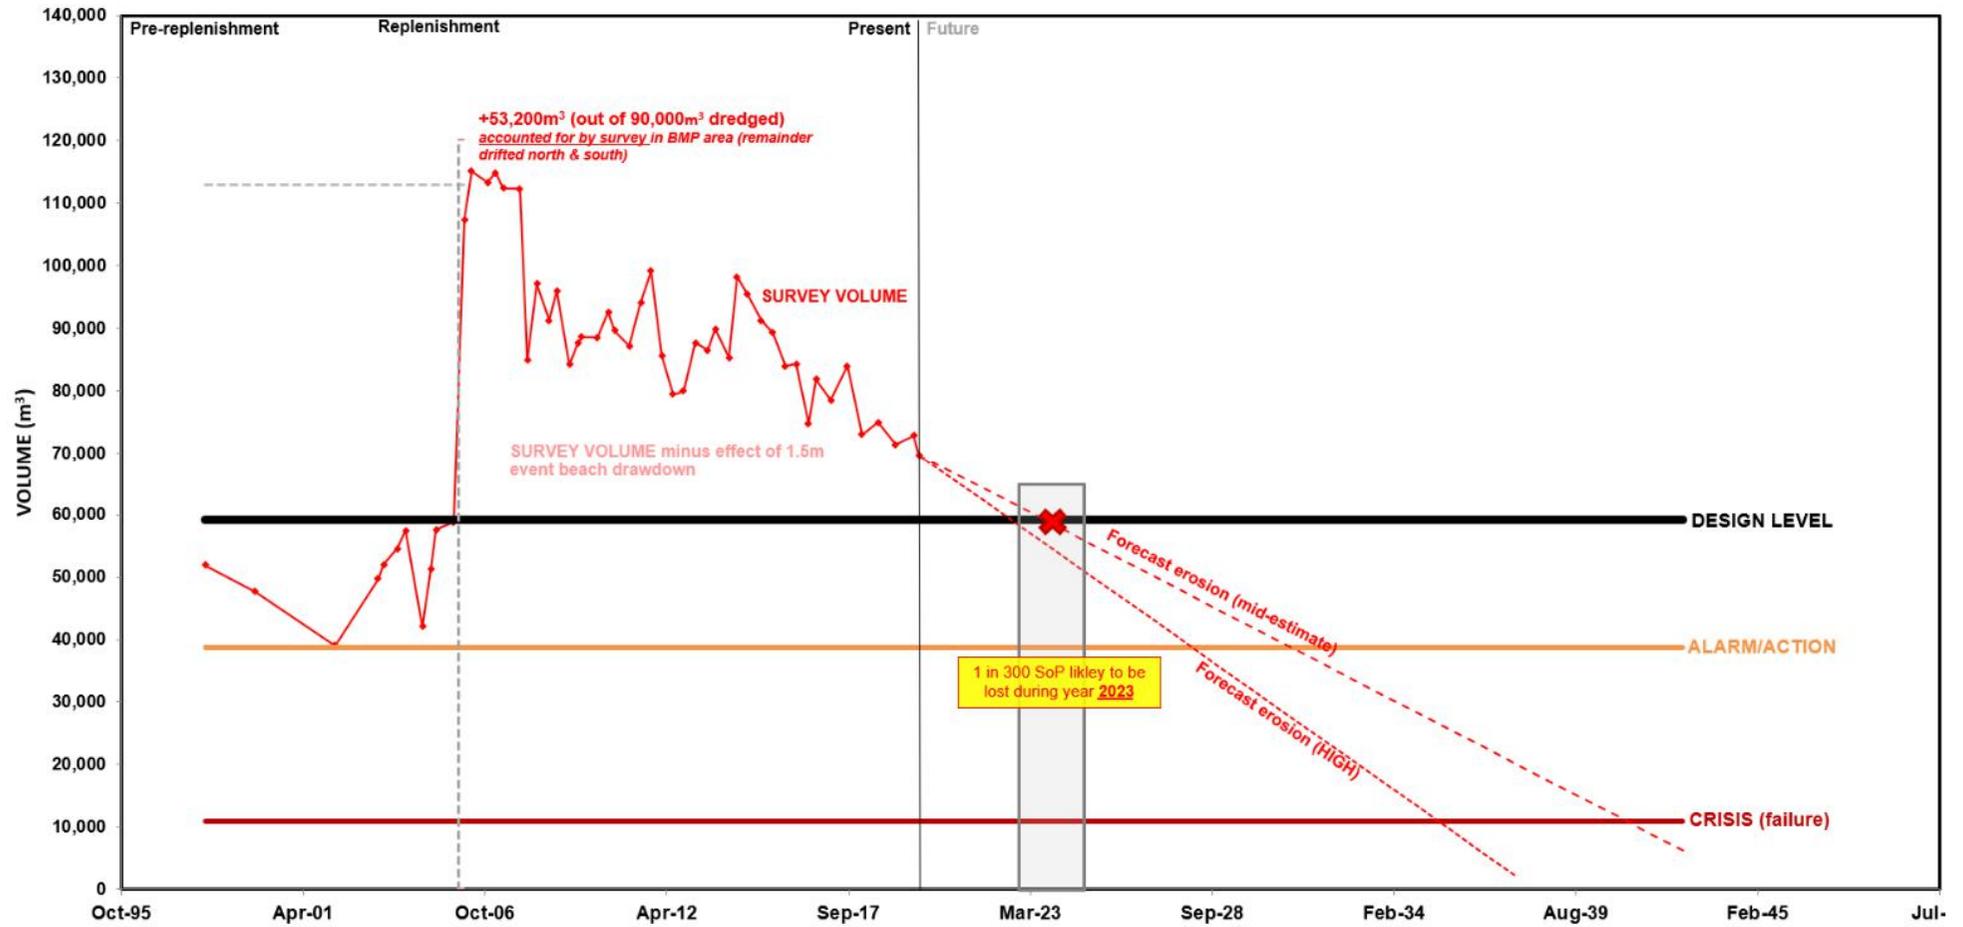
Figure 2-8 Volume plotted over time, compared to design, Alarm and Crisis Levels in the Swanage BMP area.

The key findings from this analysis are summarised in Figure 2-8, which focusses on the volume analysis along the 1.3km of frontage between the Banjo Pier and Shep's Hollow that was recharged in 2005/6. The surveyed volumes from monitoring data are compared to minimum design volume (see Section 3.1.1), and also the Alarm and Crisis Levels (see Section 3.3). This indicates that the beach is currently above the minimum design volume; the significance of which being that most of the frontage is likely above the 1:300 standard of protection targeted in the 2005/6 scheme design. If localised hotspots of erosion emerge in the near future there is, in theory, enough beach sediment to recycle to maintain this level across the BMP area. However, the average beach volume loss rate from the BMP area since replenishment is estimated at **-2,800m³ per year**. If this trend is extrapolated, the minimum design volume is lost during 2023. A higher rate whereby an additional loss per year of -1,000m³ is assumed (for worse condition and uncertainty in the existing data) could bring this about sooner, by Winter 2022.
