Swanage Beach Management Plan

Swanage Beach Management Plan Update 2020

Dorset Council

25 August 2020

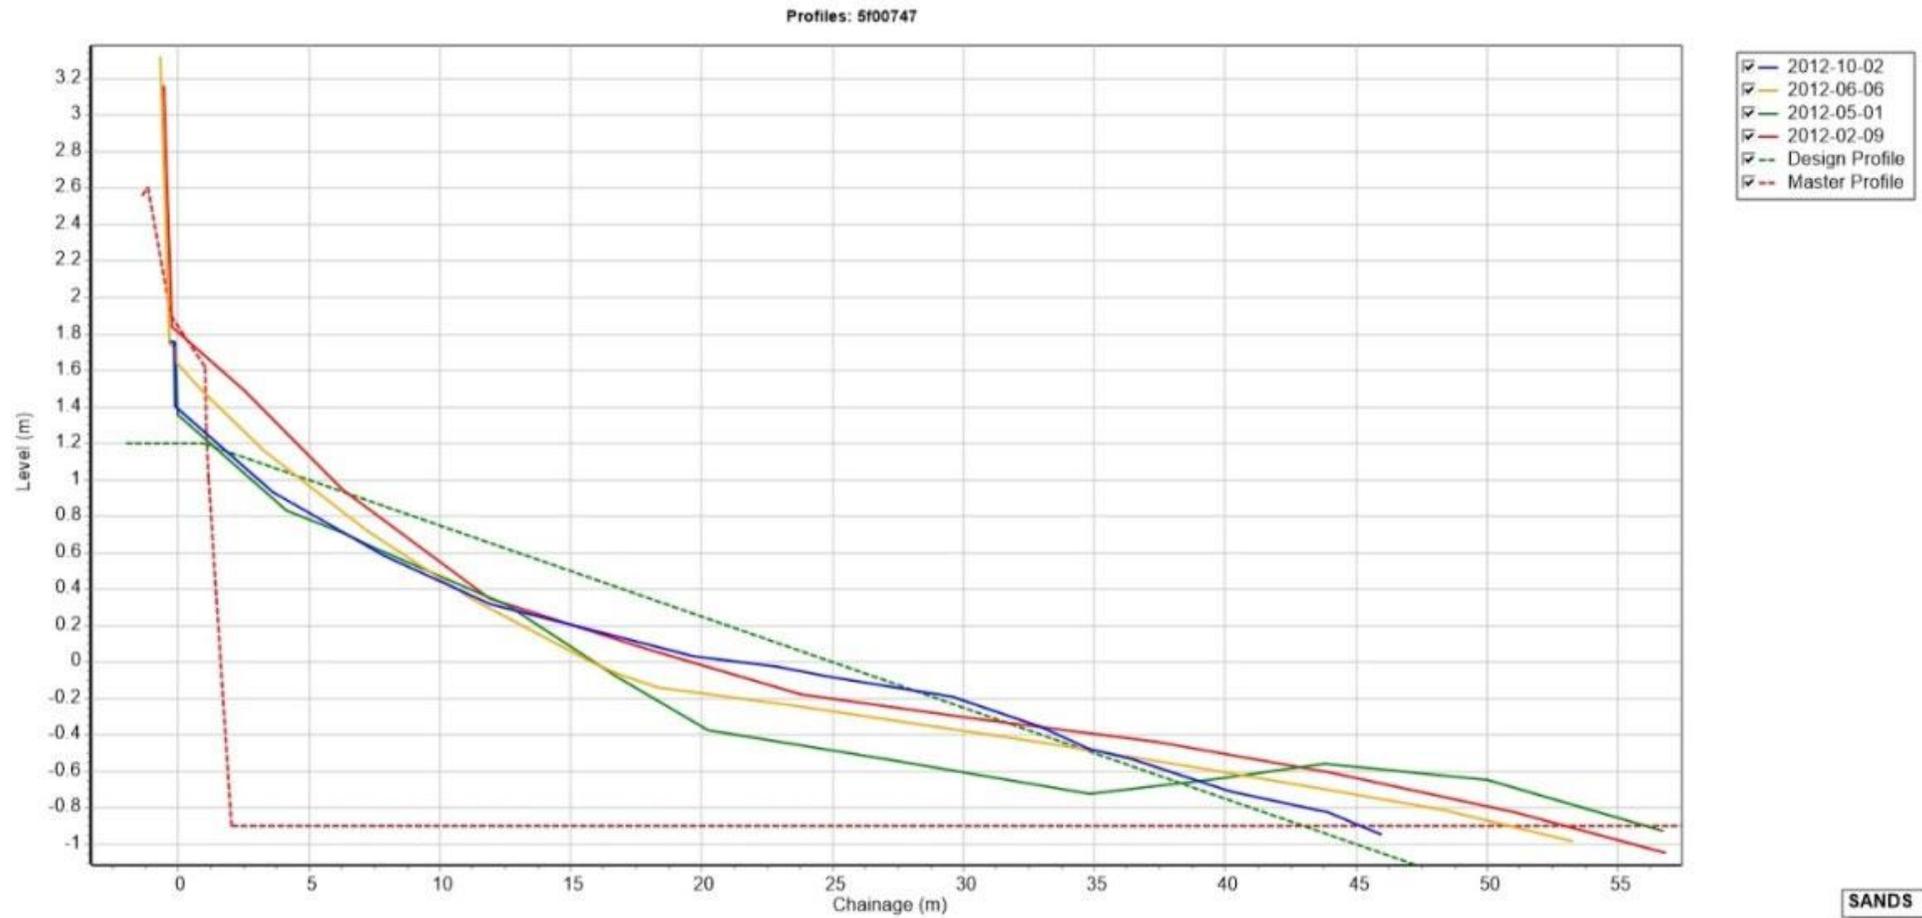
Figures 2-9 Notable profile change at Shep's Hollow end of the BMP site observed on 1st May 2012 (green line) following east-north-easterly event.

- **29th to 30th April 2012:** This event was preceded by two smaller storms on 23rd and 25th-26th. The significant wave height did not exceed storm threshold, but maximum wave heights did exceed this threshold for almost 36 hours, with unexceptional wave period (10s) and wind waves. The wind was NE-SE 20-30kn gusting 40kn with a surge during neap tides. The post-storm profile at the northern end of the BMP site lowered to around crisis level at the sea wall and for the majority of the profile, with a sand bar forming at the toe (Figure 2-9). The other four post storm profiles saw draw down of material from upper profile.

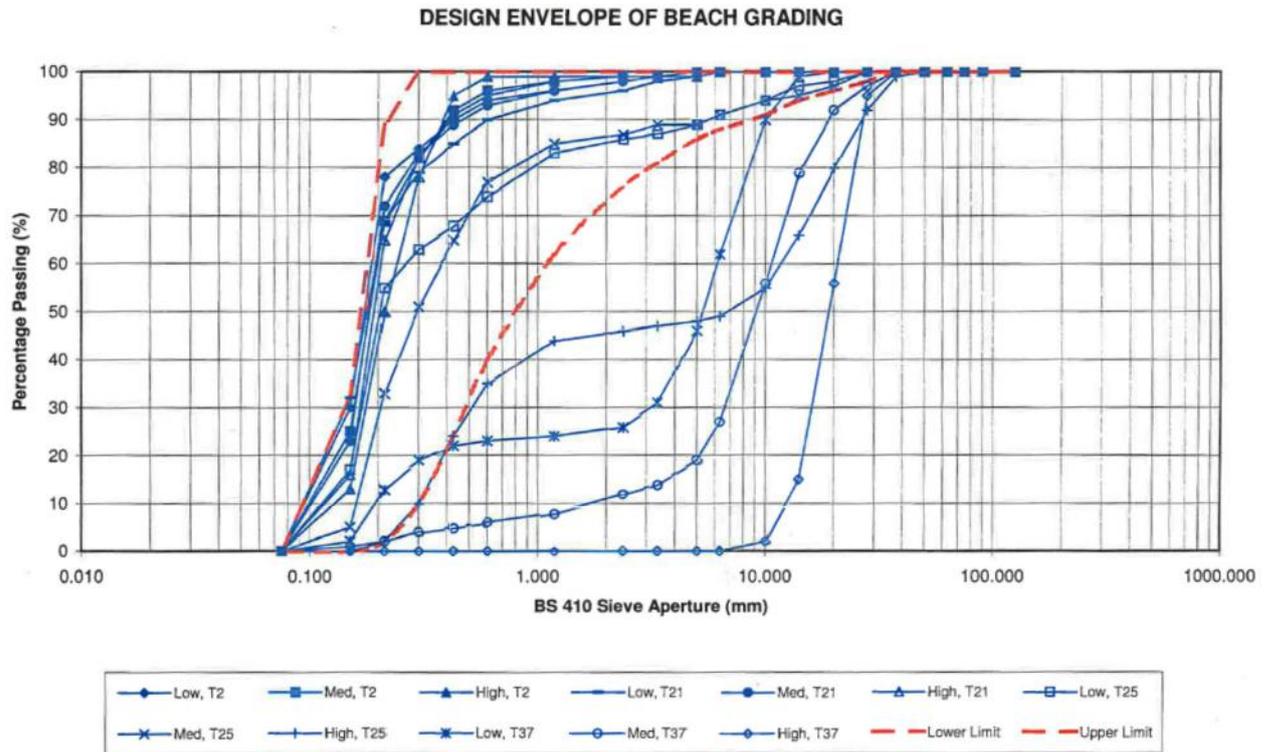
Figure 3-1 Sediment grading design envelope (red lines) in context of sediment samples taken along the Swanage Bay shoreline in 1998 that show the pre-recharged beach sediment grading (blue lines; Note, locations T2 and T21 are along the section that was eventually recharged in 2005) (from Halcrow, 2005a).

The sediment placed was derived from dredging of Poole Harbour Swash Channel for navigation purposes, so provided a beneficial use of the dredged material. The current BMP (Halcrow, 2005a) indicates that the sediment grading of this material from the Swash Channel is sand with a D₅₀ value of about 0.2mm, and with very little shingle content. This provided a sediment grading that was similar to the pre-recharge beach based on sediment sampling undertaken along Swanage Bay in 1998, and the recharge material placed is represented by the lower limit of the grading envelope shown on Figure 3-1, that was identified by a sediment grab sampling investigation of the Swash Channel in May 2002 (Halcrow, 2005a).

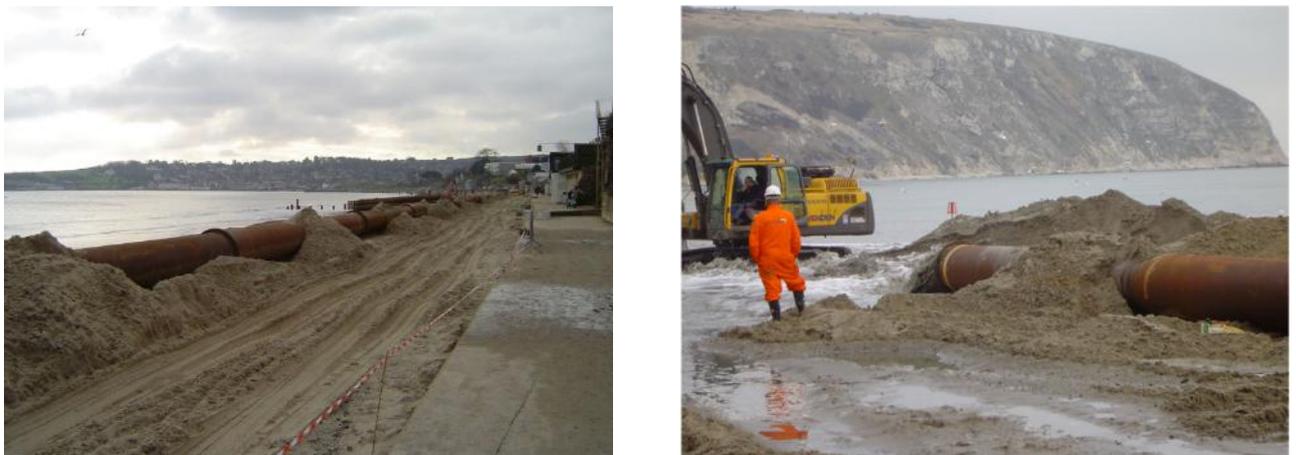
Figure 3-2 Photos of beach recharge underway in 2005/6 (from Goater, 2014).

Sediment was pumped ashore via a 750m long pipeline with 700mm diameter laid across Swanage Bay from a vessel moored offshore in Swanage Bay, and then using bulldozers to provide the design beach profile (see Figure 3-2). The pipeline used was assembled in Newhaven Harbour in Sussex and towed to Swanage. In the interests of health and safety it was necessary to close short sections of the beach when the sand was pumped ashore and being moved by heavy plant. The promenade remained open at all times (<https://poolebay.net/past-projects/beach-replenishment-2005-2007-phase-one/>; date accessed: 3rd March 2020).

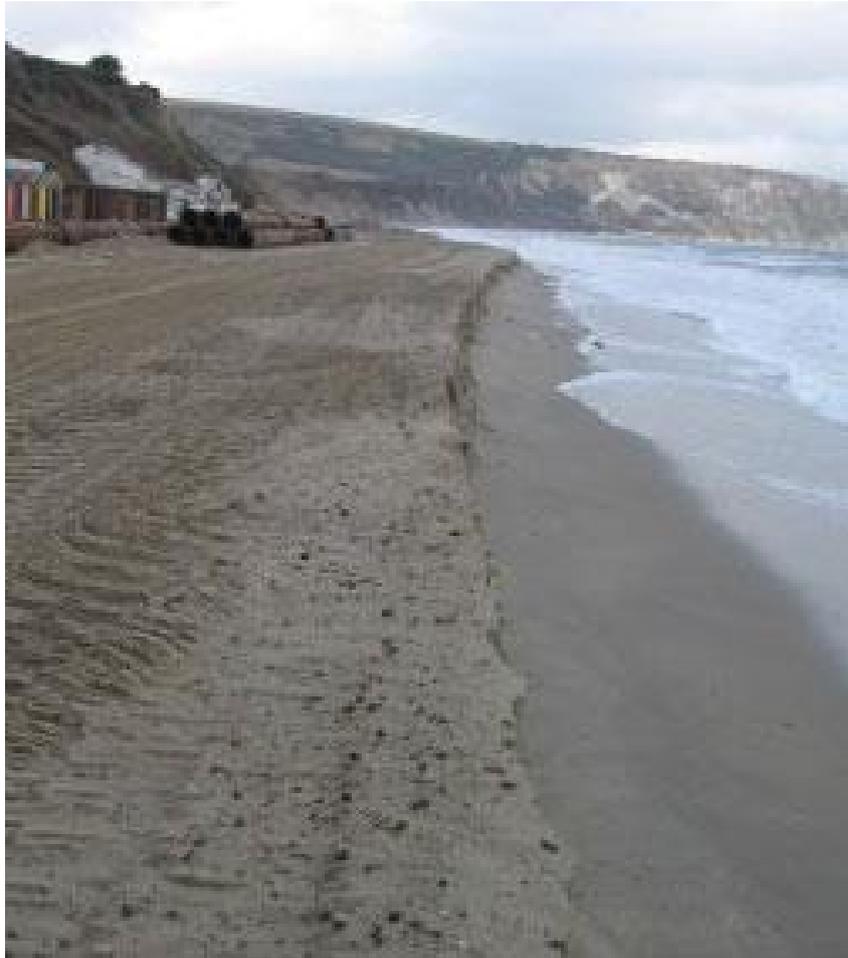
Figure 3-3 Small cliffs cut into the front of the newly recharged beach in 2006 (from Royal Geographical Society, 2007).

these soon disappeared as the sand was moved by wind and waves into a natural beach profile; see Figure 3-3 (<https://poolebay.net/past-projects/beach-replenishment-2005-2007-phase-one/>; date accessed: 3rd March 2020).

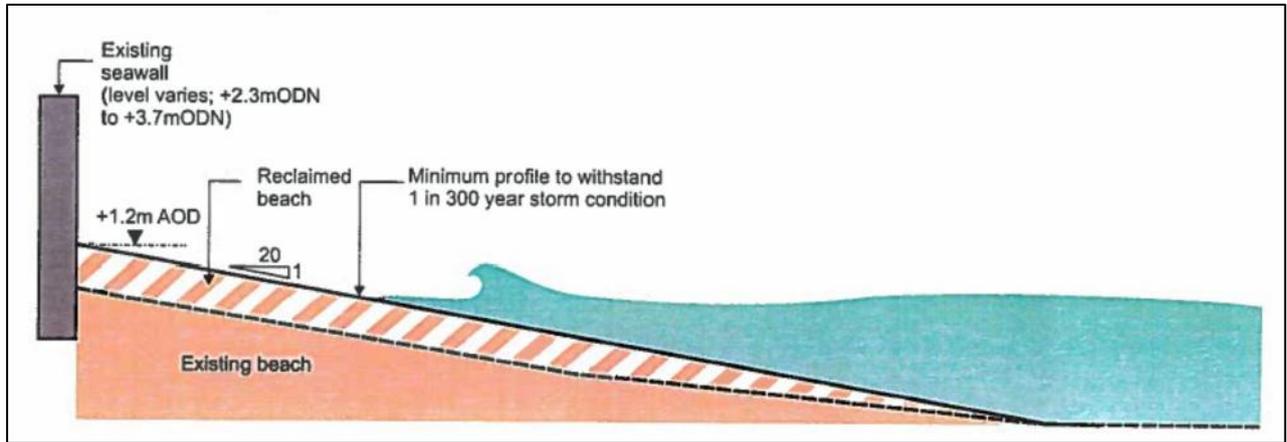
Figure 3-4 Schematic representation of minimum design beach profile required to provide 1:300 year standard of protection (from Halcrow, 2005a).

The 2005 Swanage BMP (Halcrow, 2005a) was prepared as part of the scheme and guides future maintenance to ensure the constructed design standard of 1:300 years is provided over the 50-year scheme life. The design standard is achieved by providing a beach profile with a 1:20 slope to a minimum beach crest level against the backing seawall of +1.2mODN (see Figure 3-4). During construction in 2005, the as-built drawings in the Health & Safety file (Halcrow, 2006) show the installed beach crest level against the seawall as being approximately 0.53m above this minimum level at +1.73mOD; this was to allow for loss of sediment due to longshore transport over the life of the scheme. For context, prior to the beach recharge in 2005, the beach level against the seawall was typically about +0.5mOD (see Figure 3-5).

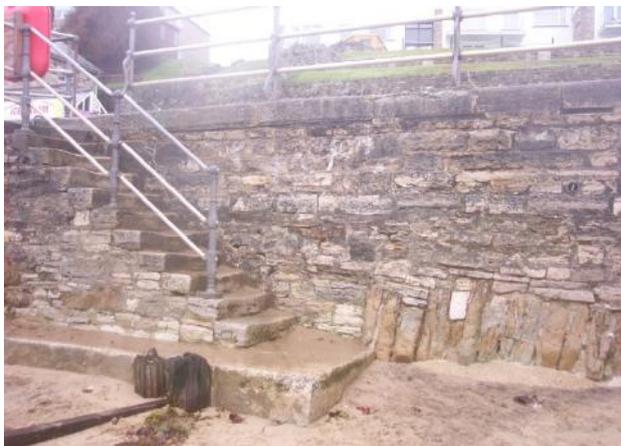
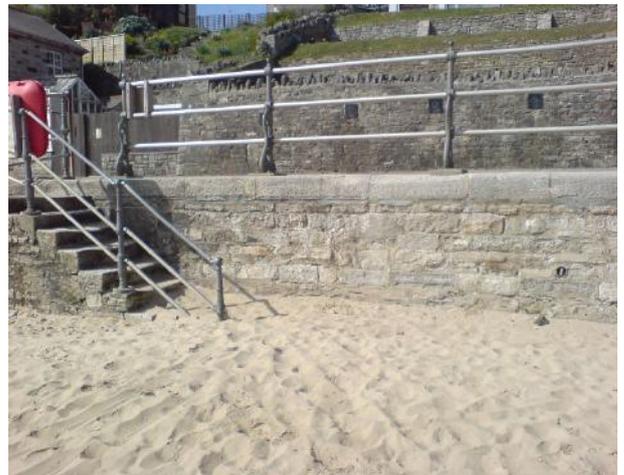
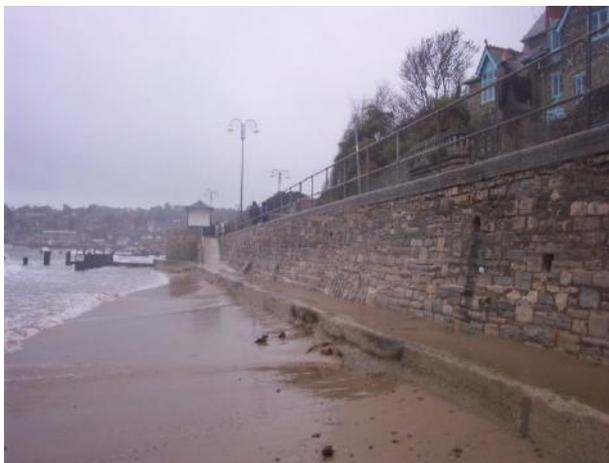
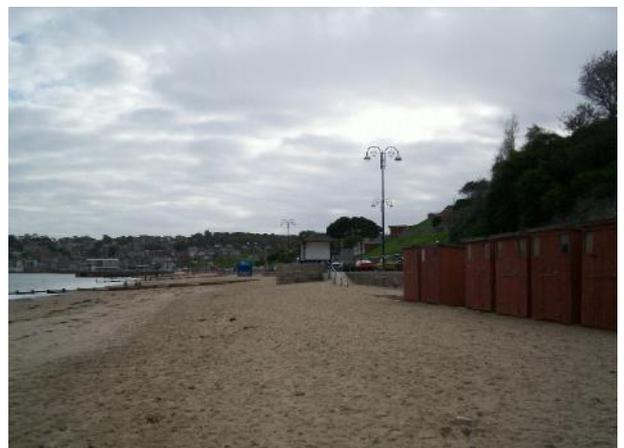
Figure 3-5 Photos showing two sections of the BMP frontage before and after beach recharge in 2005/6 (from Royal Geographical Society, 2007).

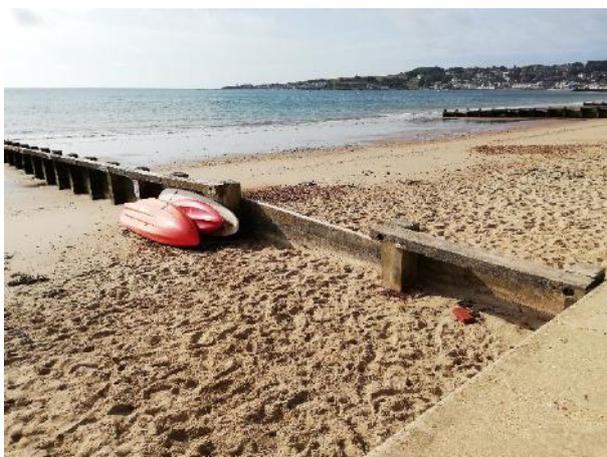
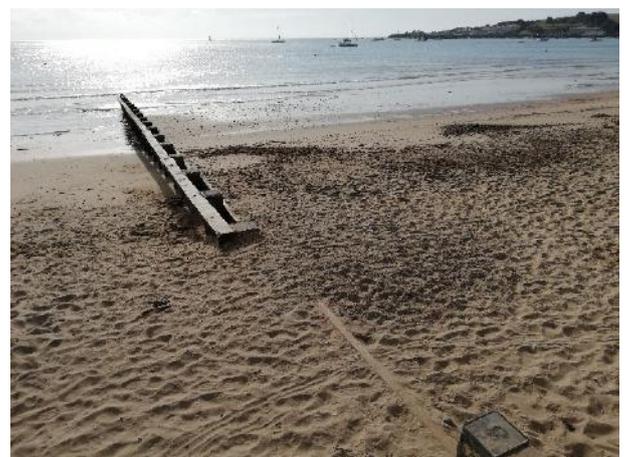
Figure 3-6 Photos showing 4m gap in the waling beam towards the landward end of each timber groyne, so allow access along the beach.

The new groynes were constructed in early 2006 (following beach recharge) using hardwood Greenheart timber and land-based plant. Each groyne is approximately 40m long and tied into the seawall or cliff line as appropriate. Timber piles of dimensions 300mm x 300mm x 7800mm were then driven into the underlying clay bed layer at 2m intervals. 75mm x 225mm x 6000mm (typical length) planks were then installed so they butted together to form a tight seal with no gaps, with the bottom planks dug into the clay bed layer to form a seal. A waling beam was then added to the top of the piles. Towards the landward end of each groyne, there is a gap in the waling beam present in order to provide a 4m wide gap for access along the beach for beach users as well as maintenance plant (see Figure 3-6). All details are shown for each groyne in the As Built drawings provided in Appendix H.

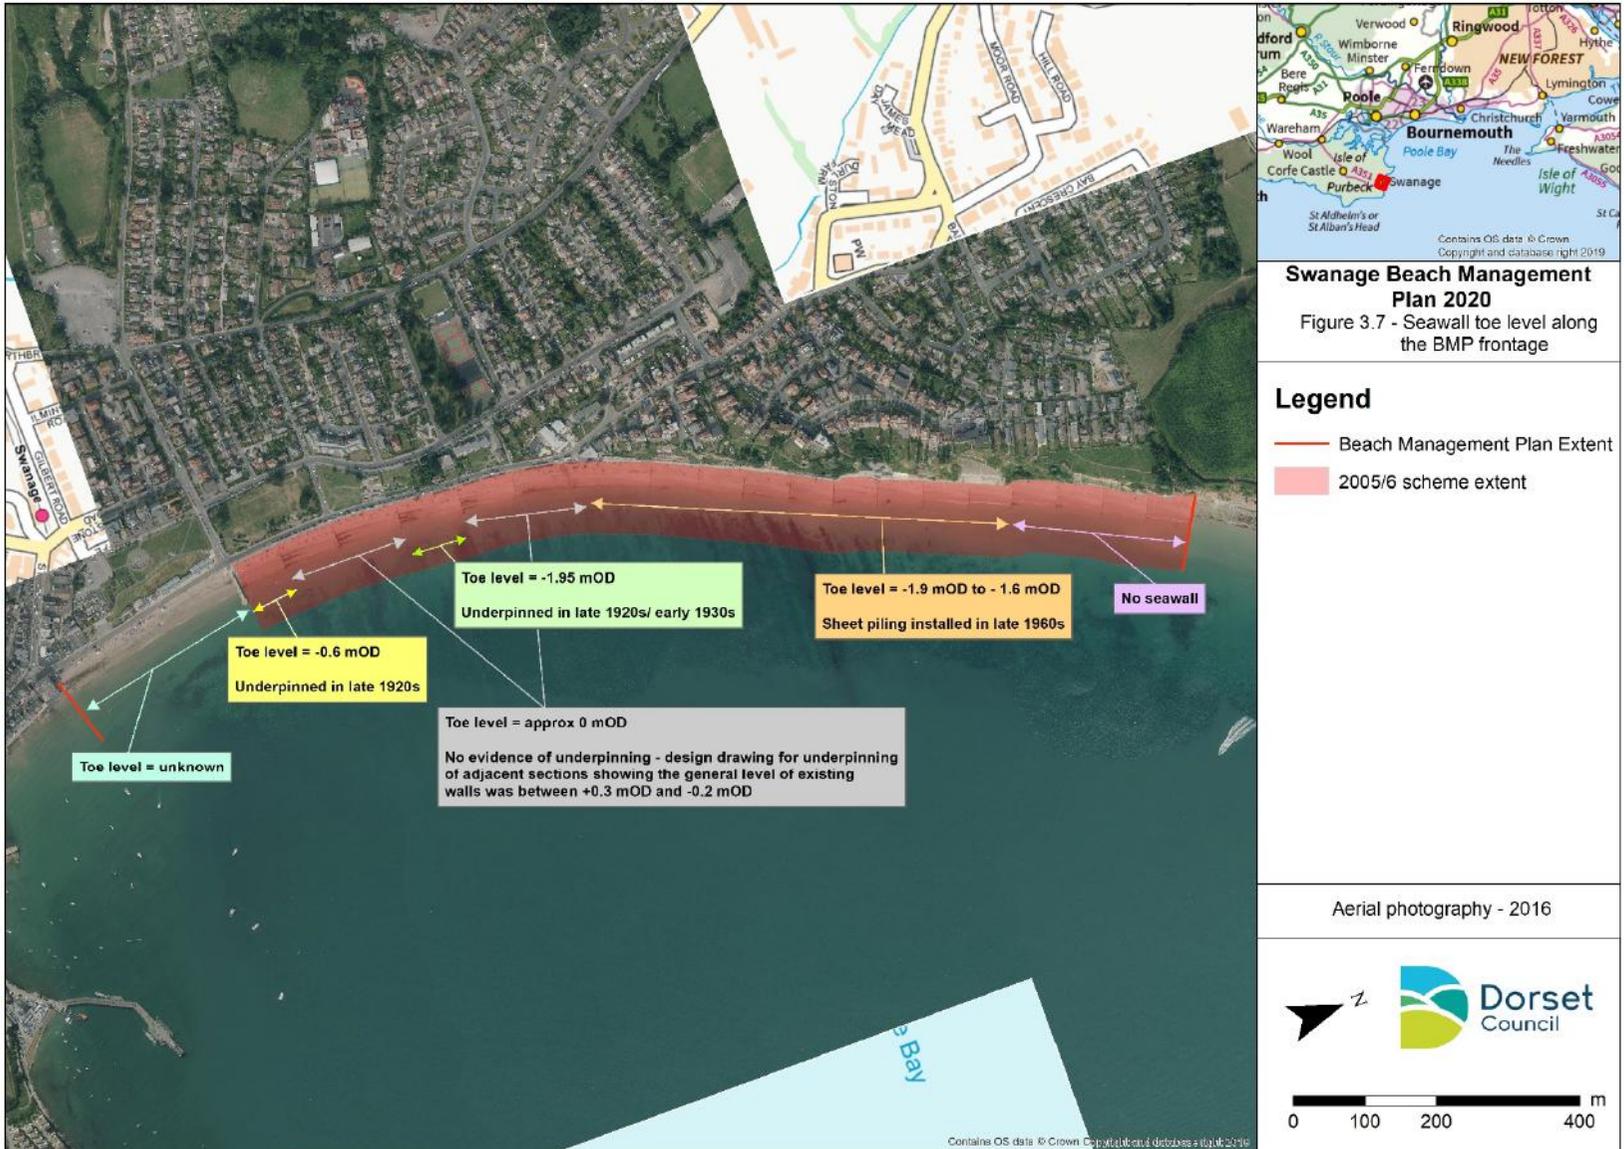
Figure 3-7 Map showing notes on the variance in seawall toe levels from the Banjo Pier northwards, based on analysis presented in Halcrow, 2005b.

This seawall has a varying toe level between the Outfall Jetty and the Ulwell Stream outfall. In the main, toe levels range from between +0.3mOD and -0.2mOD, except in localised sections where some underpinning has been carried out, deepening the toe level to between -0.6mOD and -1.95mOD (Halcrow, 2005b). Figure 3-7 illustrates where the toe levels vary along this section of the frontage. Figure 3-8 shows the seawall construction when beach levels were low prior to the 2005 beach recharge.

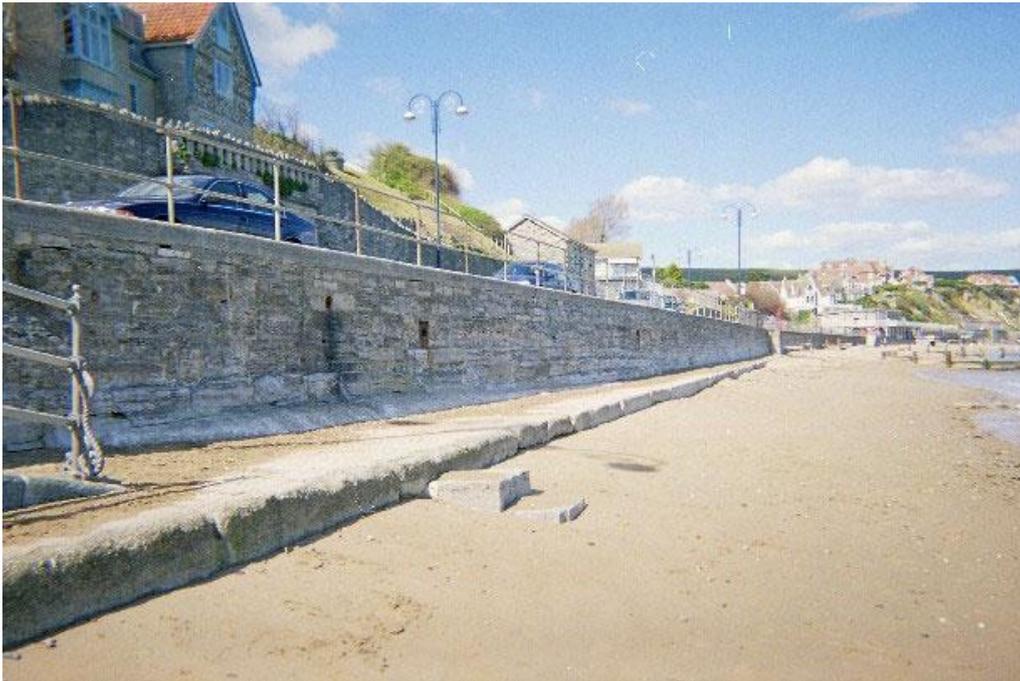
Figure 3-8 1920s seawall along part of Shore Road exposed by low beach levels prior to beach recharge in 2005, shows toe details (from Goater, 2014).

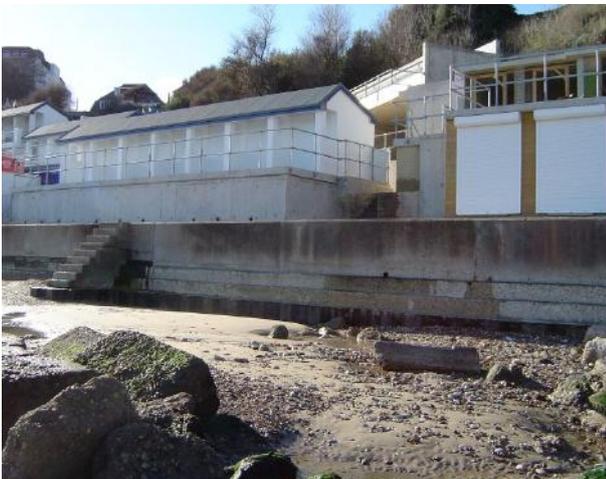
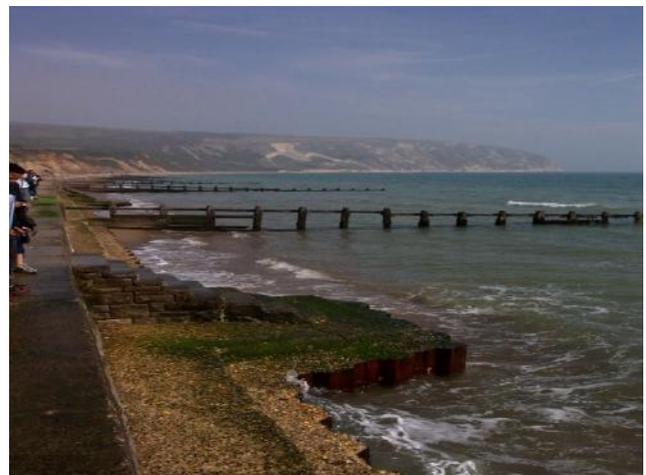
Figure 3-9 Parts of the seawall along the New Swanage frontage refurbished/rebuilt in 1962, with steel sheet pile exposed when beach levels were lower, prior to beach recharge in 2005 (left = from Goater, 2014; right = from Royal Geographical Society, 2007).

To the north of the Ulwell Stream outfall, along the New Swanage section of the BMP frontage, a series of small seawalls protecting beach huts were constructed in an erratic alignment along the toe of the cliffs in this area around the 1920s (believed to be by private landowners). In 1962, Purbeck District Council (now Dorset Council) took operational responsibility for the coastal protection measures in this area and paid for these sections of seawall to be either refurbished or rebuilt, and extended up to The Pines Hotel, with a new concrete and sheet pile toe detail added as part of these works to provide a toe depth of between -1.6mOD and -1.9mOD (Halcrow, 2005b; Dorset Coast Forum, 2014); see Figure 3-9. Timber groynes were also constructed in front of the seawall between the Ulwell Stream and Shep’s Hollow in 1962 (Halcrow, 2000; see also Section 3.1.2). Parts of this length of seawall, and some access steps, were repaired as part of the 2005/6 Swanage Beach Recharge Scheme. The as built “General Arrangement” drawings provided in Appendix H indicate where such works were undertaken.

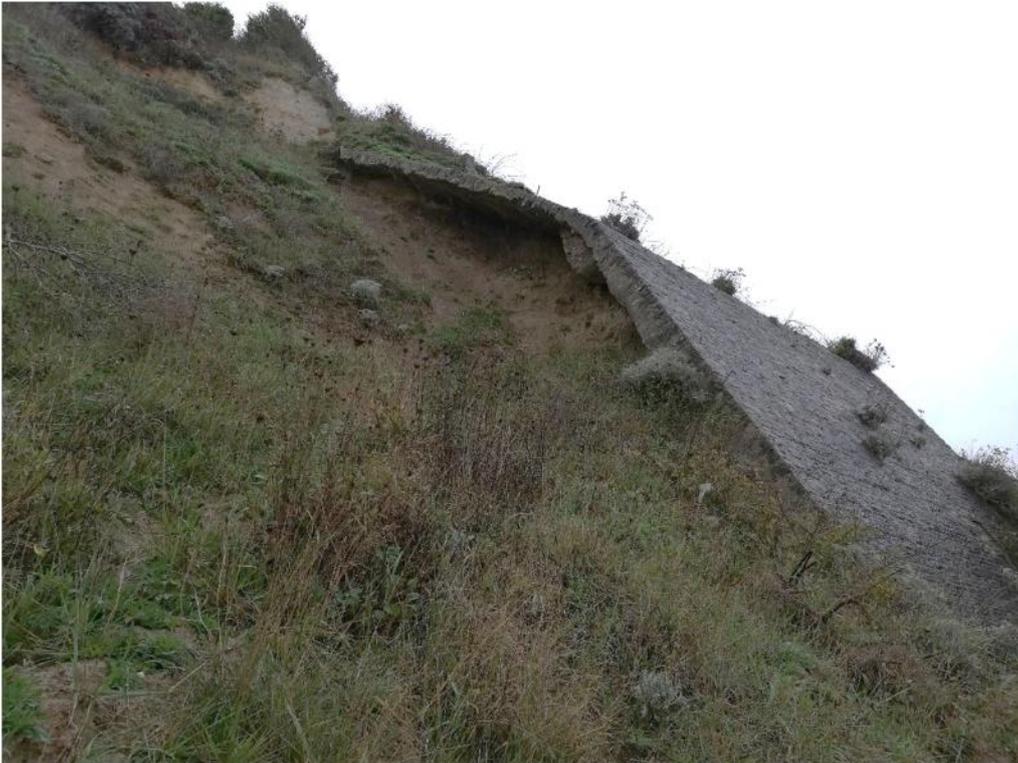
Figure 3-10 An example of historic ad hoc slope stabilisation measures introduced along the New Swanage frontage by a private landowner (photo taken on 24th October 2019).

During the 20th century, private landowners have constructed an ad-hoc arrangement of slope stabilisation measures along the New Swanage section of coast (north of Shore Road) to address ongoing coastal slope instability issues (see Figure 3-10).

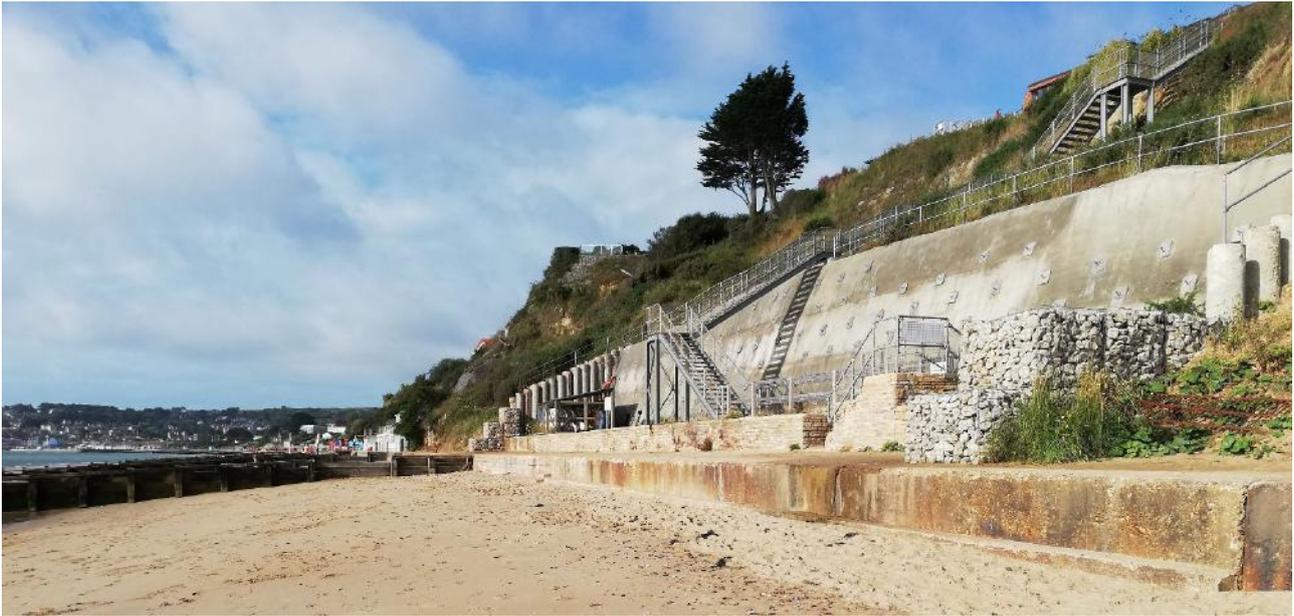
Figure 3-11 The Pines Hotel slope stabilisation scheme constructed by the private landowner between 2015 and 2017. The 1960s seawall and 2005 timber groynes at the base of the cliff are also shown.

- Phase 1 – Emergency works in 2013 (following coastal slip in 2012) saw soil nailing and slope drainage installed in the upper slope.
- Phase 2 – Planned works constructed between 2015 and 2017 installed soil nails, slope drainage and a reinforced retaining wall with bore pile retaining end walls in the lower slope (see Figure 3-11). The construction of the retaining wall involved removal of the lower part of the slope, thus creating development space for the landowner to construct a terrace of beach huts to be used to provide an income stream and offset some of the costs incurred in constructing this scheme. The design of this scheme also relies on protection at the cliff toe provided by the existing groyne field and beach management scheme constructed in 2005/6 (see Sections 3.1.1 and 3.1.2).

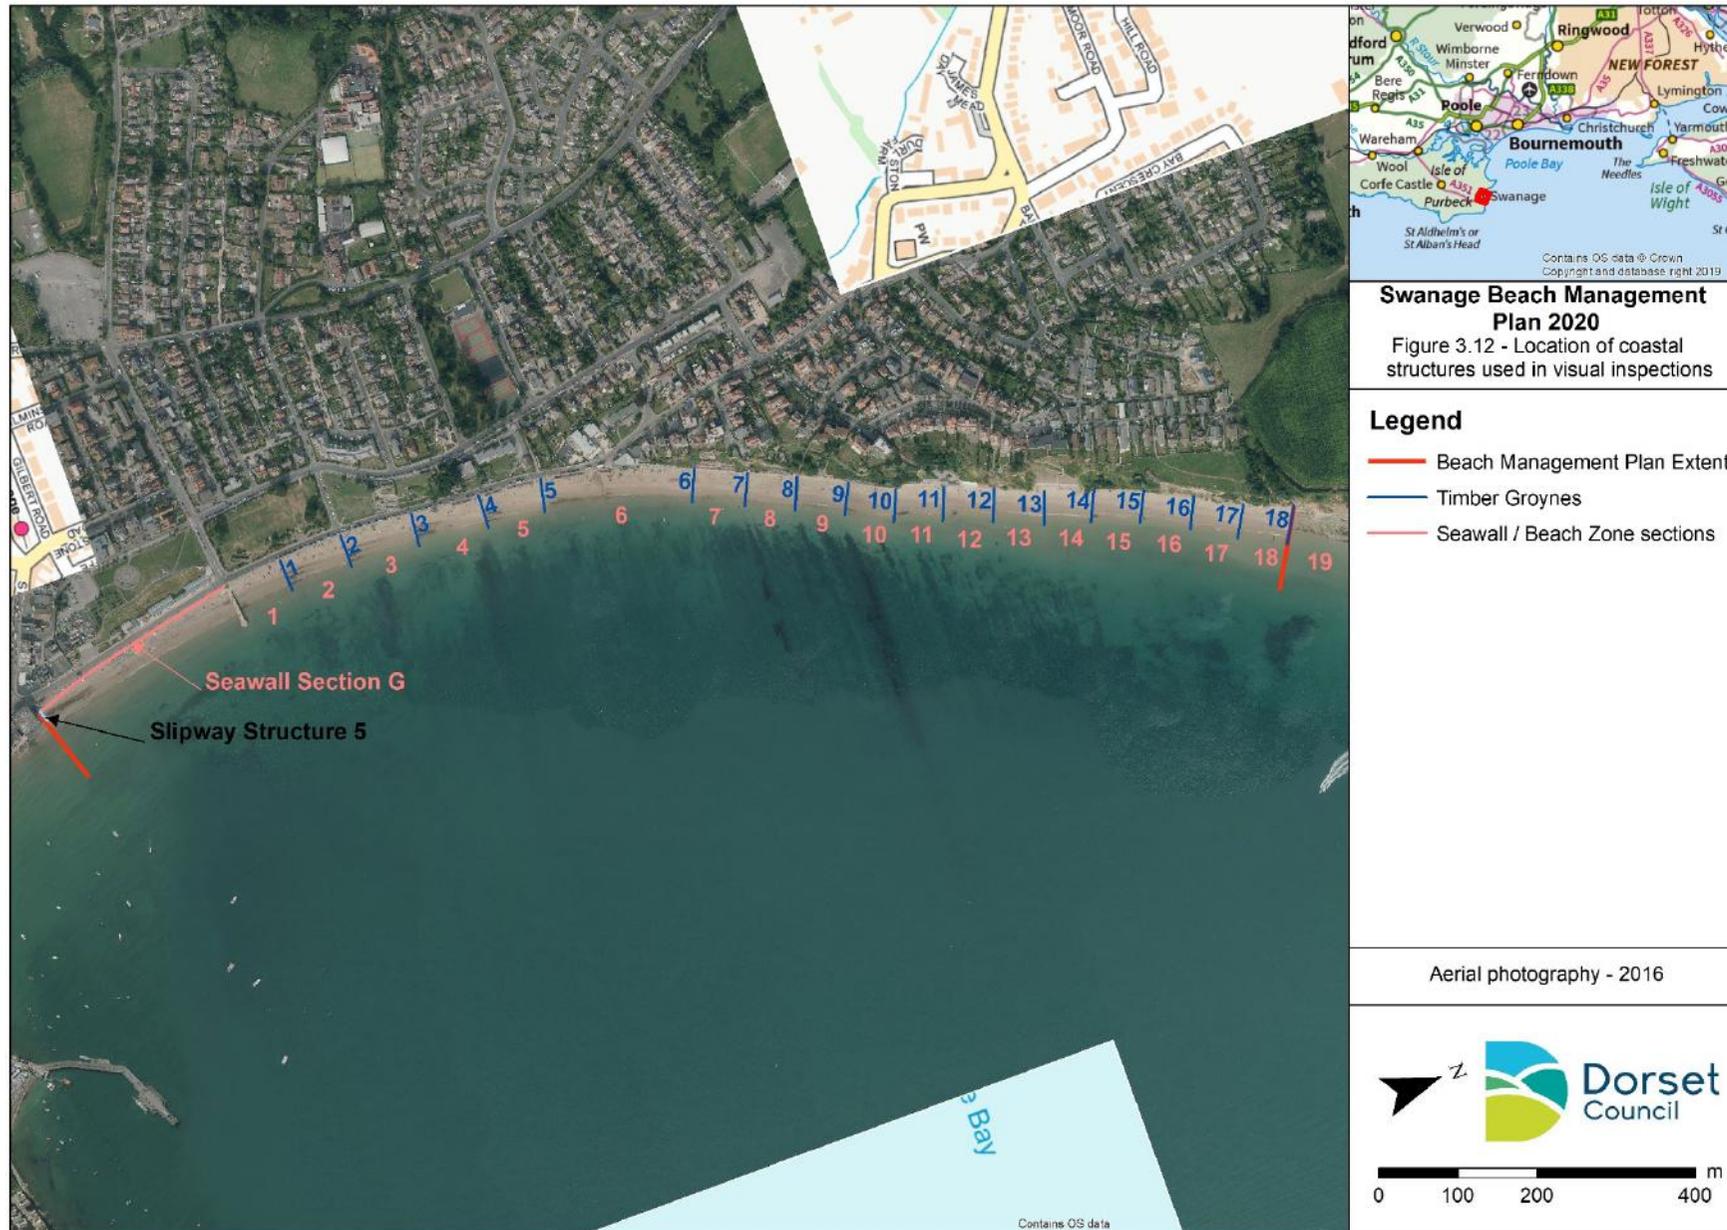
Figure 3-12 Location of timber groynes and seawall / beach zone sections inspected by WSP in 2019 (see also Table 3-1 and Appendix I).

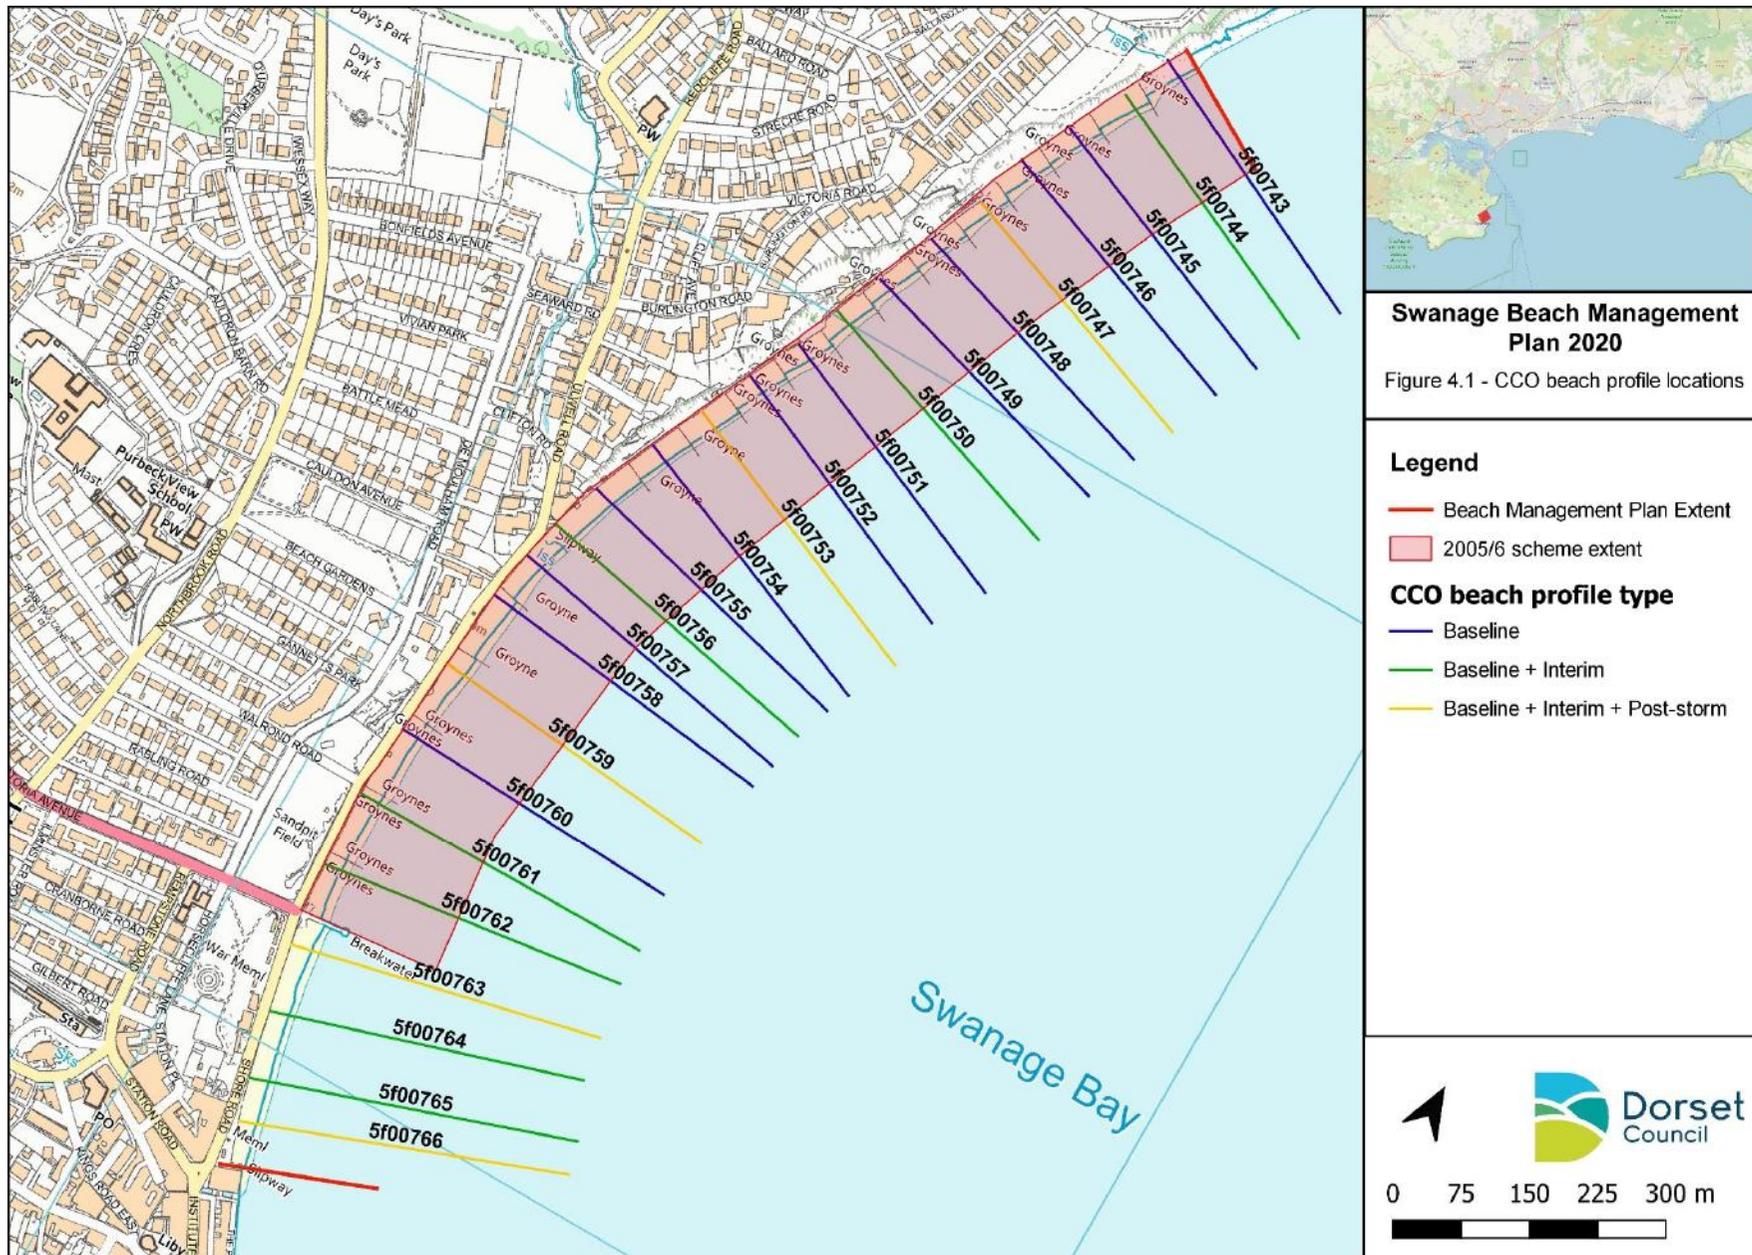
Figure 4-1 SERCMP beach profile survey locations along the Swanage BMP frontage.

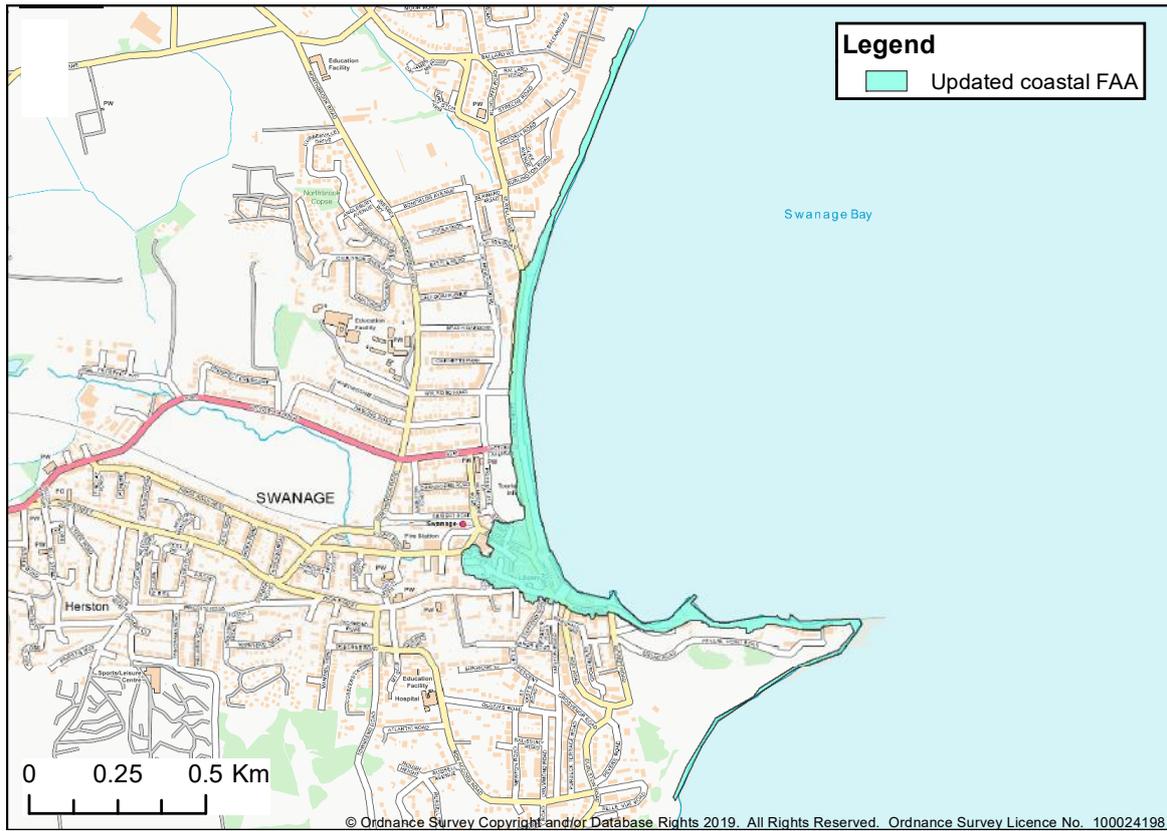
- A **Flood Alert** indicates that flooding is possible. The Flood Alert Area (FAA) along the coastal frontage at Swanage, including the BMP area, is shown in Figure 4-2. The criteria that would trigger a flood alert is based upon properties at risk of coastal flooding when the either or both of the following thresholds are forecast to be exceeded:

Figure 4-2 Flood Alert Area (FAA) along for Swanage, including along the BMP area (from JBA, 2019).

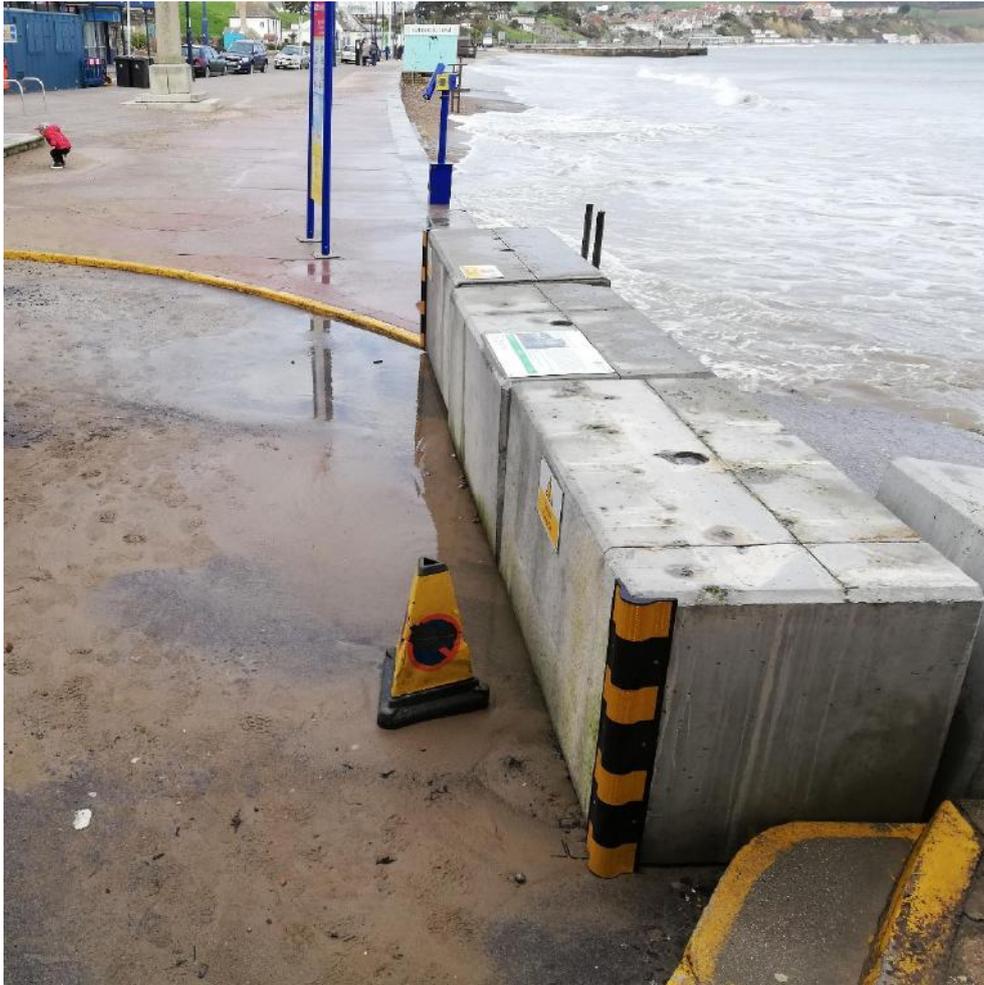
Figure 4-4 Seasonal concrete wave barriers installed at the top of the slipway adjacent to The Mowlem at the southern end of the BMP frontage in February 2020.
