Tree protection
Location of trees, categorisation & protection/management proposals

South Street, Bridport, Dorset DT6 3NP

Barrell Plan Ref: 22162-3

Client Plan Ref:
Topic (Sept-2022) S21.01
Layout (June-2024) 100708P-RF 01

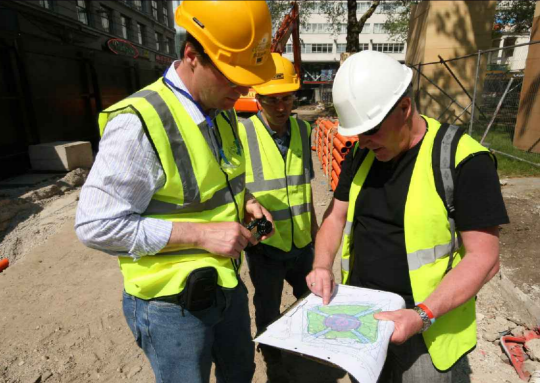
SGN 1 Monitoring tree protection

- Always:**
- ✓ have a pre-commencement meeting with the tree consultant before development starts
 - ✓ use the tree consultant to regularly check that protection remains fit for purpose
 - ✓ use the tree consultant to supervise work in RPAs
 - ✓ keep a written record of supervision

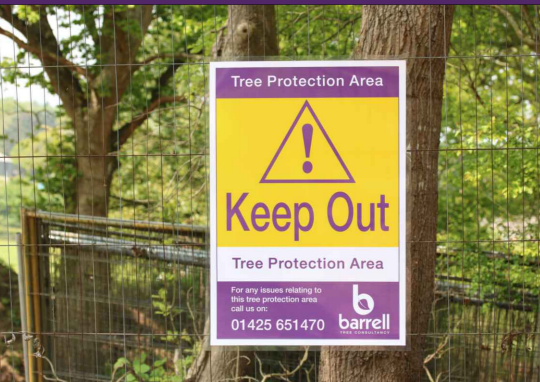
SGN 2 Fencing protected trees

- Always:**
- ✓ install protection before development starts
 - ✓ make sure protection is fit for purpose, i.e. it prevents damage to trees and soil
 - ✓ keep protection in place until there is no risk to trees
 - ✓ get written permission to move or remove any protection

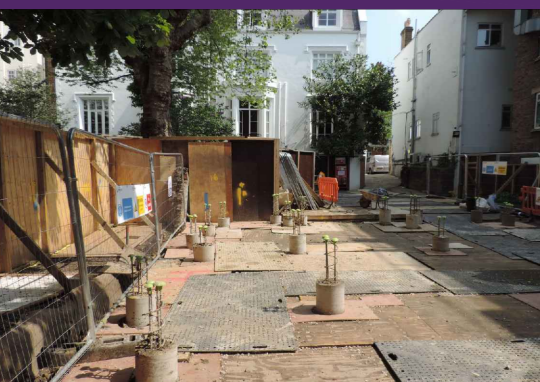
SGN 3 Ground protection

- Always:**
- ✓ install protection before development starts
 - ✓ make sure protection is fit for purpose, i.e. it prevents damage to trees and soil
 - ✓ keep protection in place until there is no risk to trees
 - ✓ get written permission to move or remove any protection

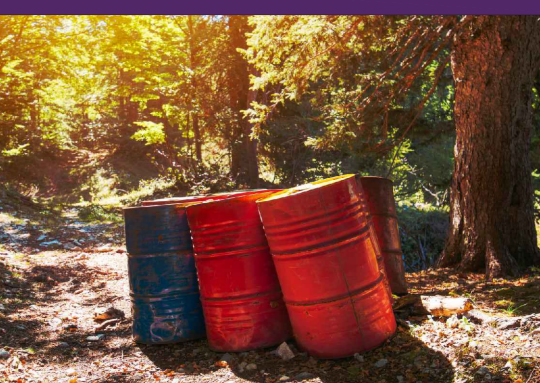
SGN 4 Pollution control

- Always:**
- ✓ keep toxic products away from RPAs

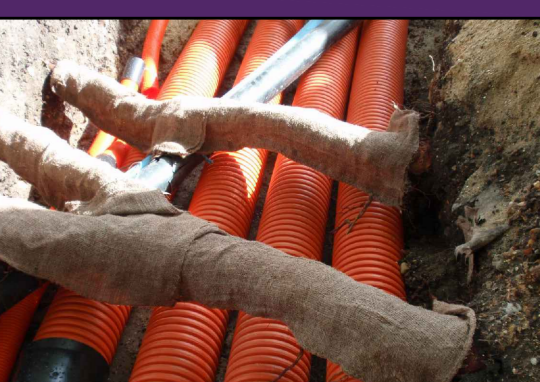
SGN 11 Installing services in RPAs

- Always:**
- ✓ use the tree consultant to supervise work in RPAs
 - ✓ select the least damaging option when installing services, so prioritise trenchless, over broken trench over continuous trench
 - ✓ hand-dig trenches if trenchless is not feasible
