# Chapter 7

## Assessment of non-designated heritage assets with the potential to experience setting change

Land North of Dorchester

January 2021

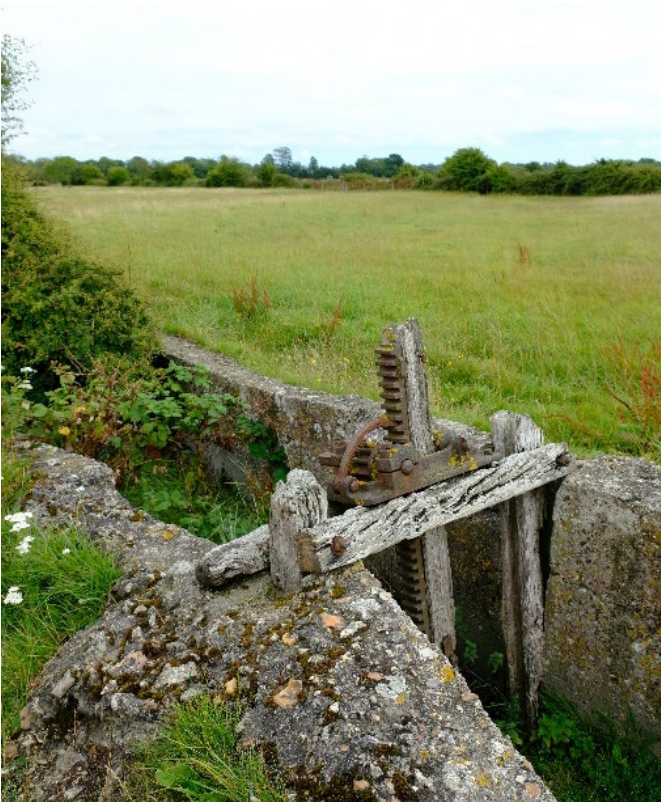
Figure 7.1: A surviving sluice in Stinsford water meadows

**7.5** Water meadows are physically attested by an elaborate system of hatches, channels, and drains. Built structures such as bridges, roadways, culverts, and water mills are also common features of water meadows. Today a network of footpaths allow access to the water meadows around Stinsford and Dorchester, which can also be experienced from the B3150 and A35.

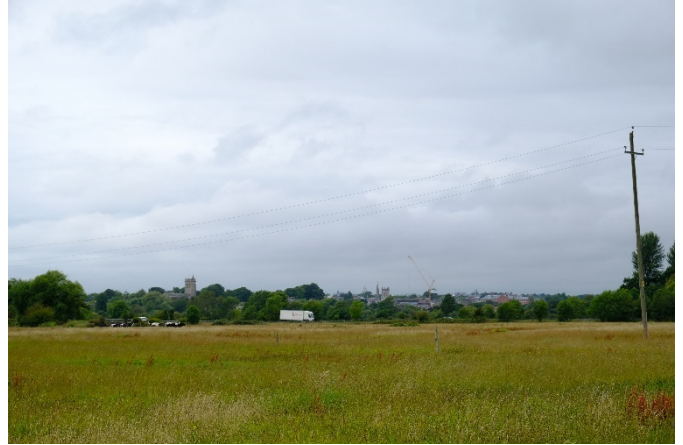
Figure 7.2: View across the water meadows towards Dorchester and the site

The towers of St George and St Peter can be seen alongside the spire of All Saints. Separating the water meadows from Dorchester and the site is the A35, which can be seen in the middle distance. The site is beyond the tree line on the other side of the A35.

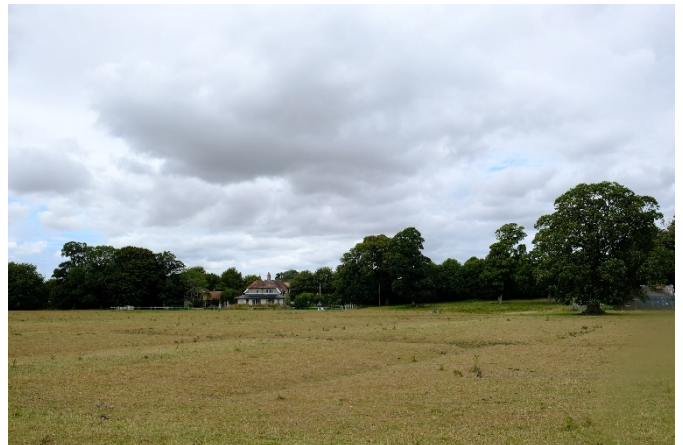
Figure 7.3: View NNE east towards the site

View from the public footpath between Dorchester and Stinsford that crosses the meadows. The building in the centre is the old lodge and approach to Stinsford House, before it was dissected by the A35. It stands on the east side of the B3150, the trees behind it lining the road. The site is beyond those trees; the indicative masterplan suggests that this area will be open space.
