# SITES FOR PROPOSED SAND & GRAVEL EXTRACTION (AS08 & AS27), WEDGEHILL FARM, HORTON HEATH, HORTON, DORSET

# **Archaeological Assessment**

FORUM Heritage Services

December 2018

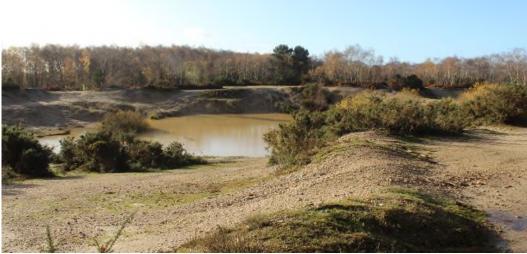
Figure 1 AS08 looking west showing the abandoned extraction pit and the belt of silver birch woodland screening the site from longer views.

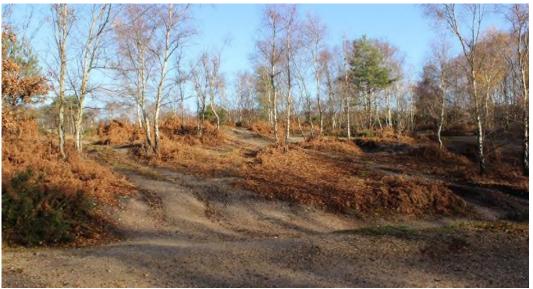
Figure 2 A view of the south-western part of AS08 showing the heathland character with bracken and silver birch trees facing north-east.

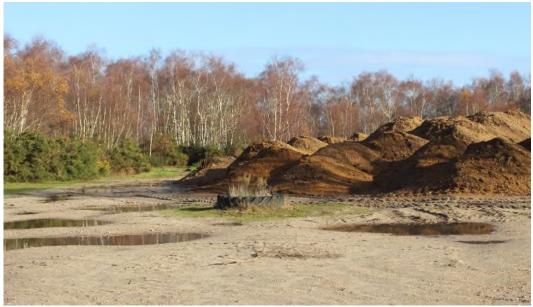
Figure 3 A view across the eastern part of AS08 facing east-north-east.

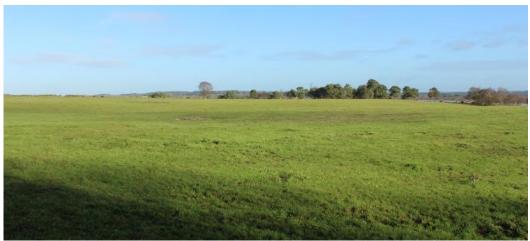
Figure 4 The view across AS27 from the south-west looking north-east.

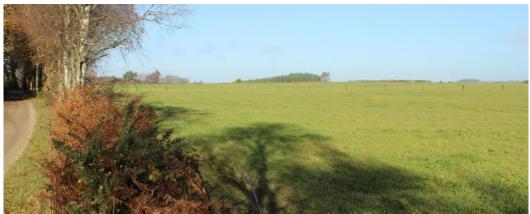
Figure 5 View across AS27 from the lane to the west looking north.

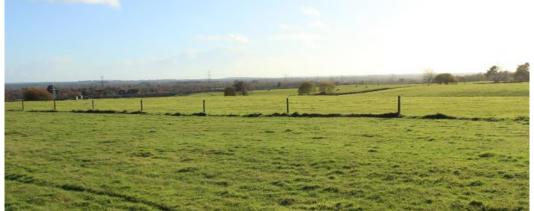
Figure 6 View from within the northern part of AS27 looking south-east.

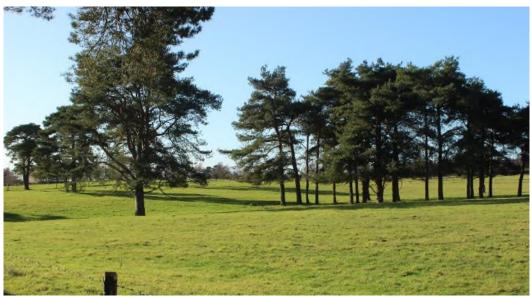
Figure 7 View into AS27 from the track to the south-east adjacent to the current quarry looking west-north-west.

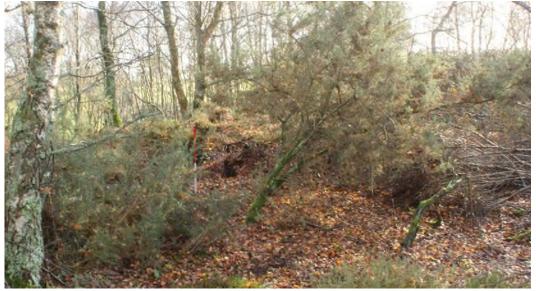
4.4 The closest of these two monuments to AS08 is the barrow 250m north-east of Monmouth's Ash Farm (MDO 06420) which lies within the woodland surrounding the proposed extraction site (Figure 13). This barrow is a relatively small feature which sits at the top of a north-east facing slope within the woodland and is located approximately 15 to 20m from a public footpath which runs along the east side of the woodland. The barrow has been extensively dug into by badgers and it is believed that the barrow was possibly excavated by antiquarians although due to the damage caused by the badger sets, it is not possible to definitively say whether there is evidence for past excavation. The barrow is visible from s short section of the public footpath, although it's relatively low profile and irregularity in its form because of the badger activity means that it is not readily identifiable barrow feature from distance (Figure 14).

Figure 13 Scheduled barrow MDO 06420 viewed from the north-west. Evidence for badger activity can be seen. Scale 1m.

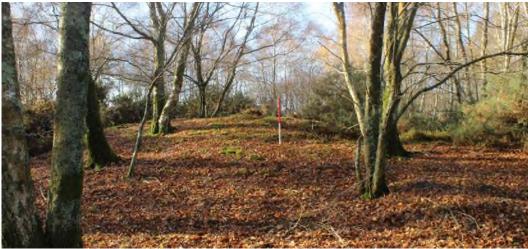
Figure 14 Scheduled barrow MDO 06420 as viewed from the public footpath to the eastern edge of the woodland. Scale 1m.

to the monument, is extremely limited. The barrow can be glimpsed from the footpath running along the east side of the woodland (Figure 14) but its small scale means that it is not a readily apparent feature in the landscape and when viewed from the south-east as the footpath enters the woodland, the density of trees means that the feature cannot be seen (Figure 22). Moving beyond the boundary forming the east side of the woodland and into the south-eastern section of AS08, the boundary hedge between AS08 and woodland further obscures views to the monument. From the trackway leading to the north-west towards the site at David's Cross the monument is not visible within the woodland (Figure 23). Between the barrow and the edge of the woodland to the north-west there is a distance of some 150m meaning that there is no visual link between the area of the proposed extraction where the current pit is located and the monument. The woodland to the south of the barrow also means that there is no inter-visibility between the two Scheduled barrows.

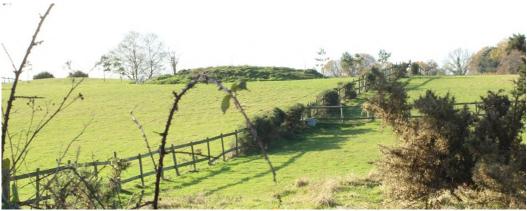
4.5 The second barrow 90m north-east of Monmouth's Ash Farm (MDO 05780) lies further to the south within a pasture field. It is a large and recognisable barrow monument which is visible from the public footpath to the east (Figure 15). The barrow lies in a similar position to MDO 06420 at the top of the north-east facing slope, this barrow actually lies directly on the parish boundary.

Figure 15 Scheduled Bronze Age barrow 90m north-east of Monmouth's Ash Farm (MDO 05780) as viewed from the public footpath to the east of the monument.

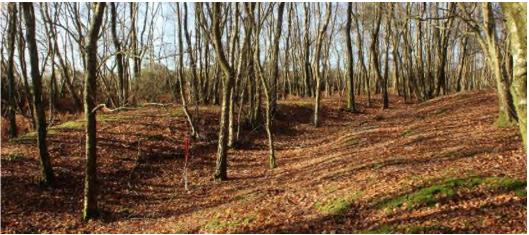
- 4.6 MDO 39901 records an undated mound at David's Cross which, given the presence of the two Scheduled barrows close by, may also represent a Bronze Age barrow although its position further down the slope rather than at the top of the slope may indicate that it is a later feature.
- 4.7 There is one site recorded on the HER within AS08 (MDO 39816) which is an historic boundary bank of medieval or post-medieval date. Given the heathland character of this area, it is most likely that this feature was associated with woodland.
- 4.8 To the south-west of AS08, MDO 39817 records an area of small-scale extraction identified from an aerial photograph and considered to be post-medieval in date.
- 4.9 Along the southern edge of the woodland surrounding AS08 at (NGR 406323, 107417), running just to the south of the Scheduled barrow are some linear hollows (Figure 16) which

are presumably historic trackways and which may be a continuation of the trackways identified in aerial photographs and recorded as MDO 38919.

Figure 16 Probable former trackways surviving as earthworks near the southern edge of the woodland surrounding AS08 and close to the Scheduled barrow MDO 06420. Scale 1m.

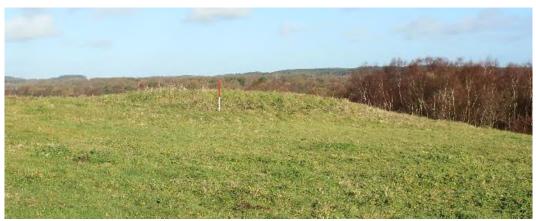
4.11 The barrow to the north-east is a small, flat-topped mound set at the top of a slope overlooking the river valley to the north-east. The barrow appears as a very low mound (less than 1m high) when viewed from the west (Figure 17) but is more prominent when viewed up the slope from the east (Figure 18). The area immediately to the west of the barrow is understood to have been used for gravel extraction in the late 20th century, reducing the ground level by approximately 2-3m as evidenced by the two platforms which have been left beneath the electricity pylons, these platforms being more prominent than the barrow and rather overshadowing the monument as recognisable earthworks. Not shown on the Ordnance Survey map is a large solar farm which has been constructed in the AS27etween this barrow and AS27 to the east of the existing gravel pit.

Figure 17 Scheduled barrow (MDO 05781) viewed from the west. Scale 1m.

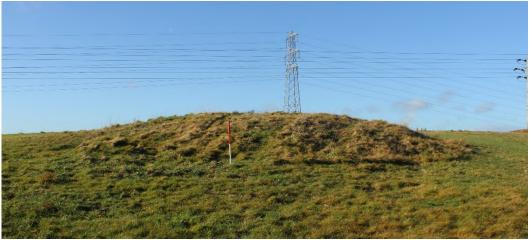
Figure 18 Scheduled barrow (MDO 05781) viewed from the east. Scale 1m.

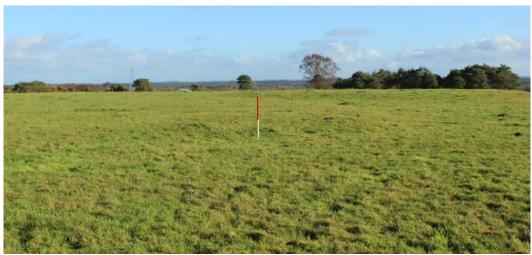
Figure 19 Irregular platform earthworks within the northern part of AS27, facing north-east. Scale 1m.

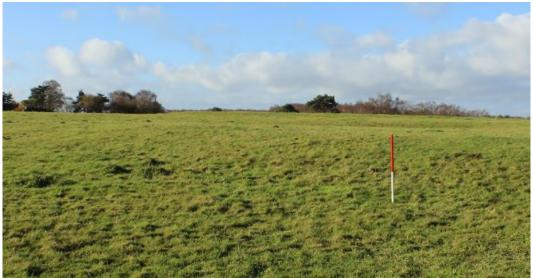
Figure 20 The edge of one the irregular platforms marked by a small scarp slope seen within the northern part of AS27, facing north-west. Scale 1m.

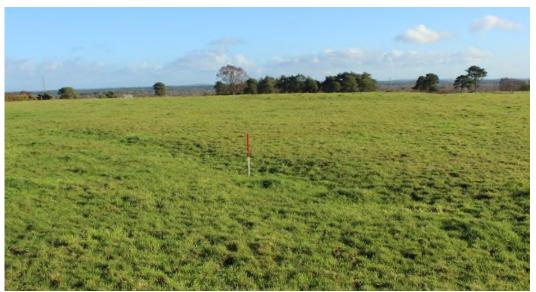
Figure 21 Possible drainage channel within the northern part of AS27. Facing north-east. Scale 1m.

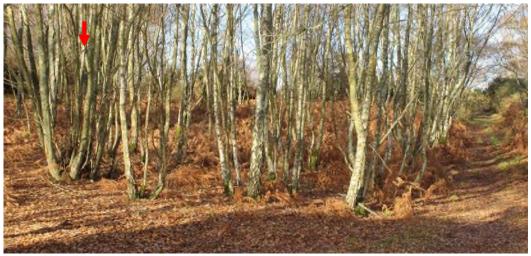
Figure 22 View north-north-east towards the barrow MDO 06420 (approximate position arrowed) within the woodland south of AS08 taken from where the public footpath enters the wood, the path being along the track to the right.

5.8 Given the extent to which the woodland surrounding the Scheduled Monument provides a significant level of screening to the monument – and hence the ability to experience it in the landscape – together with its small-scale meaning that even in an open area the barrow would have very limited visual prominence, it is considered that an area of gravel extraction to the north on the higher ground, effectively creating a 'crater' on the hill top, would not

harm the setting of the monument in terms of its visual and landscape setting. Extraction within the south-eastern part of the site as currently defined may be considered to represent less than substantial harm to the adjacent barrow, and in discussion with the agent, Mr Simon Munnings, it is understood that this part of the site can be excluded from the proposal.

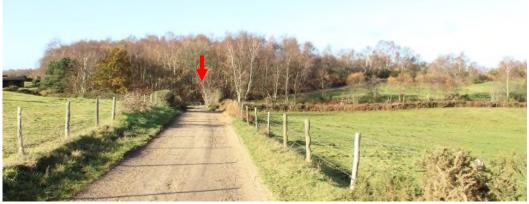
Figure 23 The view towards the woodland within which the barrow MDO 06420 is located directly in-line with the track.

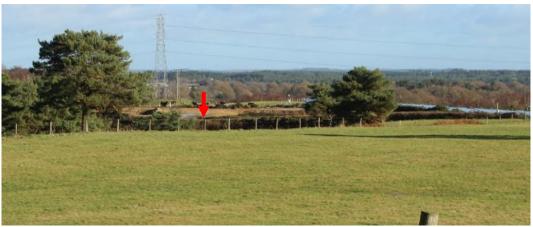
- 5.11 With regard to the Scheduled Monuments to the east of AS27, a combination of the distance, topography and the presence of the solar farm are considered to mean that there would be no adverse impact upon the ability to experience or appreciate the significance of the barrows and dyke. The single barrow (MDO 05781) is a small example of this monument type which appears to have its primary out-look and prominence to the north-east looking out and possibly originally being visible from across the valley of the River Crane. Whether this monument was intended to have some prominence in the landscape when viewed from the west/north-west is uncertain but today, possibly because of some flattening of the mound, the feature is not a strong feature in the landscape, even when viewed from closeguarters or adjacent to the existing guarry (see Figure 17, above). The barrow is not readily visible in longer views from AS27 (Figure 24). There is also no inter-visibility with the large barrow north-east of Monmouth's Ash Farm (MDO 005780), the view between the two monuments looking west being obscured by trees in the mid-ground and also nearer to the western barrow (Figure 25). Even if the view to the east-north-east from the Monmouth's Ash barrow was unhindered, the small barrow is such an insignificant earthwork that from the distance of almost 1km, it would not be visible.

Figure 24 The view to the east-north-east from the northern part of AS27 towards the Scheduled barrow MDO 05781 (location arrowed). The solar farm is visible to the right and the existing quarry just beyond the fence line.

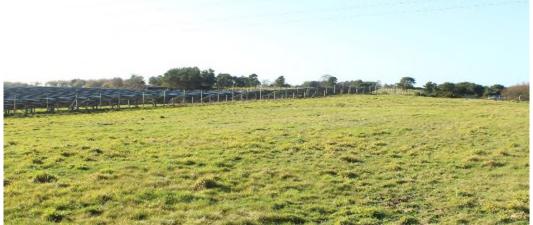
Figure 25 The view to the west-south-west from the barrow MDO 05781. AS27 can just be glimpsed above the solar farm. There is no visual connection between this monument and the large barrow north-east of Monmouth's Ash Farm (MDO 05780).
