Christchurch Historic Urban Character Area 6 Hospital & Workhouse

Christchurch Historic Urban Character Area 6
Structure of Character Area

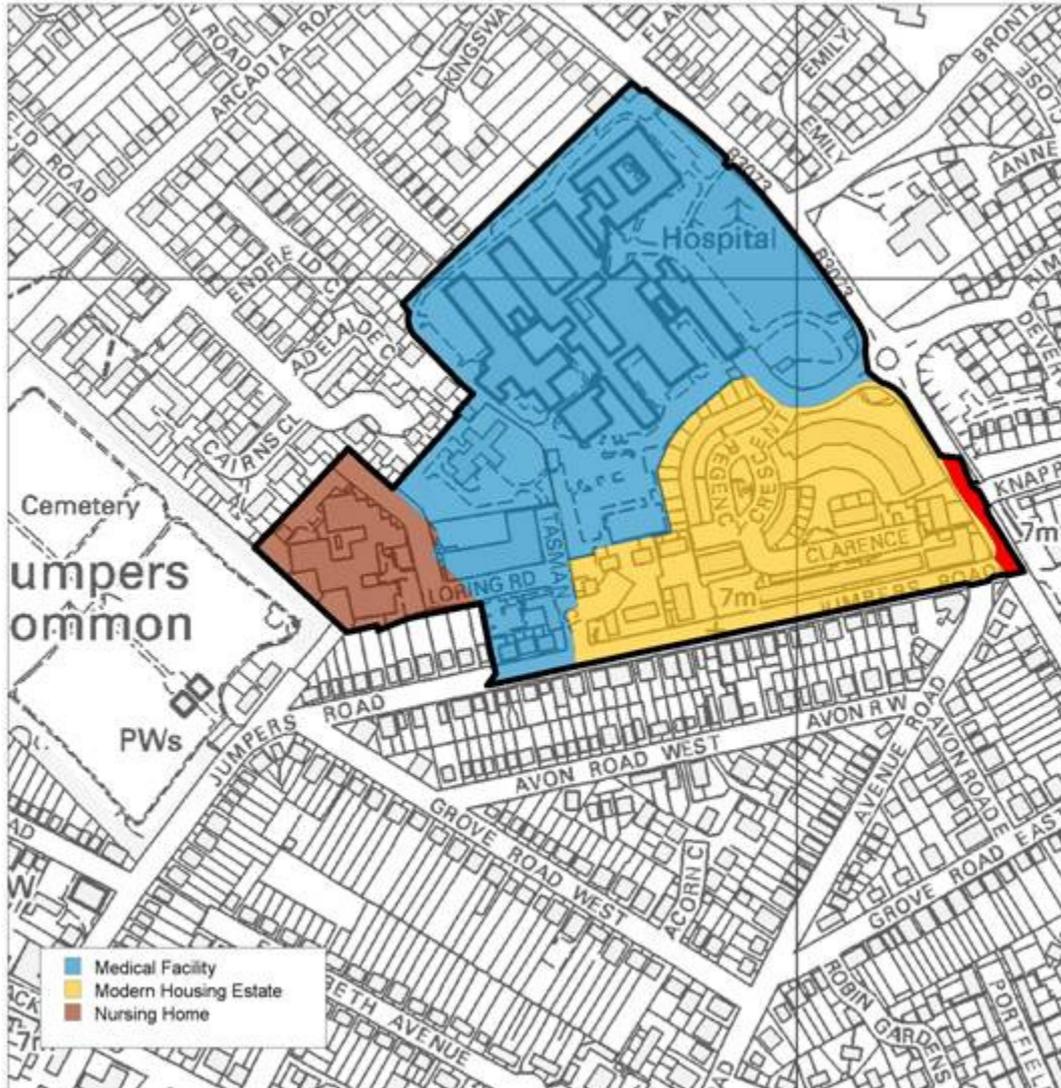
Figure 84: Map of Historic Urban Character Area 6, showing current historic urban character type.

Figure 84 shows the present day historic urban character types. The largest part of this area comprises Medical Facility, with a Nursing Home and Modern Housing Estate.

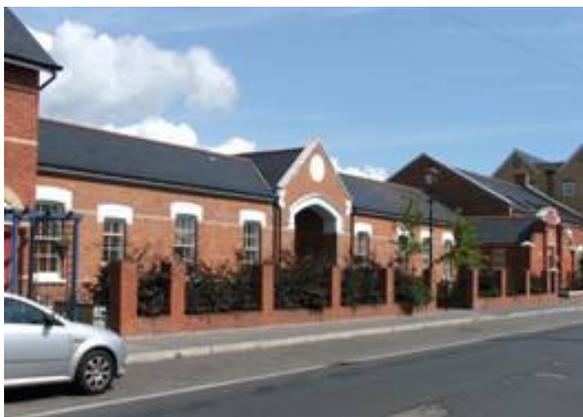
Figure 85: Workhouse entrance block

The central entrance archway, the board-room and married inmates' quarters of the workhouse survive and have been incorporated into a modern housing development which now occupies the former site of the main block of the workhouse.

The surviving workhouse buildings are in red brick with ashlar detail. The modern houses are in red brick with ashlar detail and slate roofs.

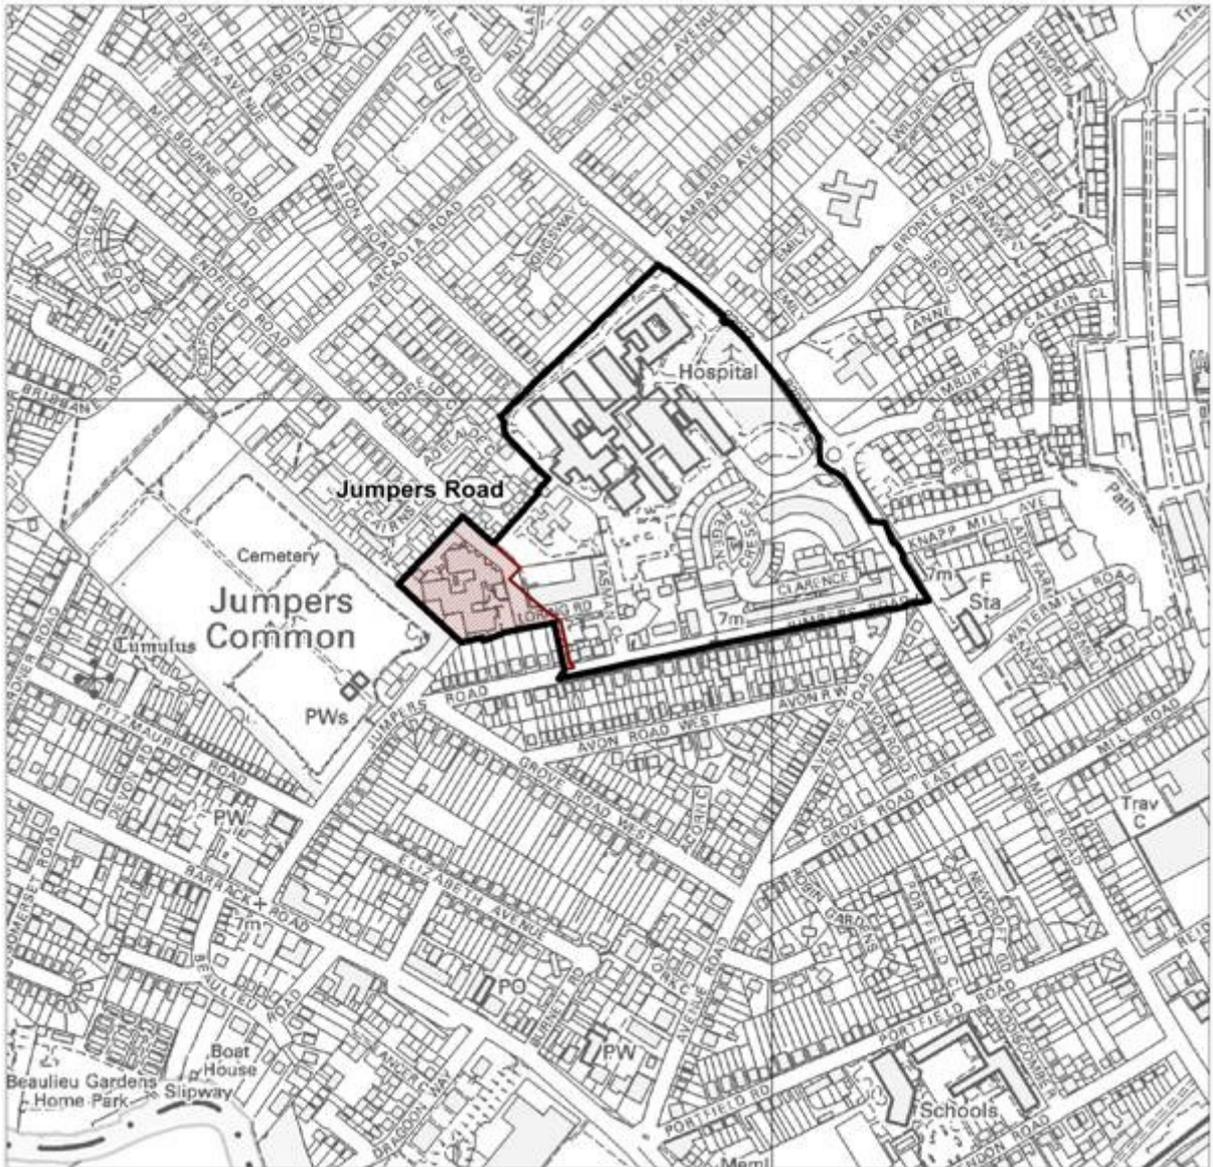
Figure 87: Archaeological features in Historic Urban Character Area 6

There has been one archaeological investigation in this character area. Terrain Archaeology was commissioned by Dorset County Council to undertake archaeological observations and recording during topsoil stripping associated with the construction of a new residential care home on Jumpers Road, at the western end of the character. No prehistoric or Roman features were observed and only a very small quantity of Bronze Age flint was recovered. Most of the features found on site appear to be 20th century in date and comprise the gravel bases to a number of small buildings, perhaps dating from World War II, together with two gravel paths or tracks (Bellamy 2005a; 2005b).
