BS5837 ARBORICULTURAL IMPACT ASSESSMENT

KNOLL HOUSE HOTEL, FERRY ROAD,
STUDLAND, DORSET, BH19 3AH

KINGFISHER RESORTS STUDLAND LTD

BS5837 Arboricultural Impact Assessment

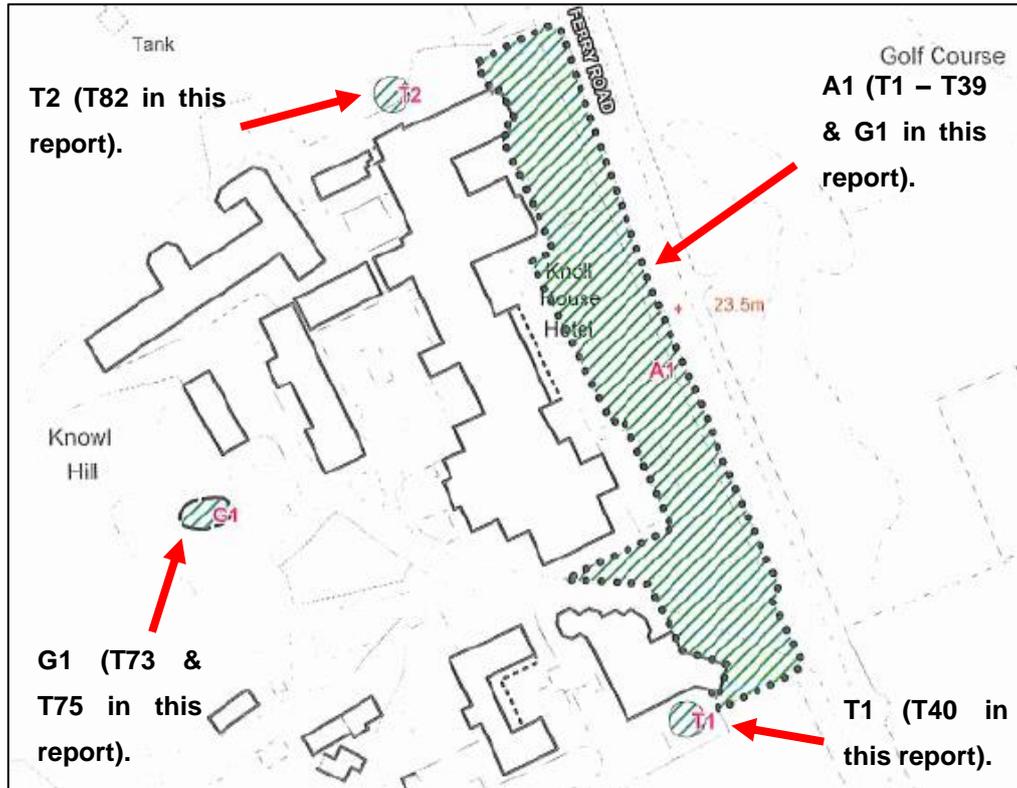
Figure 2: Extract from Purbeck District Council's TPO – Ref 494. Displayed are Tree Preservation Orders present onsite shown as green hatched areas.

A check made with the Local Planning Authority, Purbeck District Council, confirmed that a Tree Preservation Order (TPO Ref: 494) is present on site. The TPO includes:

- An Area TPO (Ref: A1) protecting T1 – T39 and G1 within this report.
- Two individual TPOs (Ref: T1 & T2) protecting an English oak and a sweet chestnut (T40 & T82 within this report respectively).
- A group TPO (Ref: G1) protecting two sweet chestnuts (T73 & T75 within this report).

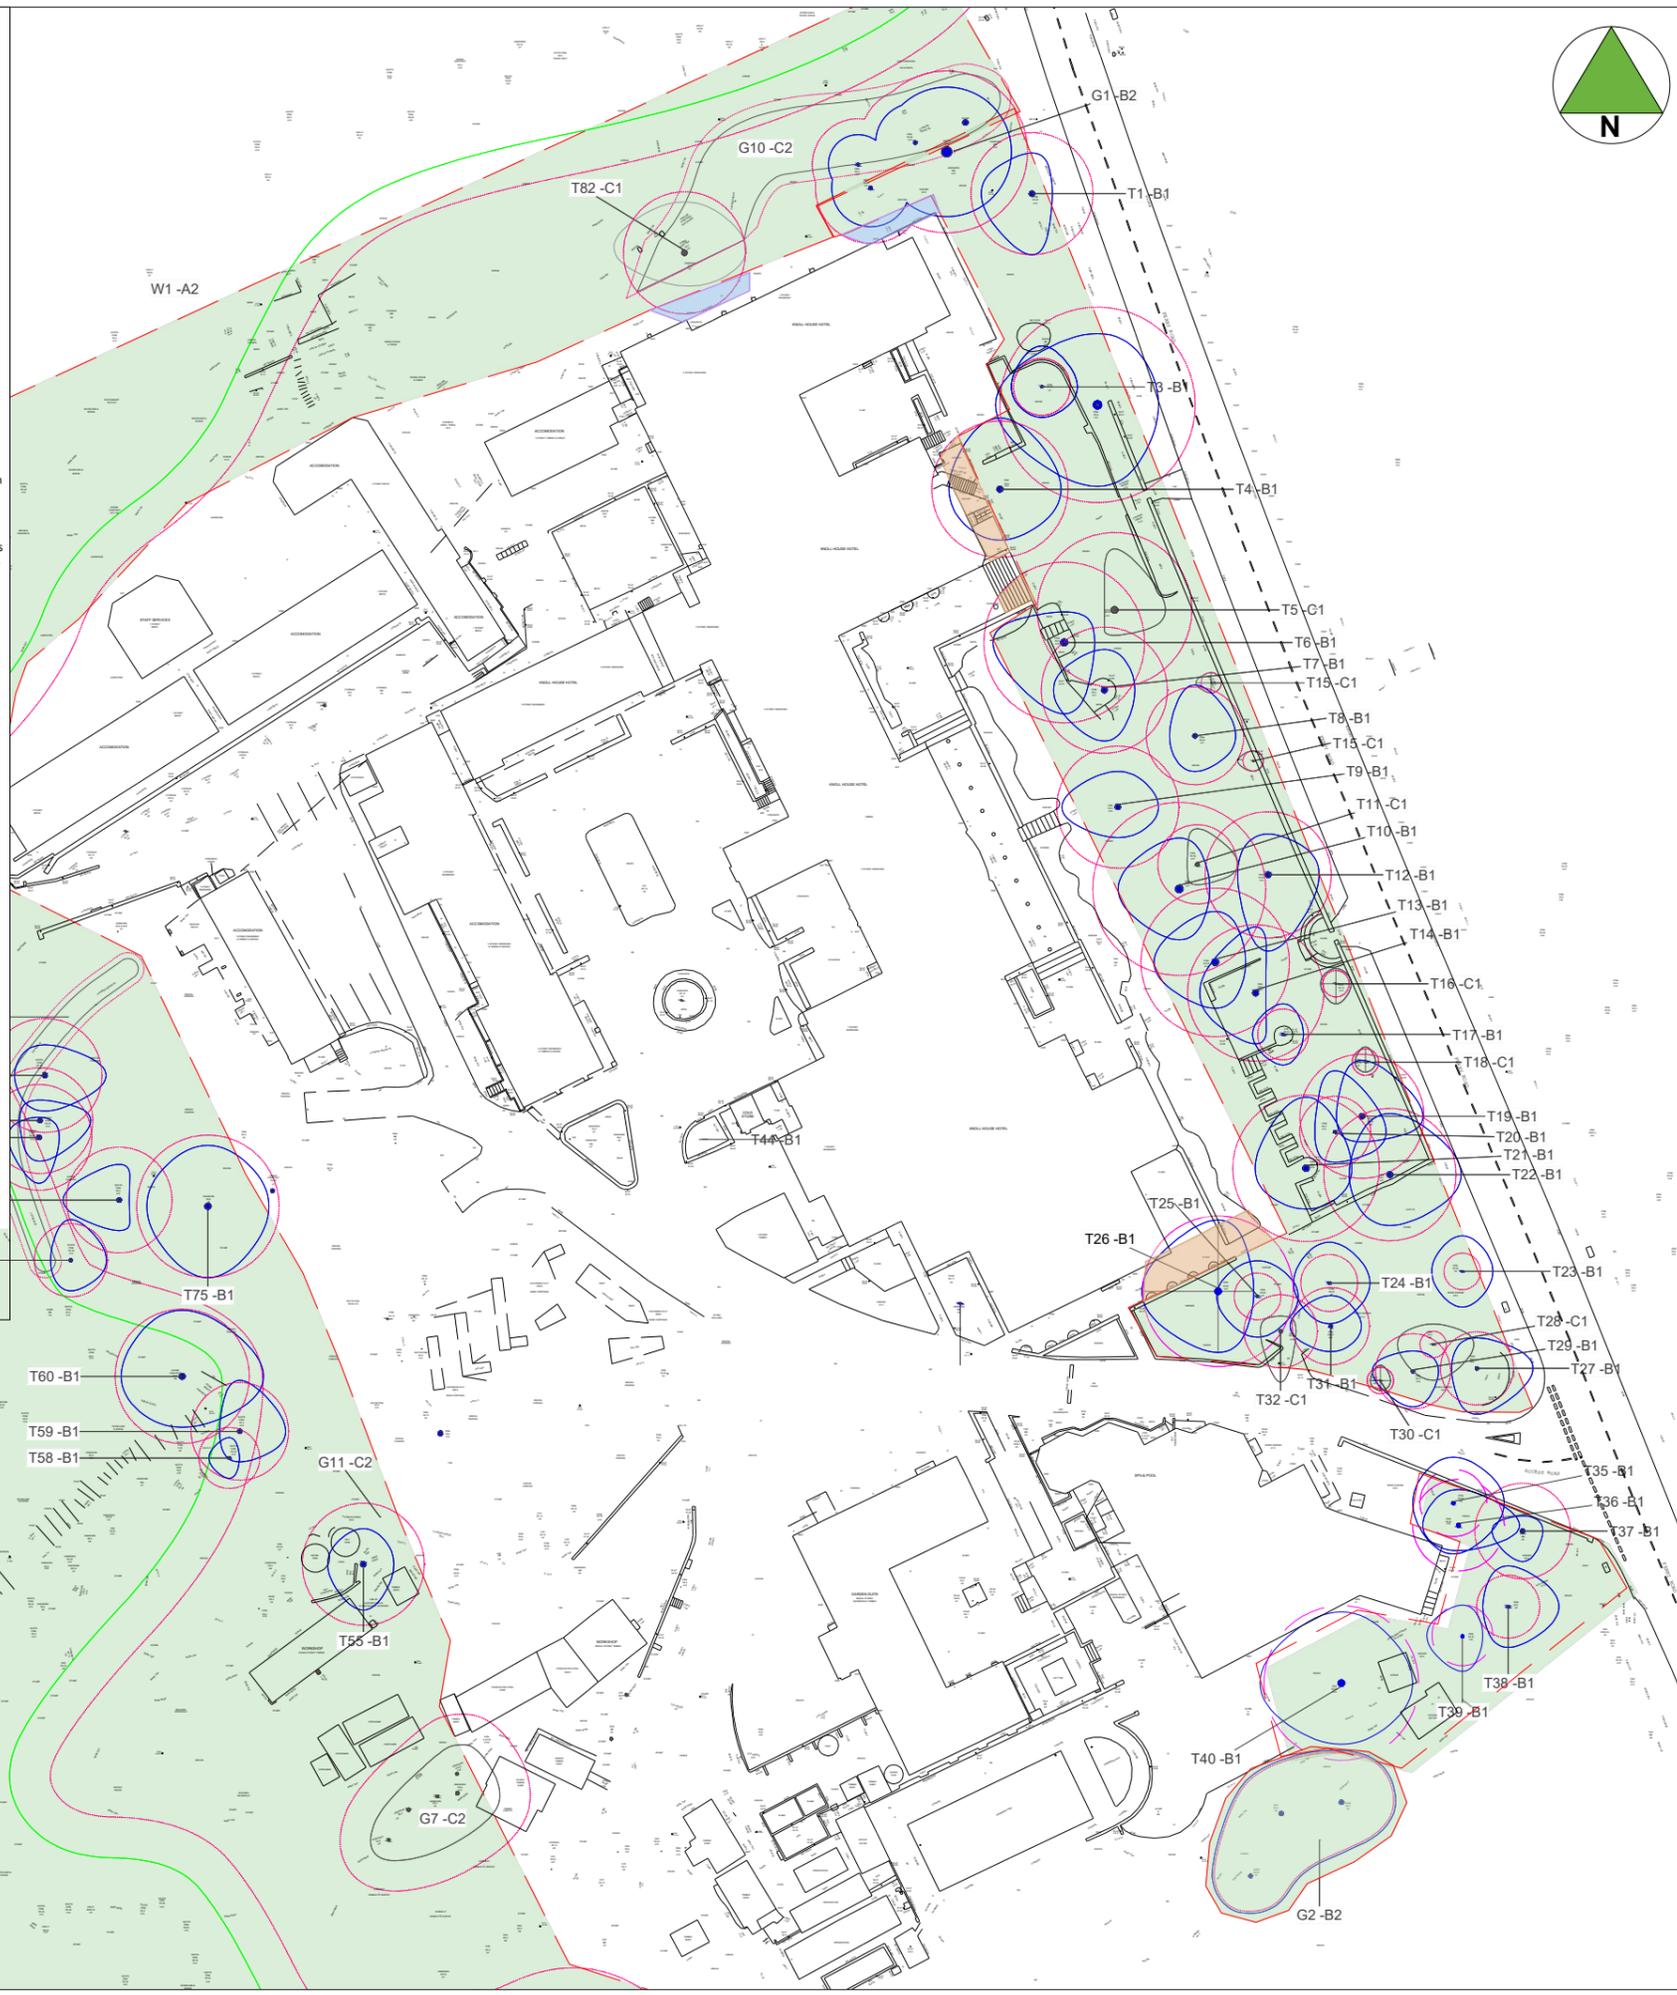
Title		
Tree Protection Plan for Demolition		
Client		
Kingfisher Resorts Studland Ltd		
Project		
Knoll house Hotel, BH19 3AH		
Date	Drawn by	Checked by
October 2022	EC	-
Drawing No	Rev	Scale
1122-P-12	-	NTS

- Demolition of brick planters and other light structures to ground level only, existing paving retained or removed and replaced with ground protection.**

Access and demolition of the existing buildings impact upon the RPAs of T4, T6, T26, T40, T82 and G1. These works should be completed as advised within the Recommendations (Section 4.2.1) and as specified within an Arboricultural Method Statement.

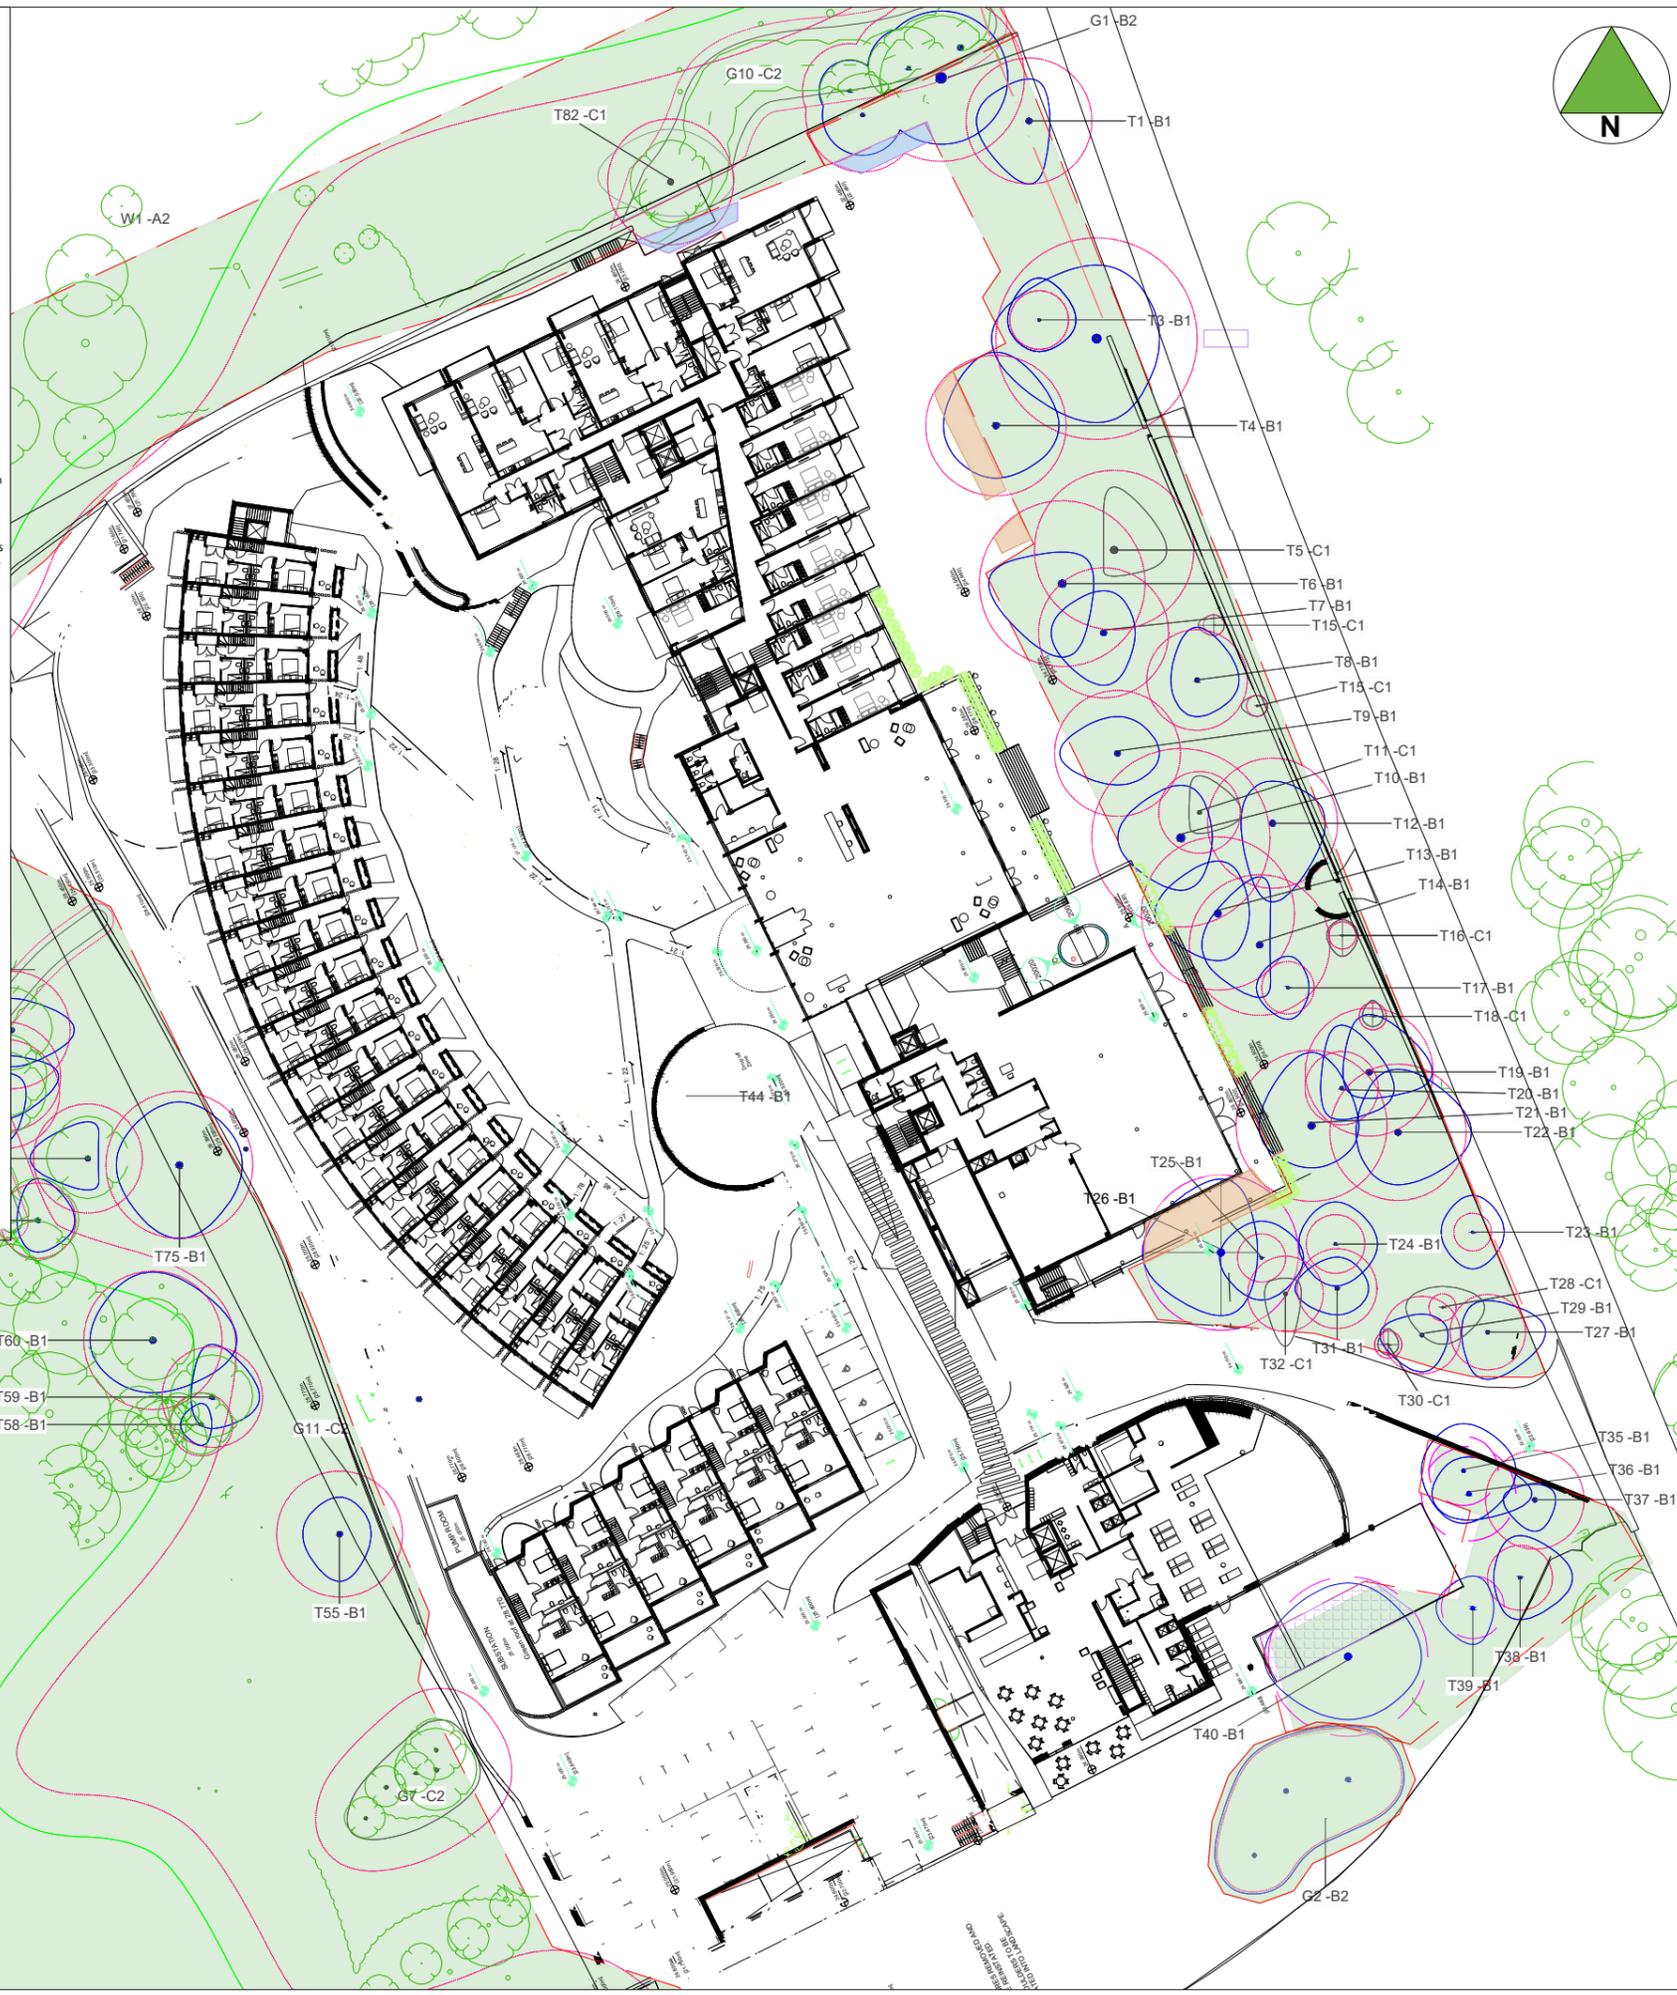
Title		
Tree Protection Plan for Construction		
Client		
Kingfisher Resorts Studland Ltd		
Project		
Knoll house Hotel, BH19 3AH		
Date	Drawn by	Checked by
October 2022	EC	-
Drawing No	Rev	Scale
1122-P-13	-	NTS

- BS5837 Root Protection Areas**
Precautionary areas within which tree roots and soil structure must be protected. All works within these areas will require special methods of work.
- Position of protective fencing and tree protection zones during construction.** Position may be amended for landscaping.
- Ground protection during demolition** to provide access around building formed of 100mm woodchip or sand laid on a geotextile membrane with plastic mat ground guard surfacing.
- Demolition of brick planters and other light structures** to ground level only, existing paving retained or removed and replaced with ground protection.
- Tree protection fencing** to be removed at the landscaping stage in order to construct above ground pool structure supported by individually hand dug posts under arboricultural guidance to retain all roots greater than 25mm.

Construction of the proposed pool structure within the RPA of T40 will consist of an above-ground system supported by individual hand hand-dug posts in order to avoid severing roots greater than 25mm diameter. Further detail regarding the foundation design and position of post locations may be provided within an Arboricultural Method

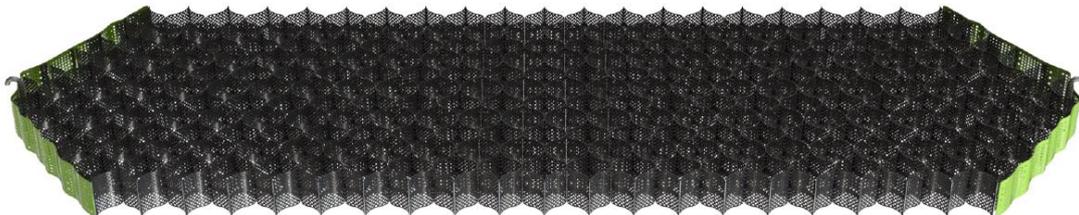
3. Lay out the Cellweb® TRP Cellular Confinement System

- Lay out the collapsed Cellweb® TRP on-top of the Treetex™.
- Place one of the supplied J pins into the centre cell at the end of the panel and secure into the ground.

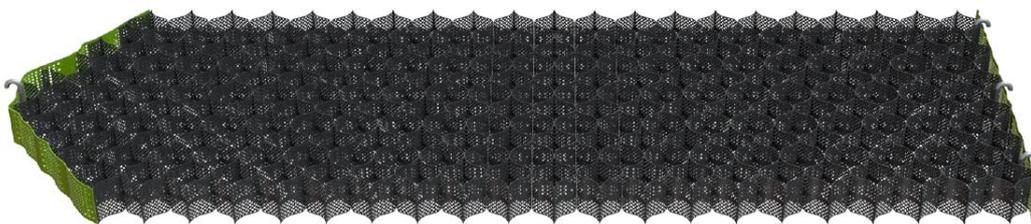
Step 3: Stapling Cellweb® TRP

- Pull out the Cellweb® TRP to its full 8.1m length and secure its length with another J pin.

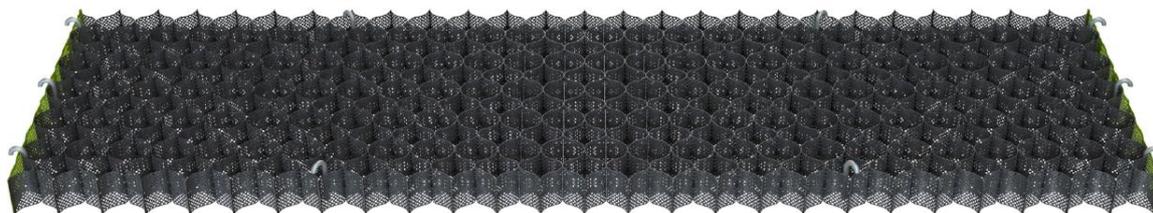
- Now measure its width to 2.56m and secure in each of the corners with the J pins.
- Use 10 pins per panel to create a panel measuring 8.1m x 2.56m.

- This will produce a cell size of 259mm x 224mm which is the required cell diameter. Each cell must be fully extended and under tension.
- Staple adjacent panels together at each cell (see Note 3).
- If a curved path or shape is required, this should be cut when the Cellweb® TRP panel is pinned out to 8.1 x 2.56m, ensuring complete cells remain. Do not try to curve or bend the Cellweb® TRP panels into place.
- All cells must be fully opened to the required diameter.
