BS5837 ARBORICULTURAL IMPACT ASSESSMENT

KNOLL HOUSE HOTEL, FERRY ROAD,
STUDLAND, DORSET, BH19 3AH

KINGFISHER RESORTS STUDLAND LTD

Focus Environmental Consultants

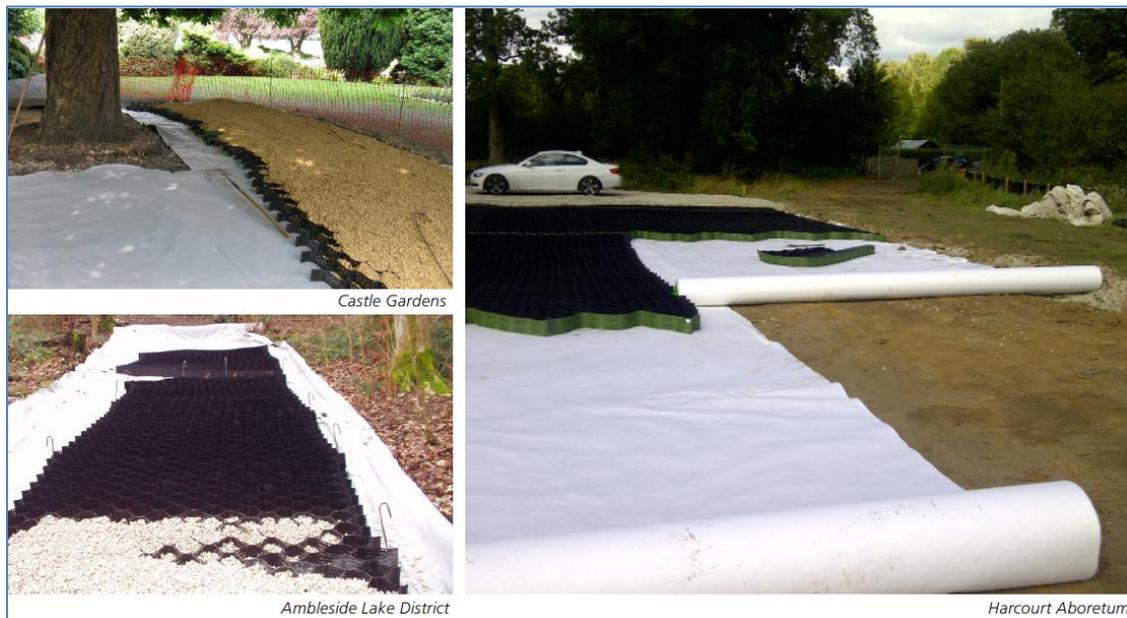
Figure 3: example cellular confinement system.

The 150mm depth cellular confinement system will then be stretched out over a geotextile membrane, pinned and filled with clean angular stone with no fines as per the manufacturer's instructions.

Interlocking construction boards will then be added and protection measures fixed back to the edge of the new hard surfacing.

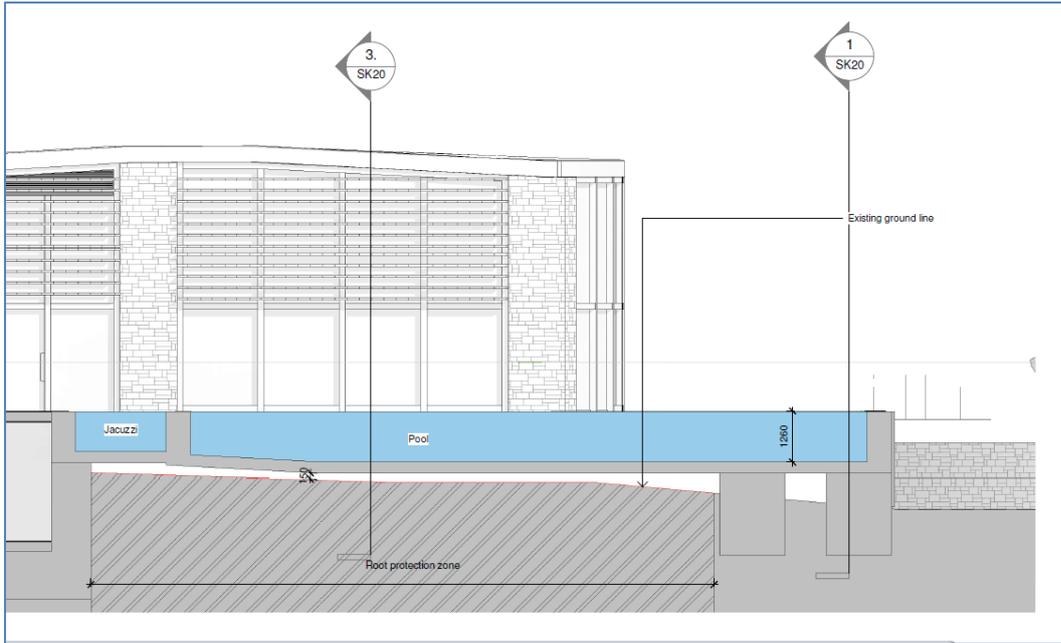
Figure 4: extract from the pool section drawings

Given the protected status of the tree, all future management will be controlled by the local authority. The design section drawing for the proposed pool may be found at Annex 5.3

The pool will be staffed to ensure that leaf drop is regularly cleaned during the spring and summer months with the pool being closed during autumn and winter.

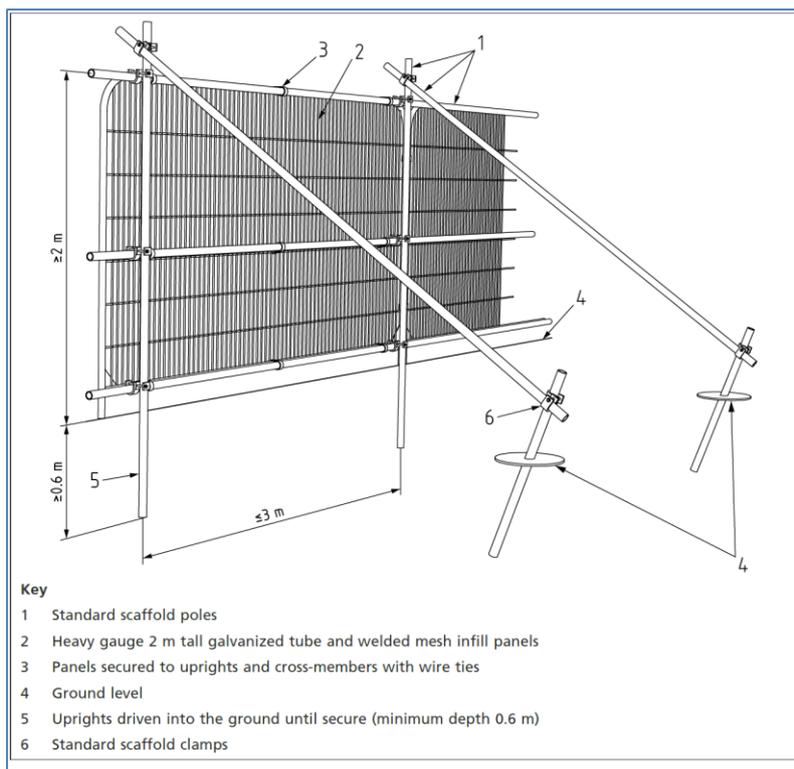
Figure 6: example tree protection barrier.

Barriers will consist of a vertical and horizontal scaffold framework that are well braced to resist impacts. The vertical tubes should be spaced at a maximum of 3m intervals and driven securely into the ground. Onto this framework, welded mesh panels should be securely fixed.

Care should be exercised when locating the vertical poles to avoid underground services and, in the case of the bracing poles, also to avoid contact with structural roots. If the presence of underground services precludes the use of driven poles, an alternative specification should be prepared in conjunction with the project arboriculturist that provides an equal level of protection.

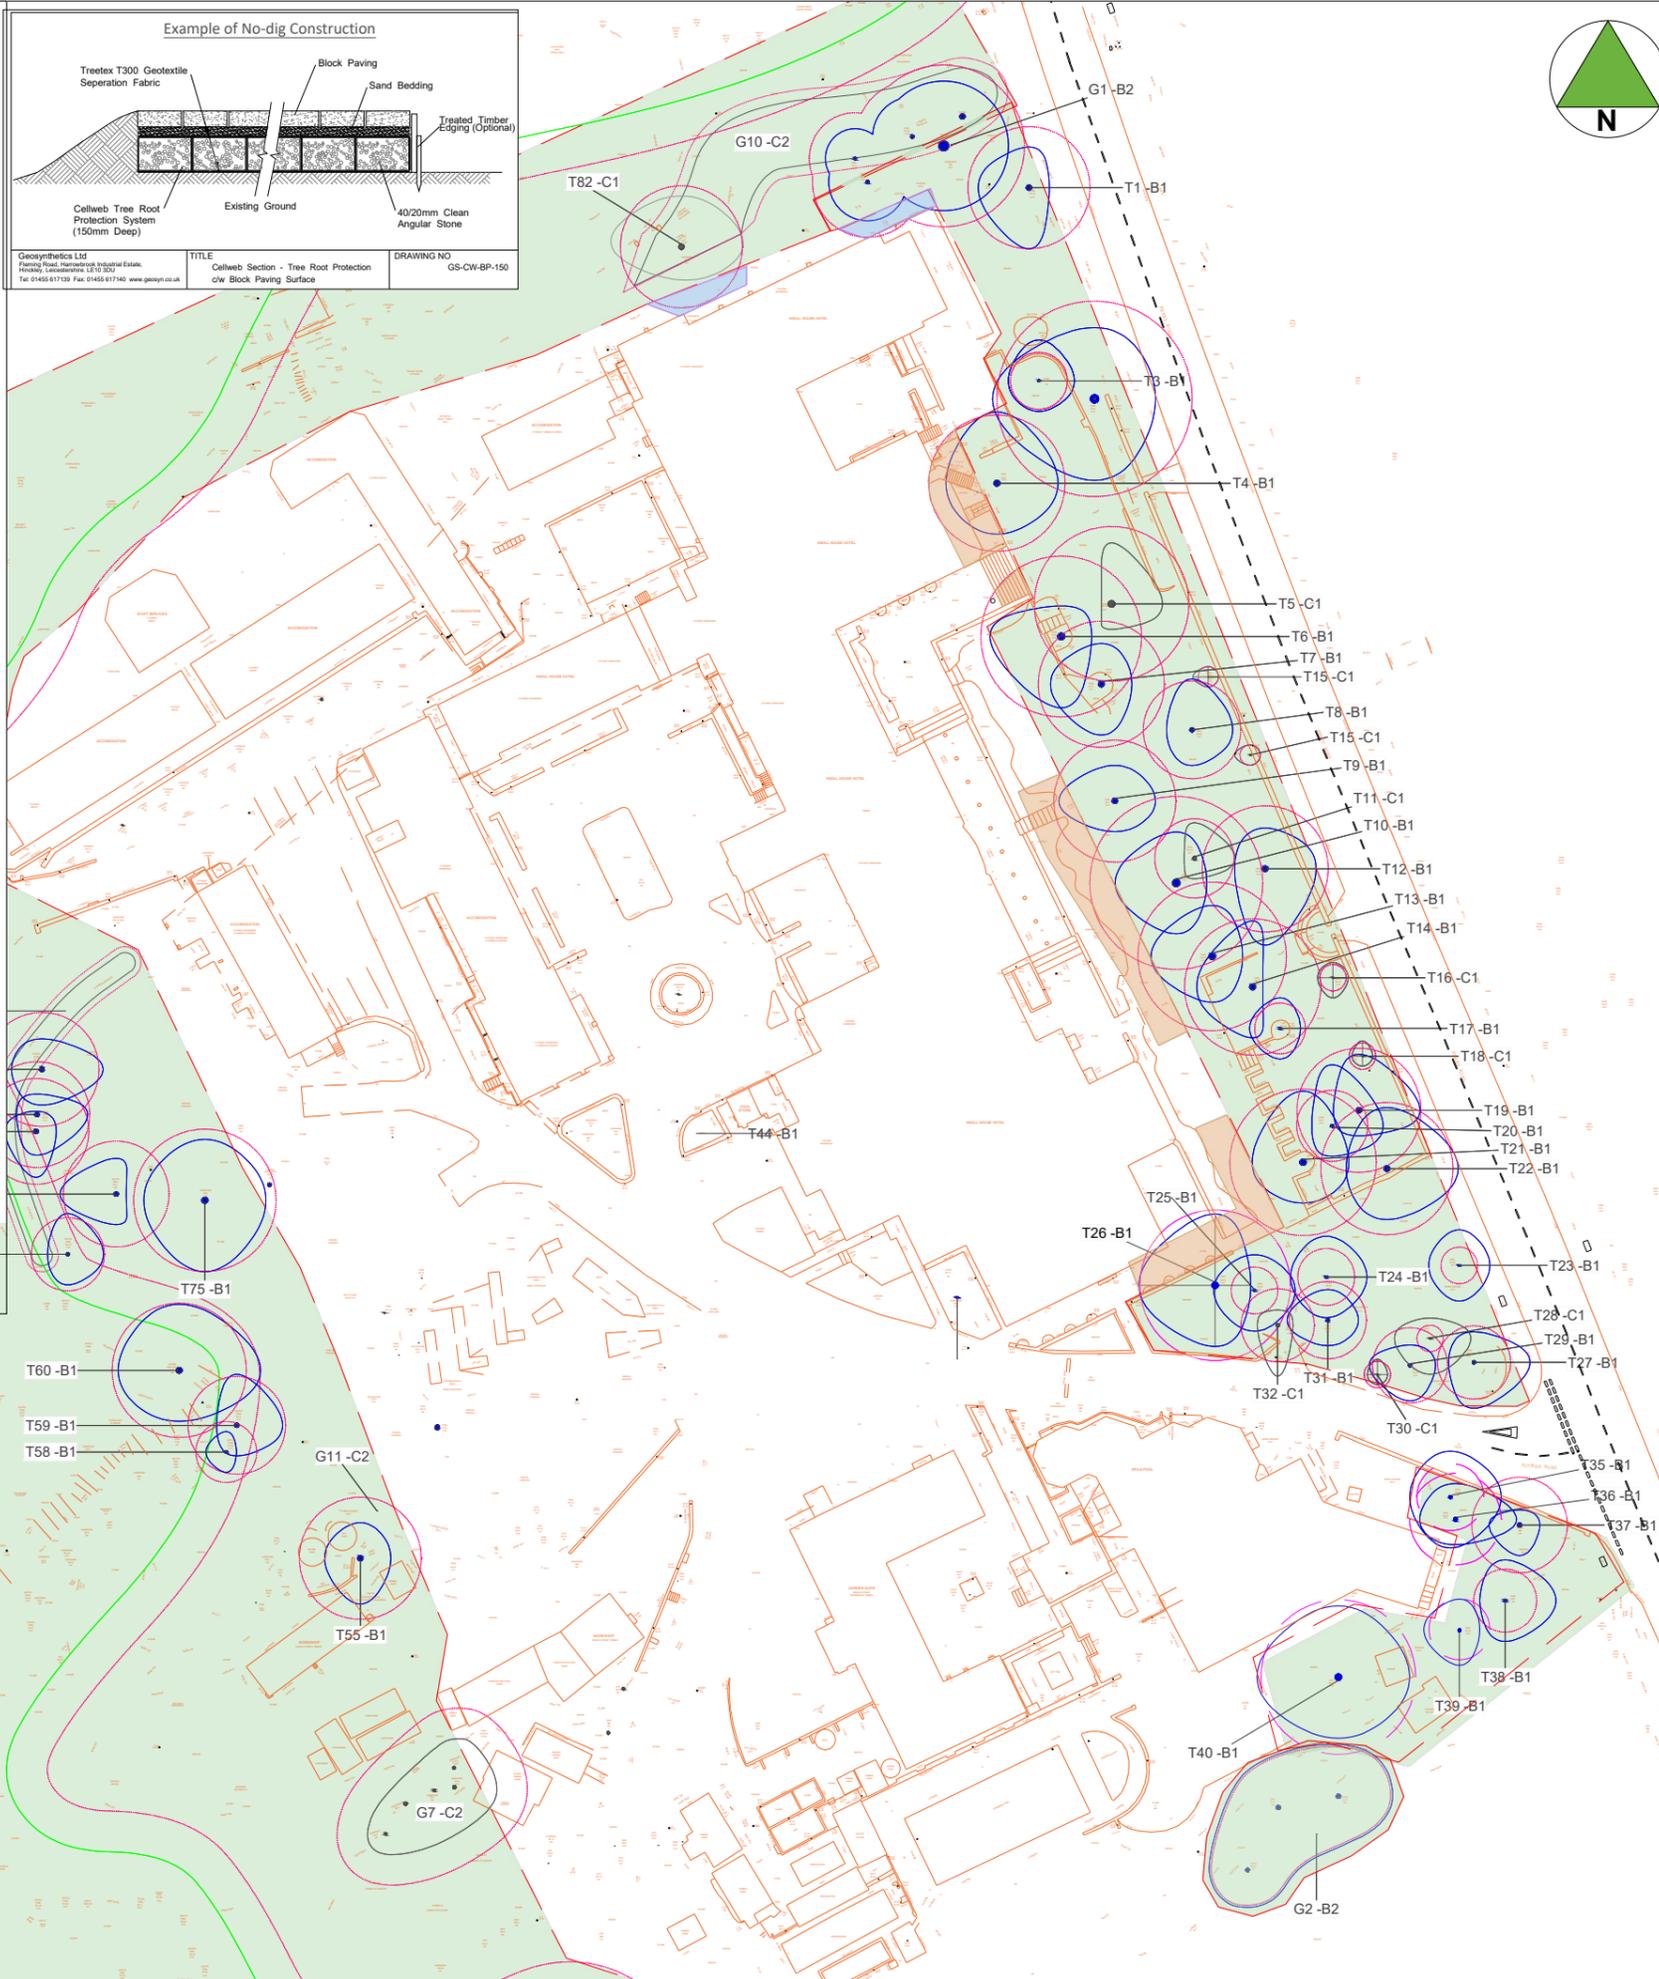
| Drawing No 1122-P-12 | Rev - | Scale NTS |

Demolition of brick planters and other light structures to ground level only, existing paving removed and replaced with cellular confinement system ground protection.

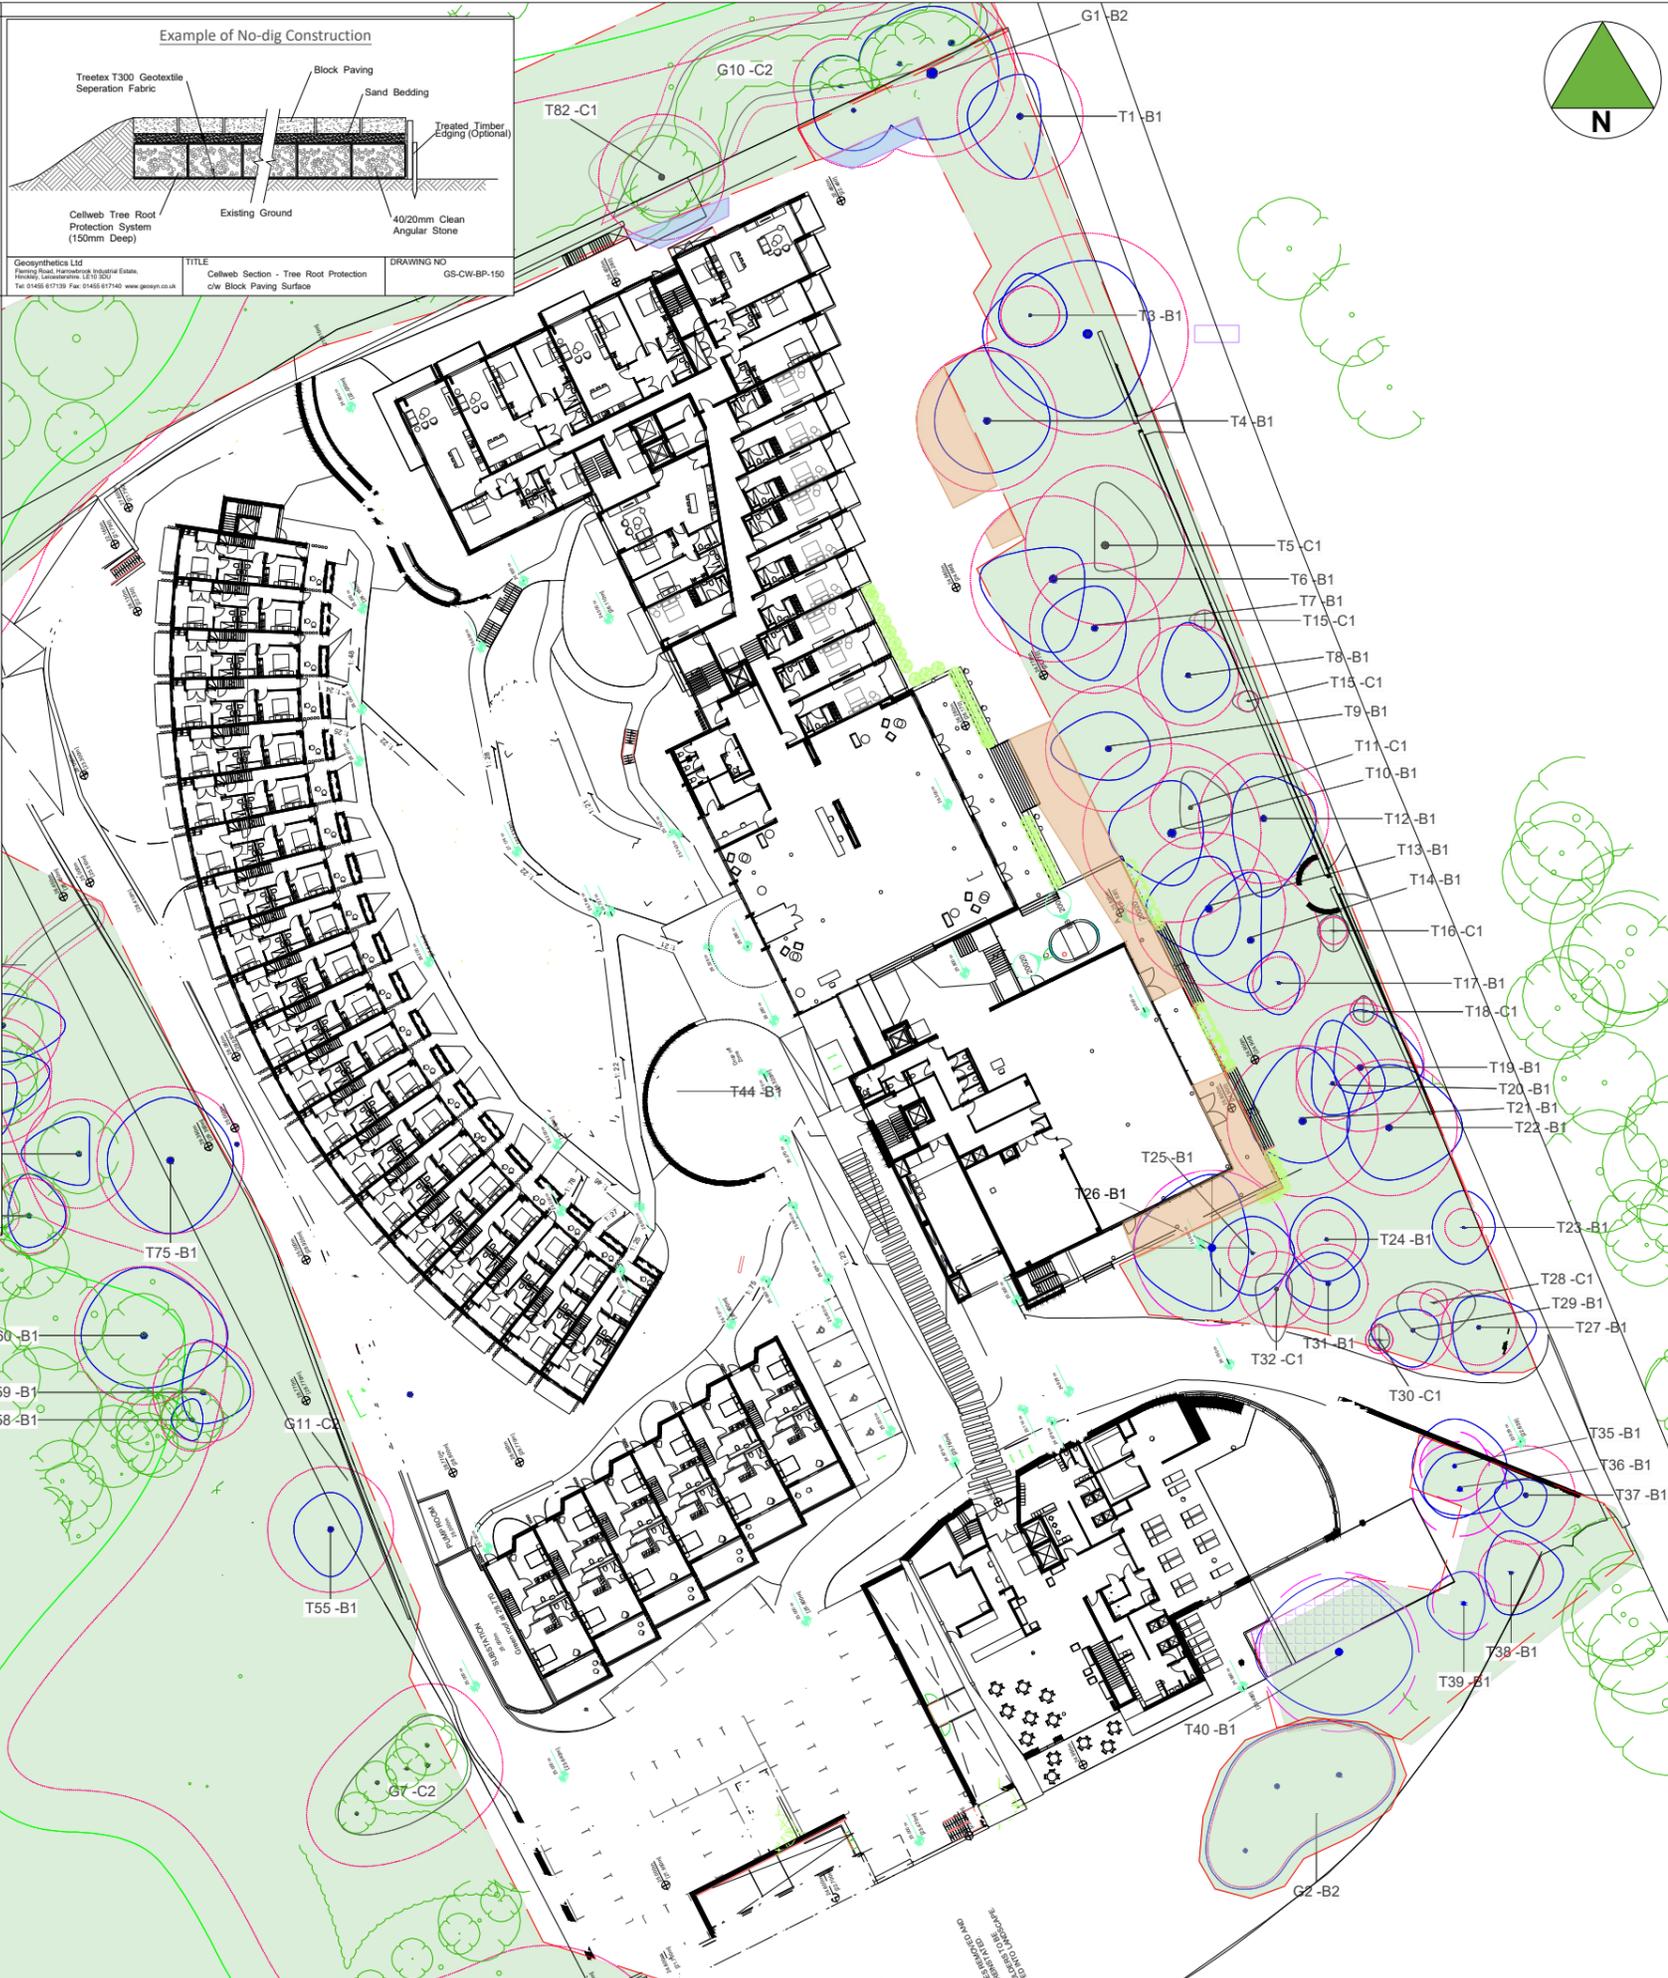
- Demolition of brick planters and other light structures to ground level only, existing paving removed and replaced with cellular confinement system ground protection.**

- Tree protection fencing to be removed at the landscaping stage in order to construct above ground pool structure under arboricultural guidance.**

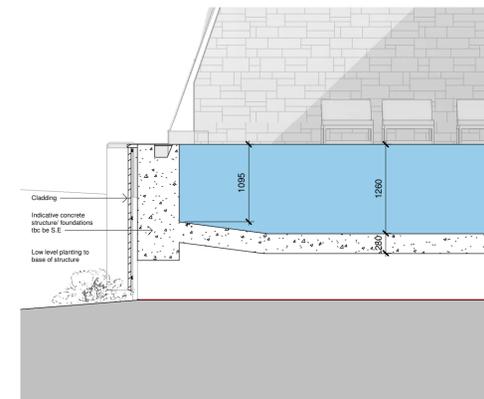
Indicative detail

* Indicative foundations subject to confirmation by S.E.

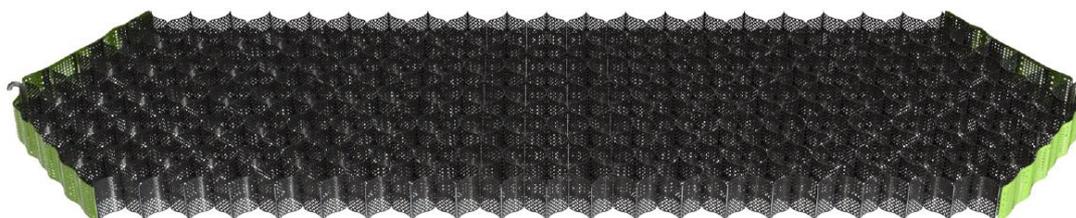
- Lay out the collapsed Cellweb® TRP on-top of the Treetex™.
- Place one of the supplied J pins into the centre cell at the end of the panel and secure into the ground.

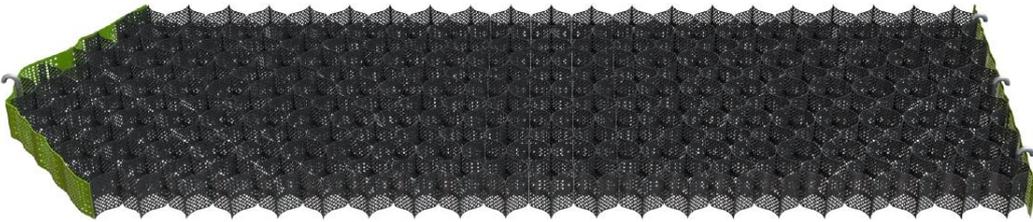
Step 3: Stapling Cellweb® TRP

- Pull out the Cellweb® TRP to its full 8.1m length and secure its length with another J pin.

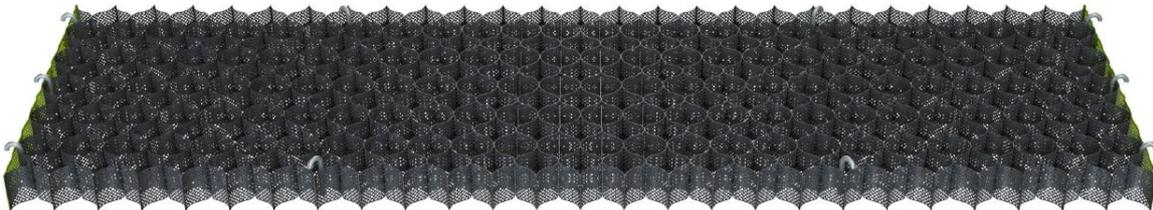
- Now measure its width to 2.56m and secure in each of the corners with the J pins.
- Use 10 pins per panel to create a panel measuring 8.1 m x 2.56m.

- This will produce a cell size of 259mm x 224mm which is the required cell diameter. Each cell must be fully extended and under tension.
- Staple adjacent panels together at each cell (see Note 3).
- If a curved path or shape is required, this should be cut when the Cellweb® TRP panel is pinned out to 8.1 x 2.56m, ensuring complete cells remain. Do not try to curve or bend the Cellweb® TRP panels into place.
- All cells must be fully opened to the required diameter.
