Christchurch Bay and Harbour Flood and  
Coastal Erosion Risk Management Study  
**Technical Annex 11: Historical Habitat Change in  
Christchurch Harbour**

# Christchurch Bay and Harbour Flood and Coastal Erosion Risk Management Study

## Technical Annex 11: Historical Habitat Change in Christchurch Harbour

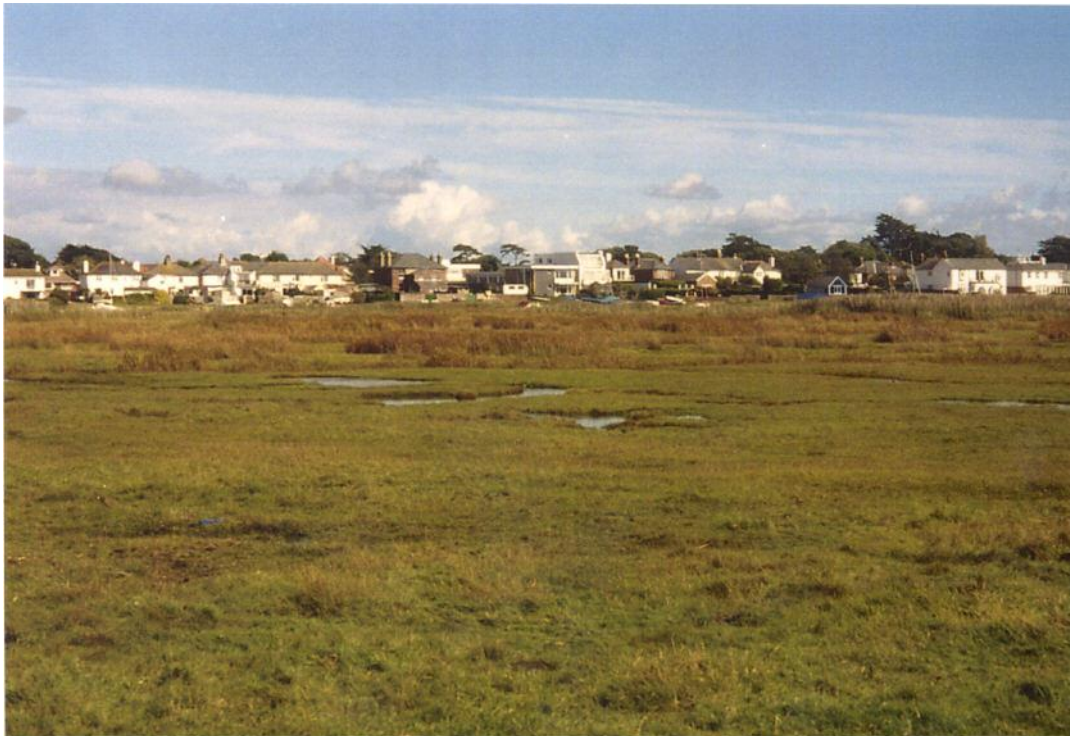
Figure 2: Salt marsh vegetation on Stanpit Marsh (facing east).

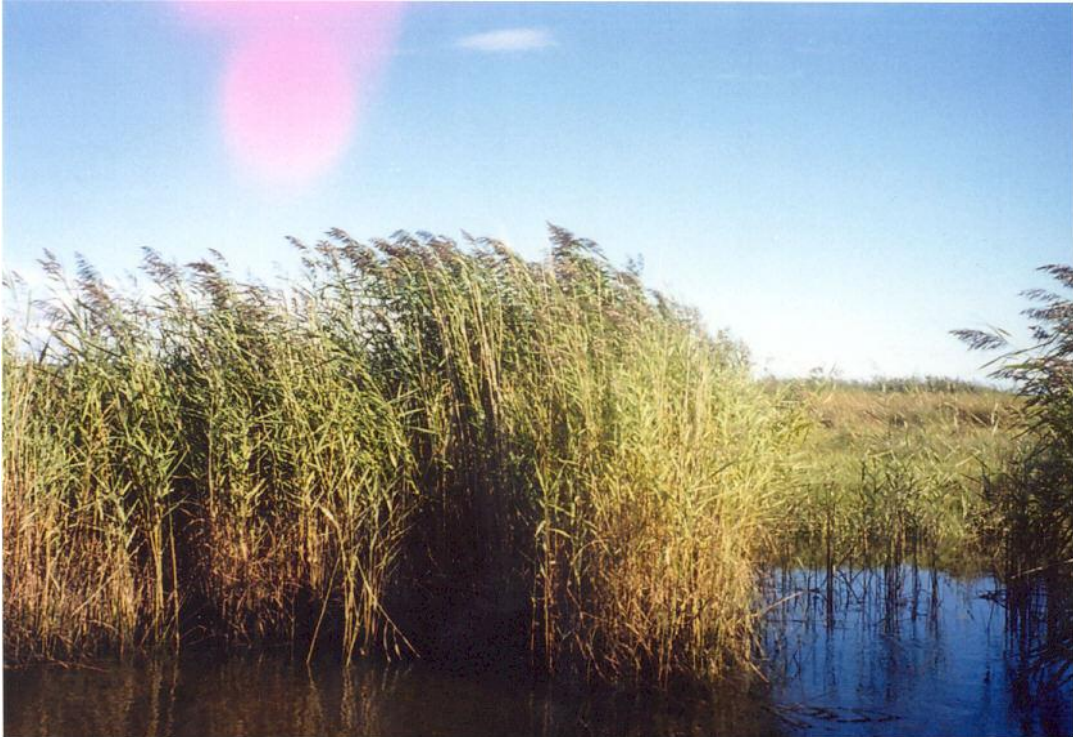
4. Reedbeds are classified as wetland vegetation and are dominated by stands of the common reed *Phragmites australis*. They often grow in marshes and swamps, along streams, lakes, ponds, ditches, and wet wastelands. Reedbeds are ephemeral in nature, i.e. reeds colonise open water (see Figure 3). Over time leaf litter builds up and the reedbed dries up where it is then colonised by alder and willow.

Figure 3: Reed bed at Stanpit Marsh (facing south)

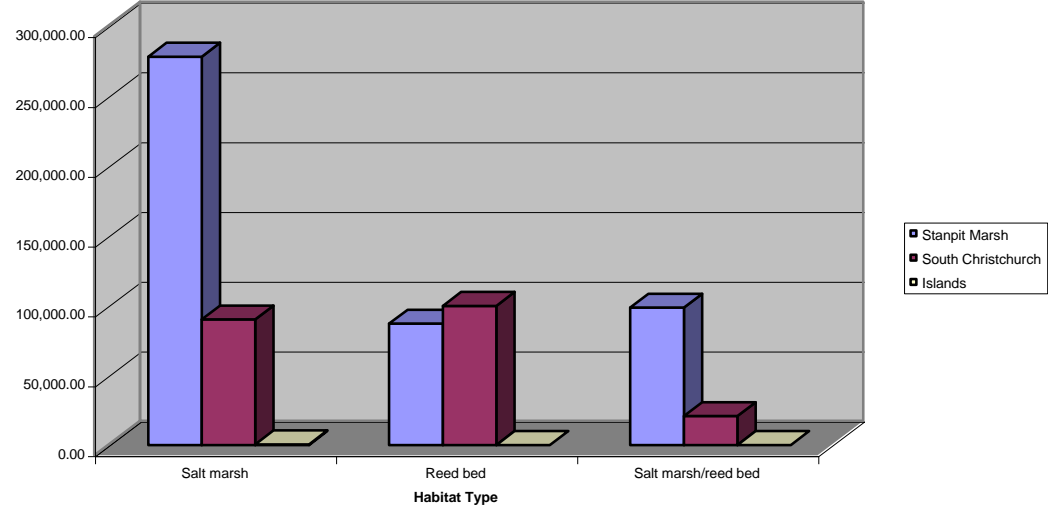
Based on polygon and area analysis in Arcview, Figures 7 and 8 below simply show the distribution of habitat type within Christchurch Harbour and how it differs between 1971 and 1997. It is seen that the distribution of salt marsh is far greater than the amount of reed bed or reed bed/salt marsh and that is itself generally less than reed bed, with exception to Stanpit Marsh. It is also evident that the proportion of salt marsh to reed bed is greater in Stanpit Marsh to South Christchurch; and there is more reed marsh located on the more western and southern margins of Christchurch Harbour than in Stanpit Marsh.

**Figure 8: Harbour Sections and their Composition (1997)**

Figures 7 to 10 show how the historical analysis is quantified, in that the areas within Christchurch Harbour occupied by salt marsh and salt marsh/reed bed are eroding; while areas of reed bed and in Stanpit Marsh, areas of salt marsh/reedbed are accreting. The results also confirm that the degree of net historical change between 1971 and 1997 has been greatest across South Christchurch as opposed to Stanpit Marsh. Figure 11 summaries the historical change of Christchurch Harbour

The analysis carried out for Christchurch Harbour shows that between 1971 and 1997 there has been an increase in the area of reed bed habitat and salt marsh/reed bed and a reduction in the salt marsh. This historic change has been more prominent across Stanpit Marsh than South Christchurch, but does display a greater net change across South Christchurch; and as Figure 8 shows, the actual rate of change is relatively low compared to the total change.

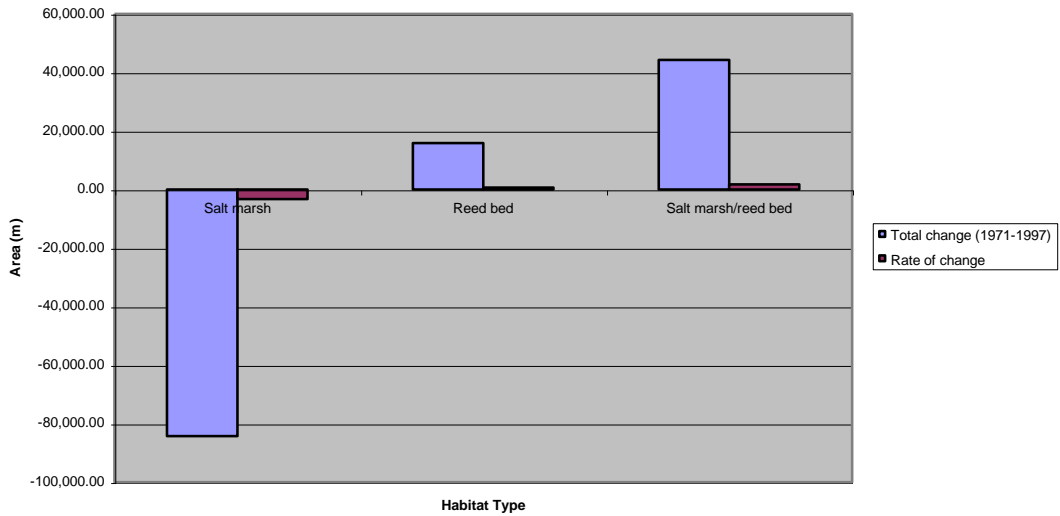
The change in habitat and the rate at which this takes place between 1971 and 1997 is shown in Figure 9. Salt marsh has eroded the most during this time, with losses in area reaching 85,000m<sup>2</sup>. Areas of reed bed have accreted by 16,000 m<sup>2</sup> and salt marsh/reedbed accreted by 44,000m<sup>2</sup>. These changes have occurred across the whole harbour, but appear to have been more substantial in South Christchurch than on Stanpit Marsh, as shown by Figure 10 and discussed below.

**Figure 9: Habitat area change in Christchurch Harbour 1971-1997**

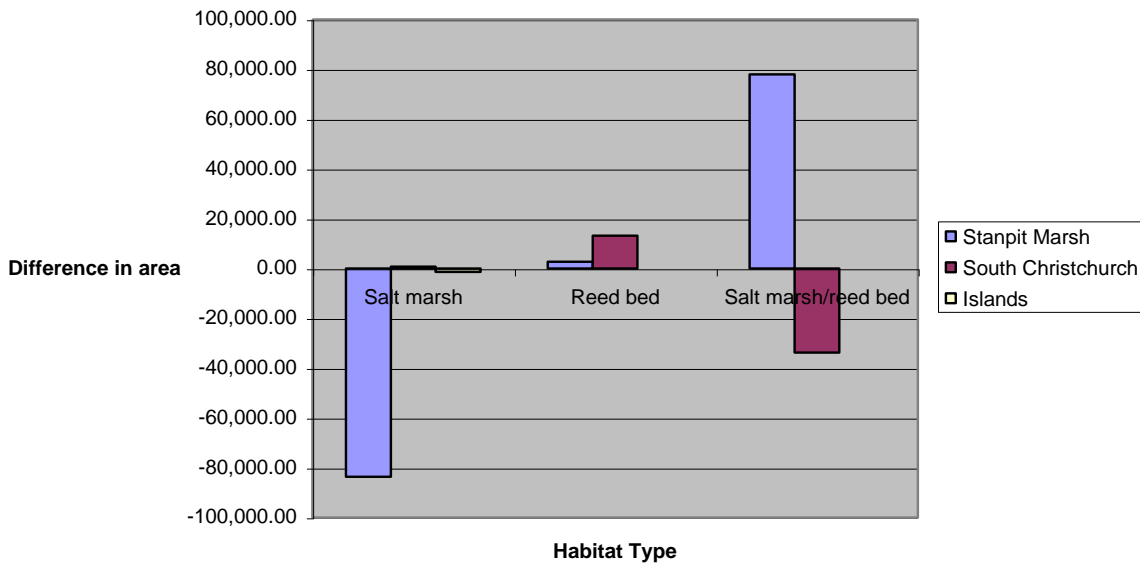
**Figure 10: Total change in area (1971-1997)**
