8. Visual Impact Assessment Methodology

9. Visibility Study (see Drawing No. 922/PL7, Visibility Photographs and Visual Assessments)

**A PROPOSED DEVELOPMENT OF LAND ADJACENT TO
BARNABY MEAD, GILLINGHAM, DORSET
centred on NGR ST 81055682**

Results of archaeological trench evaluation

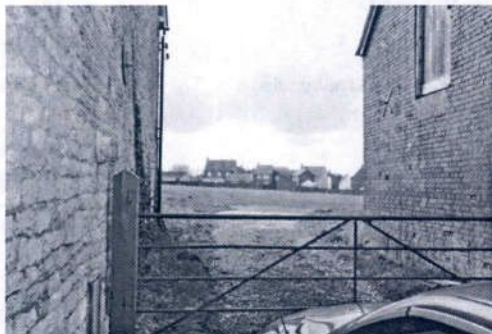
VIEWPOINT A – looking through the gap between the buildings at Bay Farm. **Major visual impact** during construction but mitigated by proposed green space and planting between this viewpoint and closest houses.

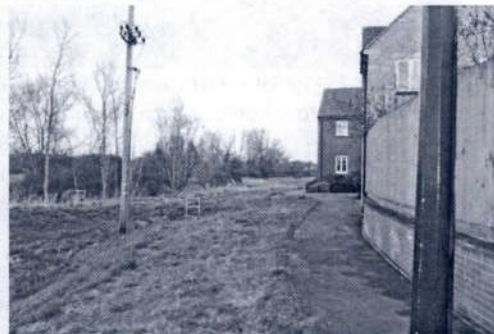
VIEWPOINT B – looking east along the northern edge of Barnaby Mead towards the north western corner of the Application Site. **No visual impact** as housing will be hidden by houses on right.

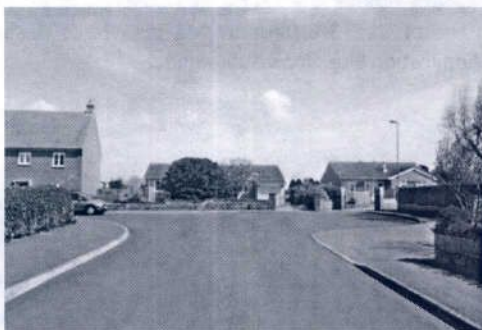
VIEWPOINT C – looking east from Barnaby Mead, the Application Site is behind the houses; the two bungalows to the right, Nos. 18 and 19, were part of the original scheme, the house to the left is part of the recent development. The new residences will be seen behind and above the bungalows. **Medium visual impact.**

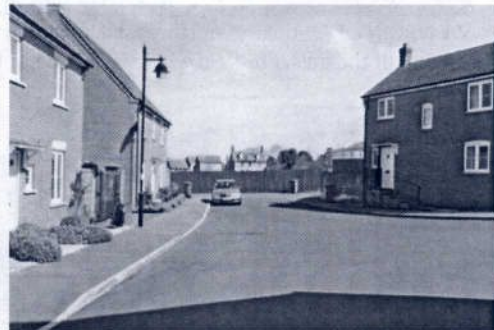
VIEWPOINT D – a view east from the Barnaby Mead area looking to Bay Farm and the properties on Bay Lane. **Medium visual impact.**

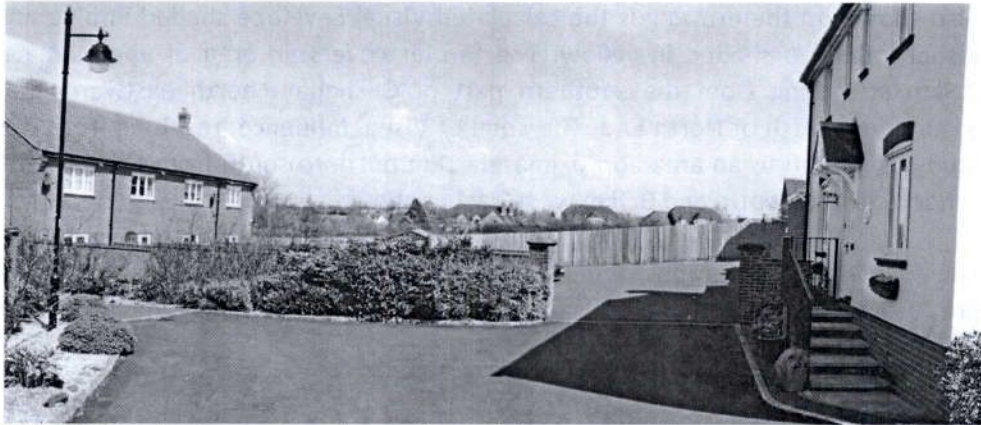
VIEWPOINT E – looking east from the northern cul-de-sac in Barnaby Mead to The Gate House, The Cedars and Lime Tree House on Bay Lane. **Medium visual impact.**

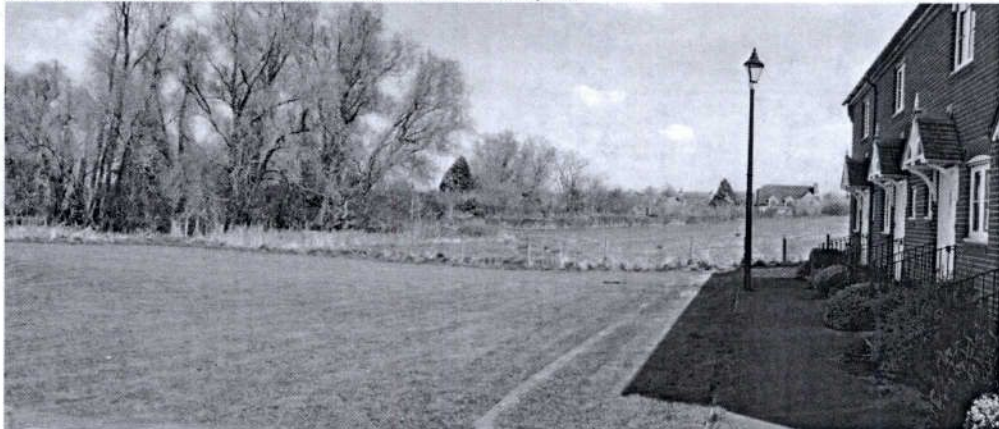
VIEWPOINT F – looking north east along the frontage of Nos. 3-6 Barnaby Mead towards the northern section of the adjacent field which is outside of the Application Site. **No visual impact.**

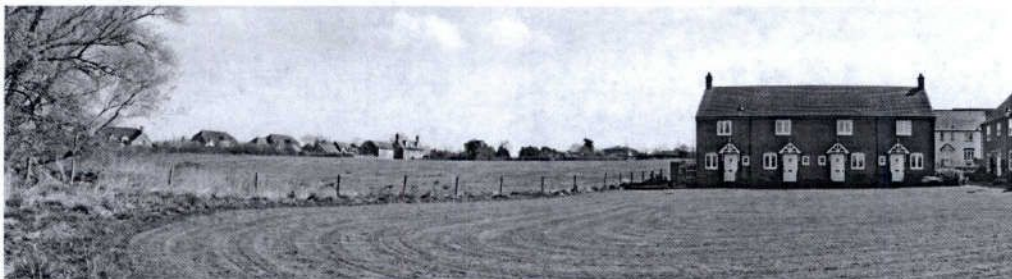
VIEWPOINT G – looking south east towards the northern section of the Application Site towards Bay Lane and the school. **Medium visual impact.**

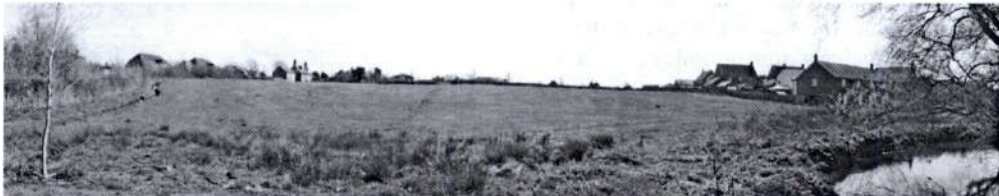
VIEWPOINT H – a similar view but from within the field north of the Application Site adjacent to Shreen Water, illustrating a view from the properties on Bay Road (see below).

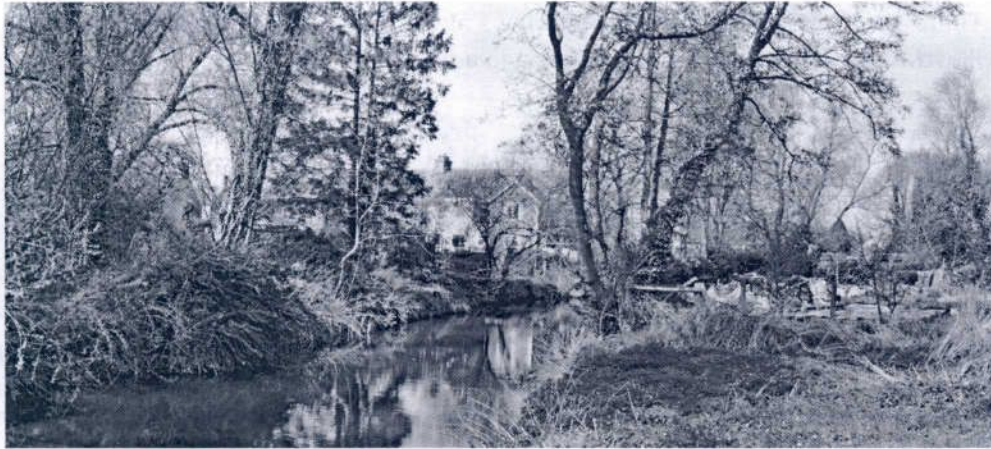
VIEWPOINT I – a reverse view from the above viewpoint illustrating the vegetation adjacent to Shreen Water which, even in winter, provides a degree of screening (see Viewpoints M-O below for assessment).

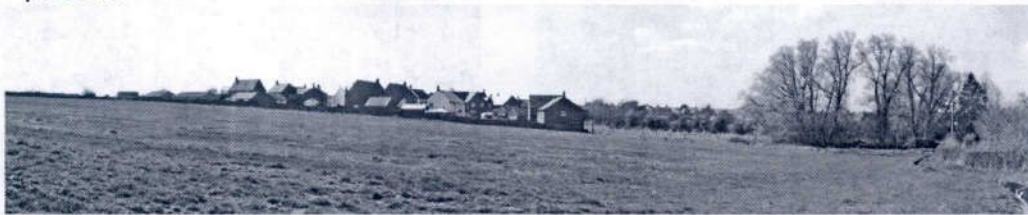
VIEWPOINT J – a view inside the 3-4m high eastern boundary hedge adjacent to The Cedars giving an illustration of the view from the upper floor windows. **Major visual impact.**

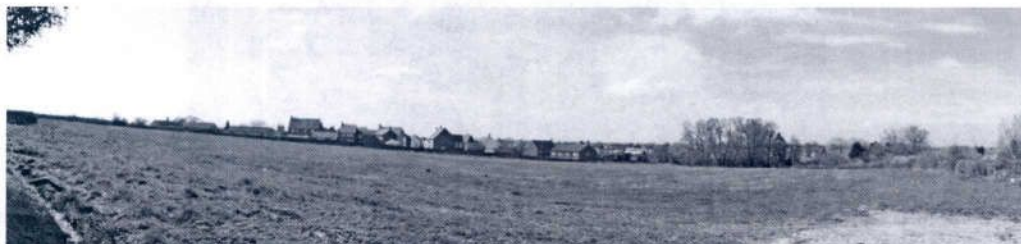
VIEWPOINT L – a view from adjacent to Bay Farm looking west across the Application Site towards Barnaby Mead. **Major visual impact.**

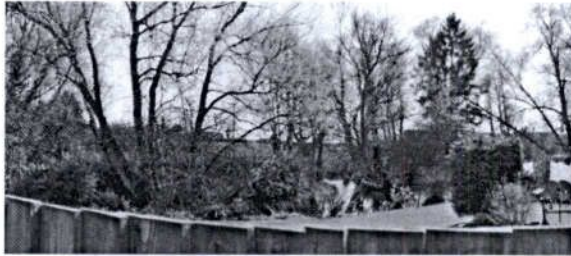
VIEWPOINT M – looking south over the fence on Bay Road. **Minor** visual impact.

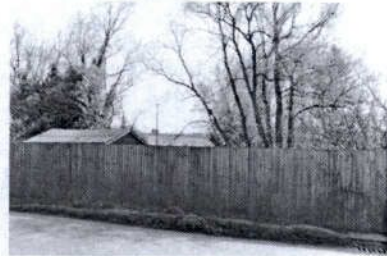
VIEWPOINT N – looking south across Bay Road from adjacent No. 4 Shreen Way. **Minor** visual impact.

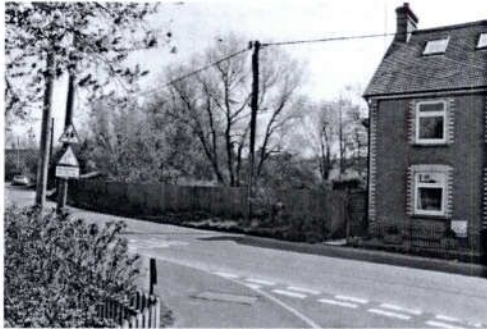
VIEWPOINT O – a view at the entrance to Shreen Way looking south east. **Minor** visual impact.

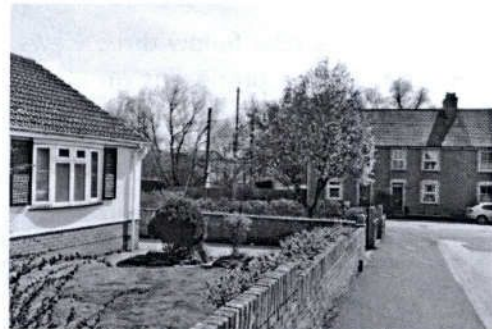
VIEWPOINT P – a view from Lodbourne Gardens adjacent to No. 21. **Minor** visual impact.

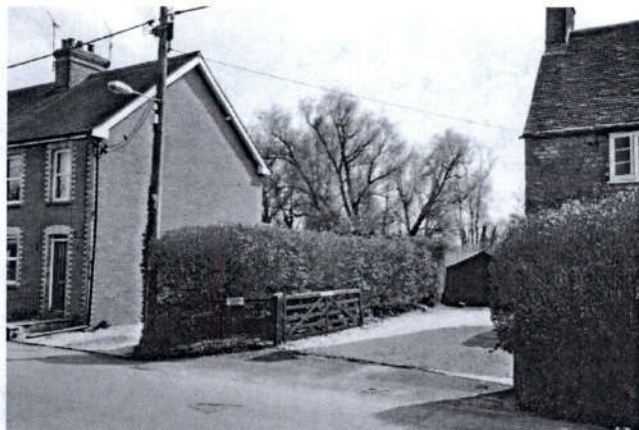
VIEWPOINT Q – a view through the gap at the western end of Elm View Terrace. No visual impact from public area but there will be views into site from houses with **Medium** visual impact.

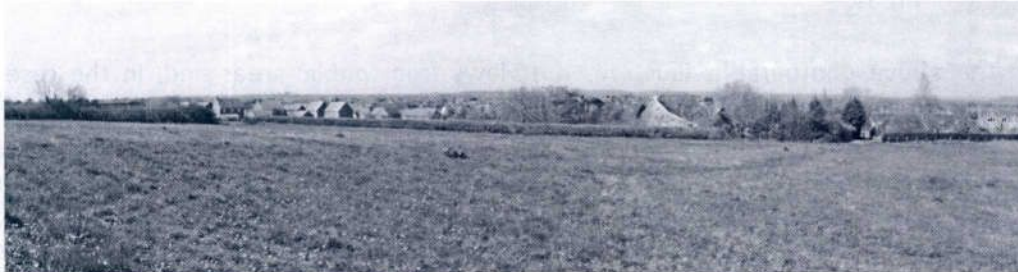
VIEWPOINT R – looking north west from the eastern boundary of the field with the houses in Barnaby Mead to the left of view. **Minor visual impact.**

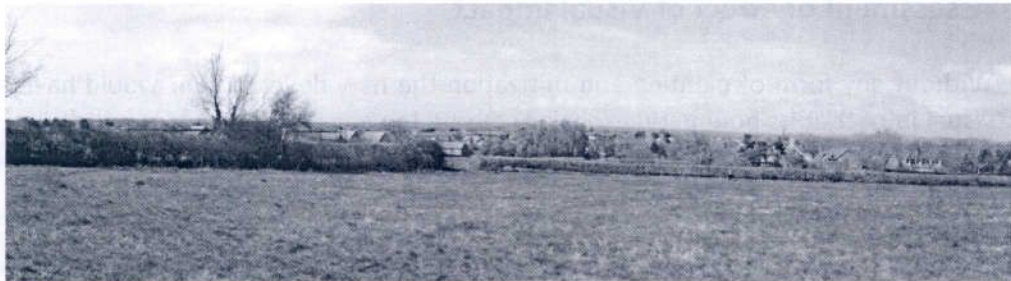
VIEWPOINT S – a similar view from near the gate into the tennis courts, the new development will be partially screened by the hedgerow to the left and the vegetation south of Bay Farm. **Minor visual impact.**

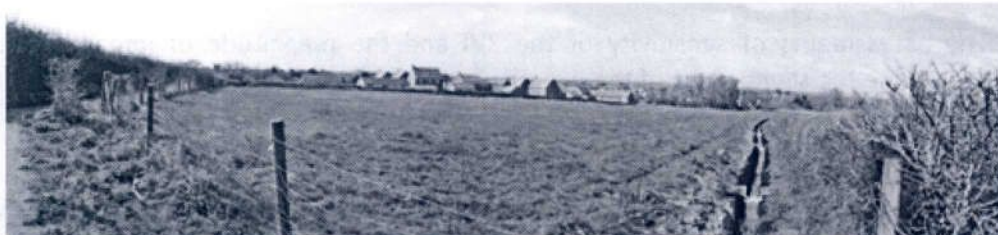
VIEWPOINT T – an open view from the eastern end of the public footpath which runs along the southern boundary of the Application Site. **Major visual impact** but this will be mitigated at this point by the southern section of the proposed landscape buffer strip.

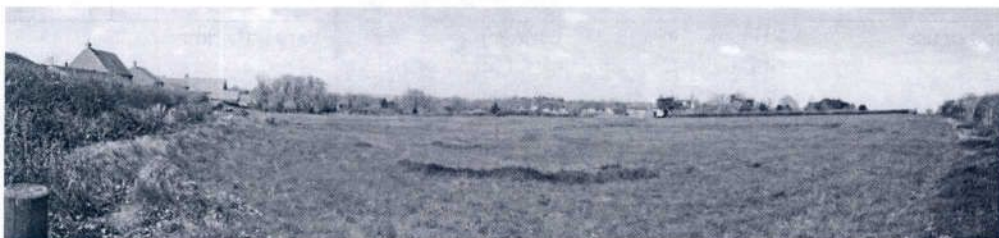
VIEWPOINT U – a similar view at the western end of the public footpath which will have views of the boundary treatment of the closest properties. **Major visual impact.**
