Christchurch Bay and Harbour Flood and
Coastal Erosion Risk Management Study
Technical Annex 10: SSSI Condition Assessment

Provided by
Natural England

Technical Annex 10: SSSI Condition Assessment

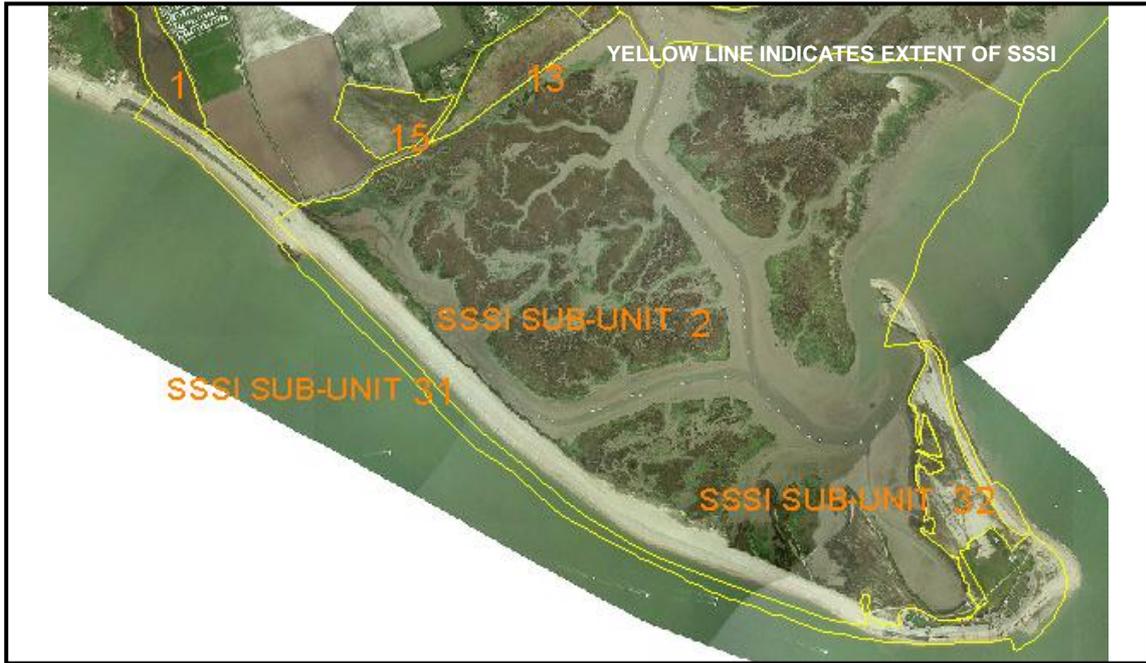
MANAGEMENT UNIT	CBY7
COASTAL DEFENCES	Seawall, timber groynes rock revetment, open shingle beach
SSSI UNIT REF. AREA	SSSI Sub Unit 31 23.92 ha
SSSI TYPE / HABITAT	Littoral rock
DATE OF LAST INSPECTION	20 th January 1998
SSSI CONDITION	Favourable
COMMENTS (JAN 1998)	None

CHRISTCHURCH BAY STRATEGY OPTIONS		LIKELY IMPACT ON SSSI WITH RESPECT TO PRESENT CONDITION			
		Decline	Maintain	Improve	
1	Do Nothing	●			
2	Hold the line (extend rock revetment)		●		
3	Hold the line (recharge beach/beach management plan) *		●		*preferred option

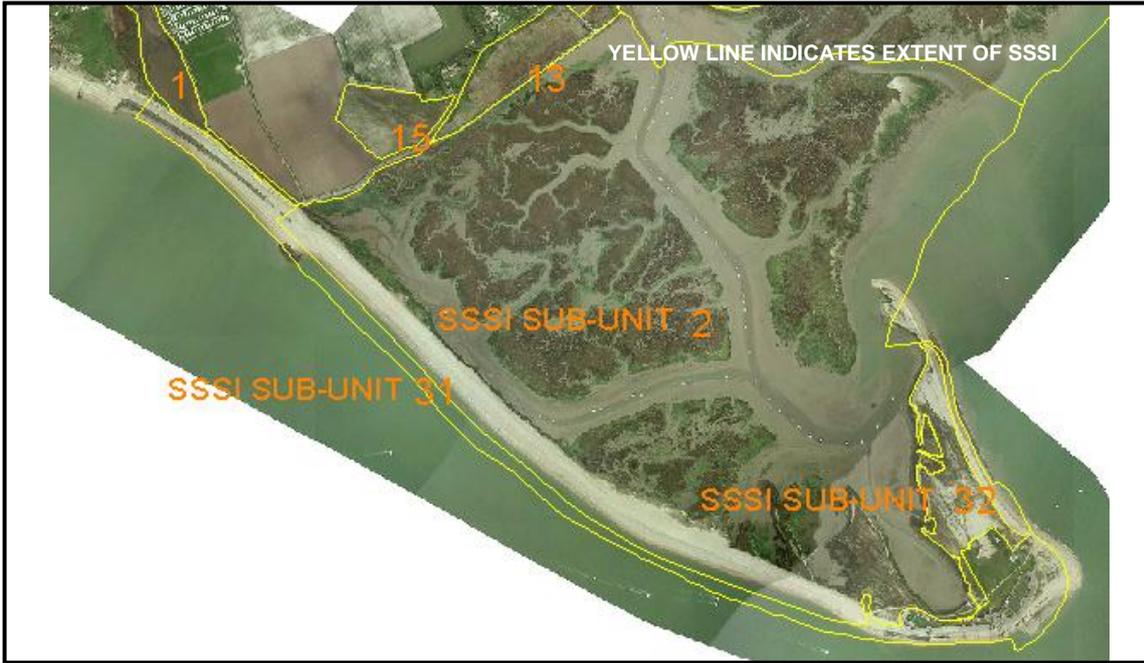
MANAGEMENT UNIT	CBY7
COASTAL DEFENCES	Shingle re-curve / undefended
SSSI UNIT REF. AREA	SSSI Sub Unit 32 7.81 ha
SSSI TYPE / HABITAT	Littoral rock
DATE OF LAST INSPECTION	10 th November 2000
SSSI CONDITION	Favourable
COMMENTS (NOV 2000)	None

CHRISTCHURCH BAY STRATEGY OPTIONS		LIKELY IMPACT ON SSSI WITH RESPECT TO PRESENT CONDITION			
		Decline	Maintain	Improve	
1	Do Nothing	●			
2	Hold the line (extend rock revetment)		●		
3	Hold the line (recharge beach/beach management plan) *		●		*preferred option
