Buildings at Risk

2013

Building at Risk

North Dorset District Council

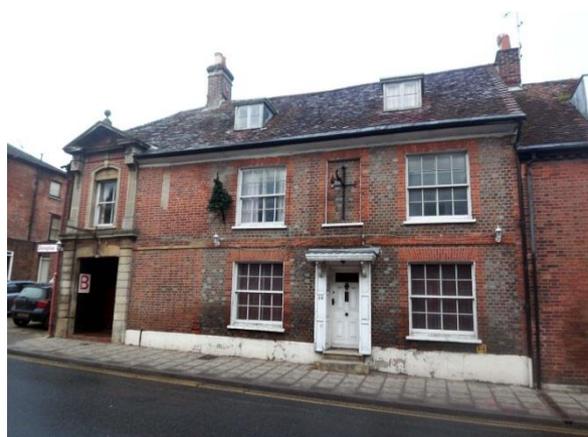
2010

General: Chimney of brick construction - lead flashing failing on left side. (Poor)

Joinery: All wood work (fair)

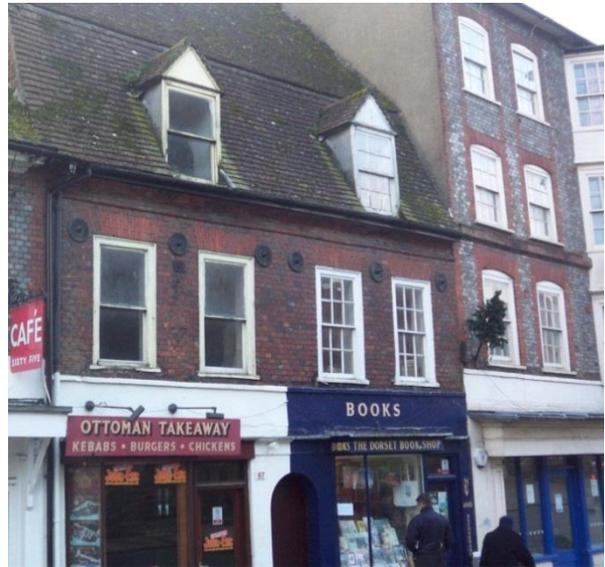
2010

Joinery: Sash at roof level (poor) and 1st floor sash windows decoratively poor with some evidence of rot (poor).

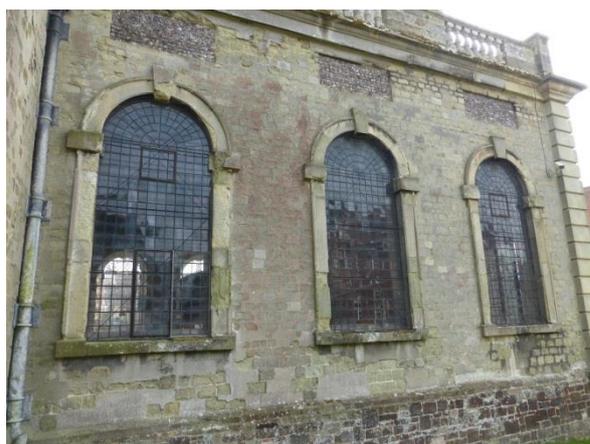
North Aisle

A visual inspection of the cupola is difficult due to access but it is clear that it is in a very poor state, the wood work is in need of attention; additionally the north wall which is built of Shaftesbury green sandstone is in an extremely poor condition. On a visual inspection and photographic evidence it is clear that the wall is de-laminating at several points and urgent attention is required. Pointing generally fair but gaps on south wall of chancel.

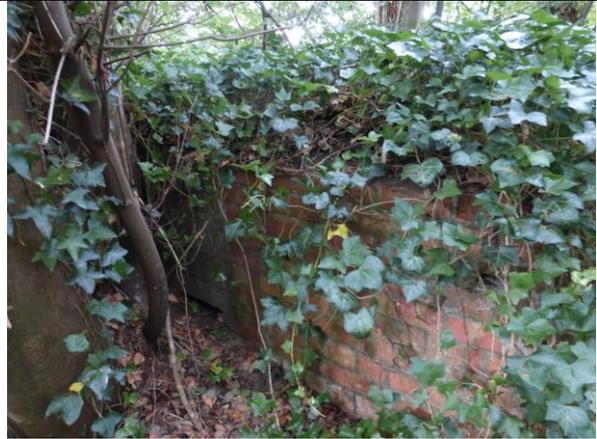
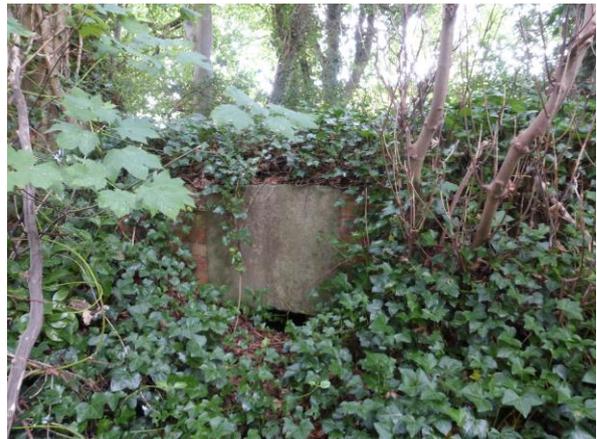
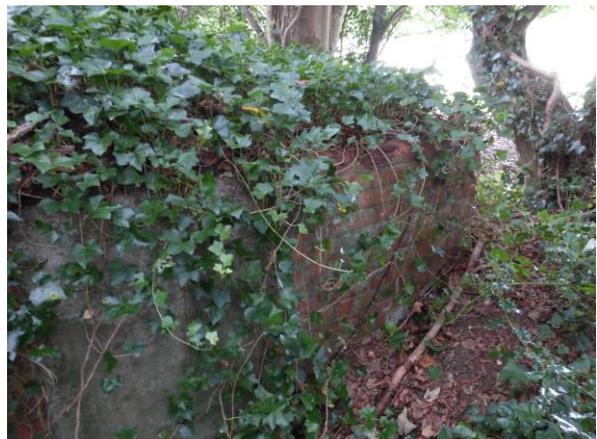
A WWII pill box constructed in 1940-1, probably as a component of the anti-tank ditch defence (Grade II listed). Strategically located on the corner of the ditch between the Bryanston Estate and the Borough. Part of an extensive complex of anti-tank defences along the western edge of the town. Blandford was the focal point of the stop-line which ran along the River Stour from Stalbridge to Christchurch. Completely overgrown with vegetation and large trees – potential root damage. BT to be contacted to clear the structure.

Walling: Brick and concrete. Appears to be in good condition but large areas are obscured.

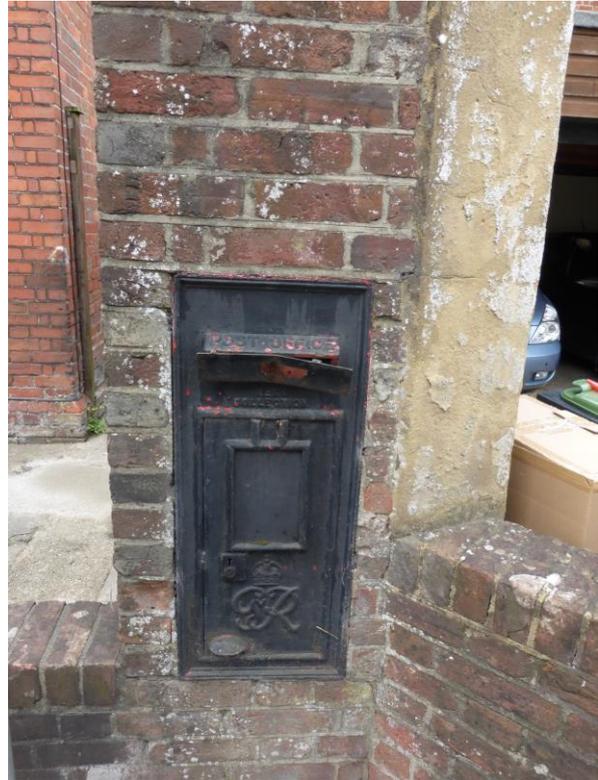
George VI post box, redundant. In poor condition and poorly sealed, with litter forced into the opening. Royal Mail to be contacted for preservation. Blandford Civic Society is willing to take over responsibility for maintenance.

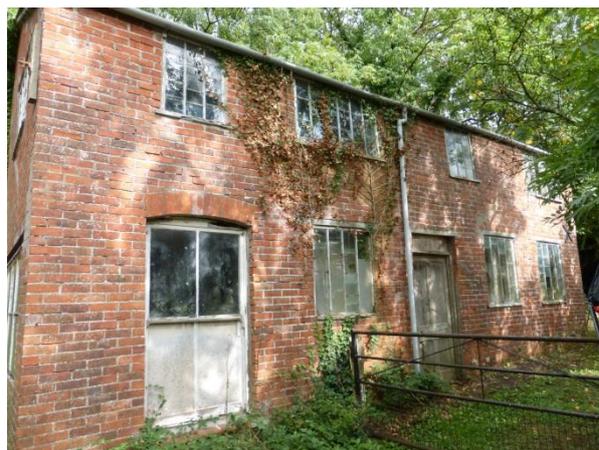
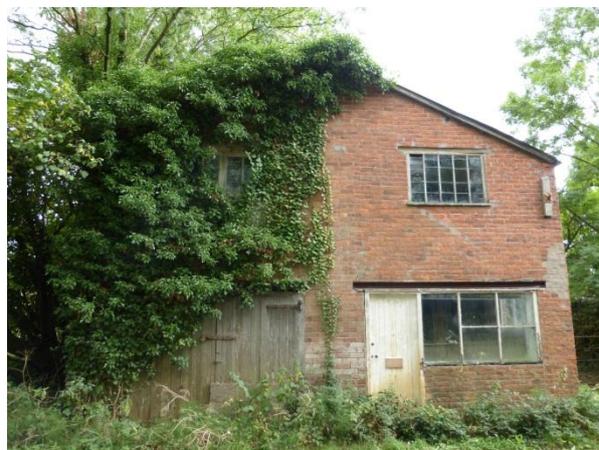
Mid 19th Century outbuildings of brick construction and plain tile roof, it appears to have been built in two phases the newest close to the road. The rear of the building is in domestic use for storage and the front is unoccupied, the front of the building may have been in use as a workshop. It should be noted that there is extensive vegetation growth and this is having a detrimental effect on the long term structure of the building.

Walling: Major structural crack at front of building – no visible repairs since 2010 survey (poor)

Joinery: Poor condition and rotten throughout.

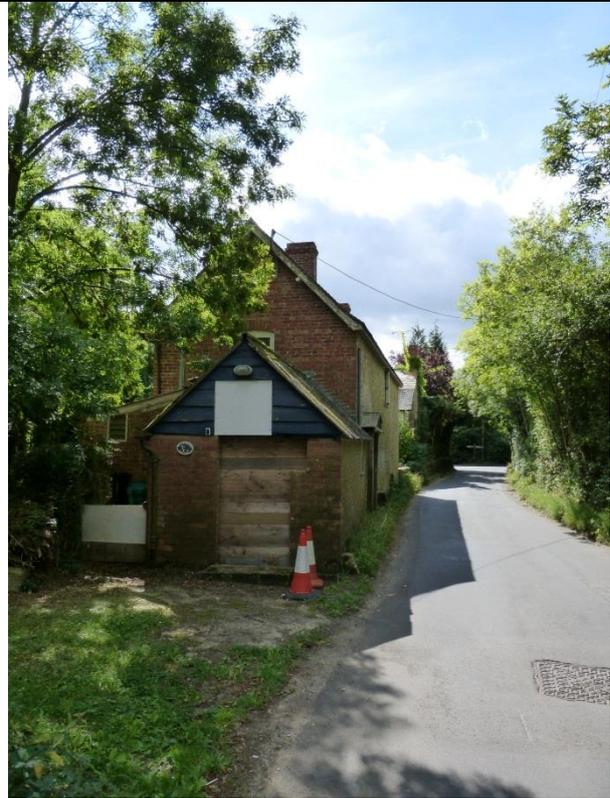
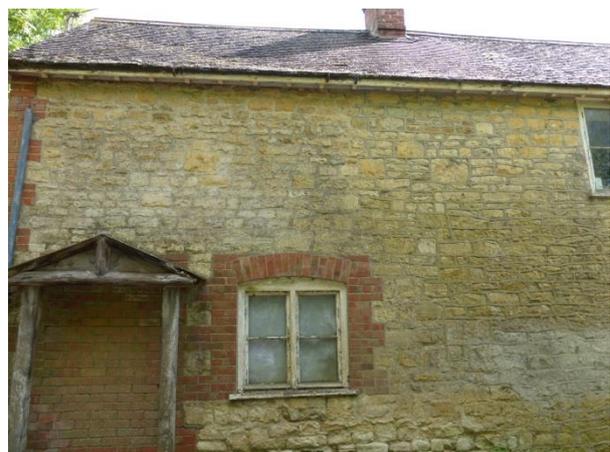
Early 19th Century brick and stone built Cottage. Gabled roof with later building attached which has a corrugated roof. Cottage is in reasonable state of repair.

Joinery: Wood work on ancillary building very poor in 2010 – now boarded. Wood work on cottage poor, though window frame on end wall currently being replaced.

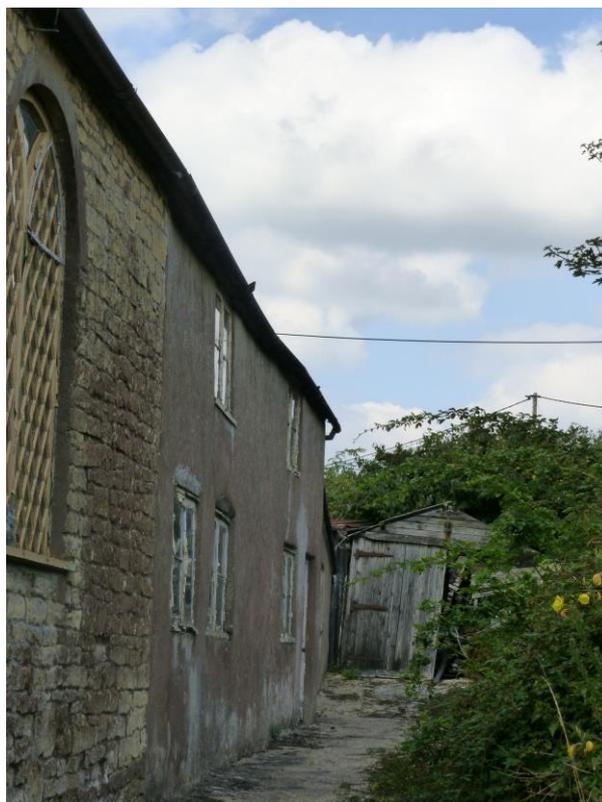
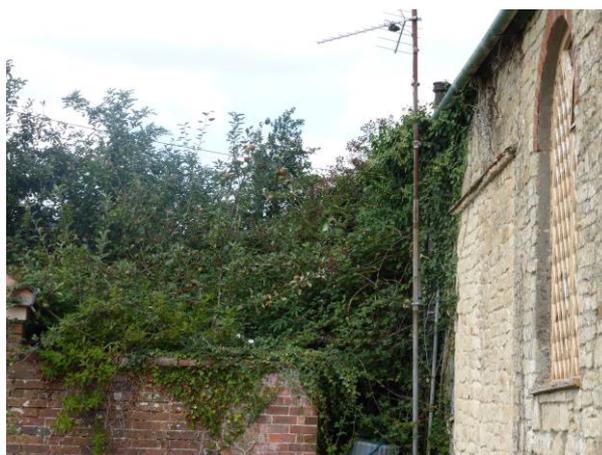
Part domestic part former chapel. Chapel restored and converted into a dwelling. Chapel house, probably 18C, enlarged 1824. 2 storeys with irregular fenestration. Condition unchanged since 2011 survey, with some deterioration especially in the woodwork.

Joinery: all window and door frames very poor on the house, mostly rotten.

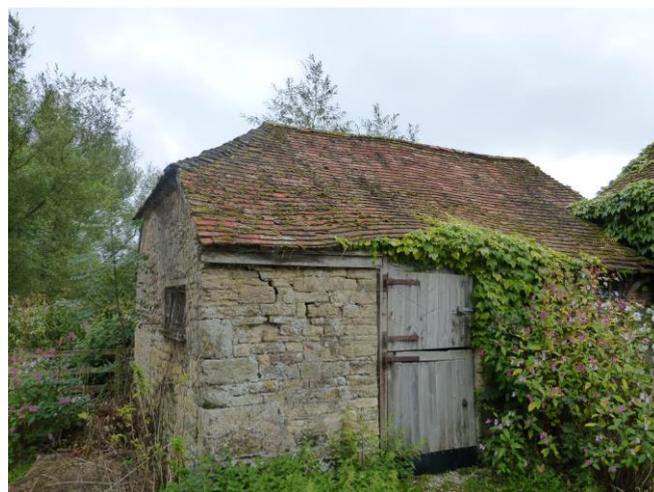
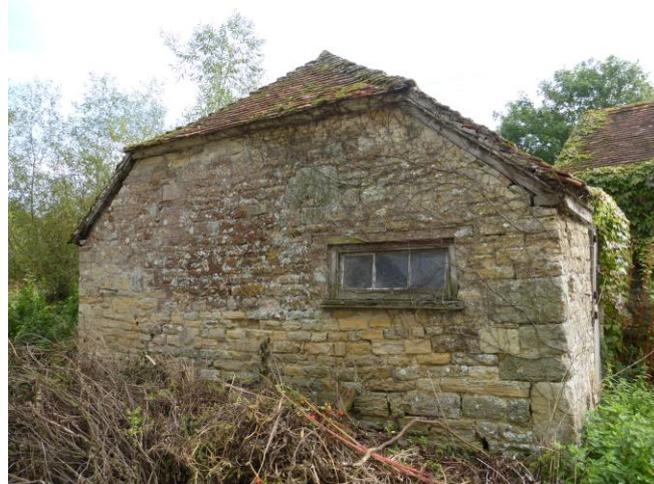
Pointing: Significant missing mortar (poor)

Joinery: Some damage (poor)

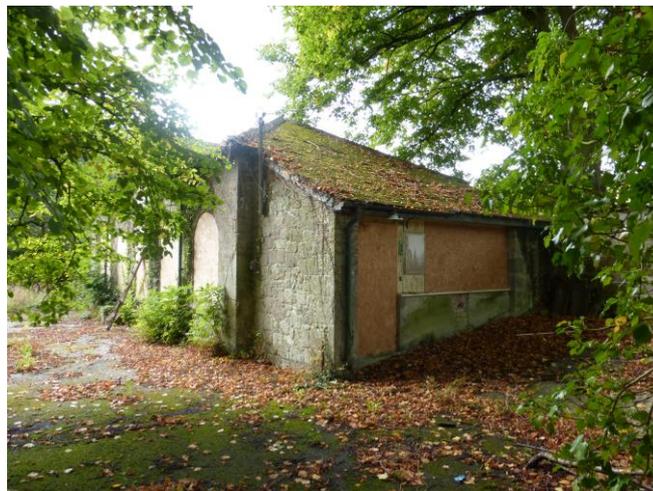
Mid 19th Century stable block most likely built at the same time as the school (1844) constructed of rubble stone and dressed Shaftesbury sandstone, some concrete evident under front bay window. Roof is possibly slate but covered in moss. Since the 2010 survey, the vegetation and trees have been cut back but no remedial work has started.

Roof: Extensive work required to clear moss and ascertain condition (poor)

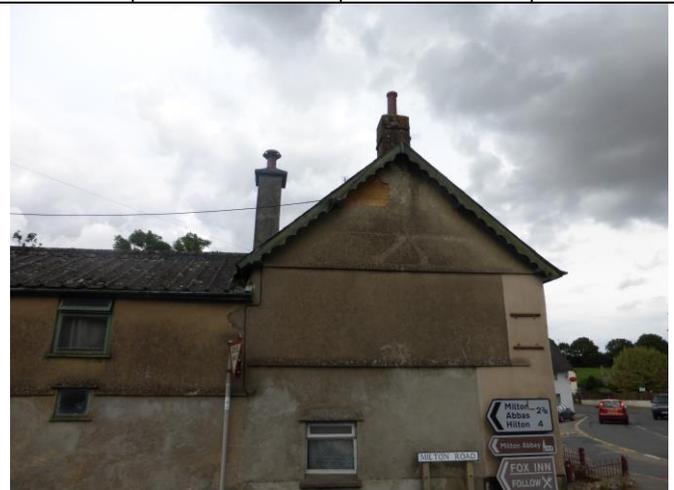
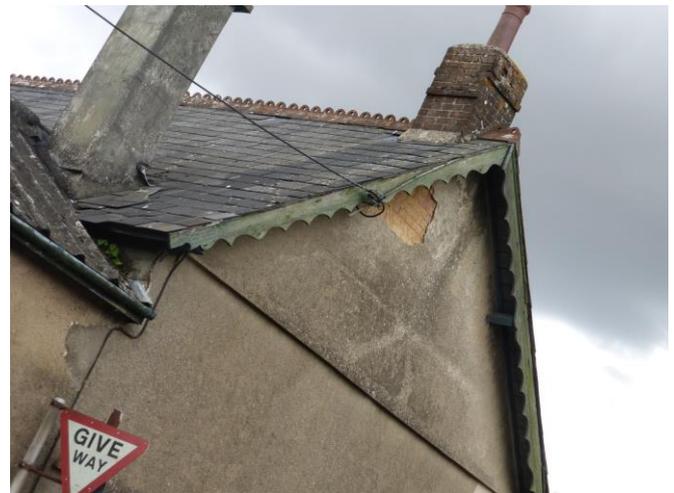
Late 19th Century in poor condition throughout. Two stack's, lean to on Milton Road end. Subject to flooding from brook at rear of property – purchased two years ago – owner resident in Bere Regis. Area of concern render loss, gable apex Milton Road side as evident in attached photo. Would consider this a danger to the public. Condition remains unchanged since the 2011 survey – no further render has been lost, but significant cracks remain, hence a continuing danger.

Roof: Tile slippage rear of front house. (Poor) Corrugated Asbestos Roof (fair)

Walling: Poor throughout

Joinery: Poor throughout

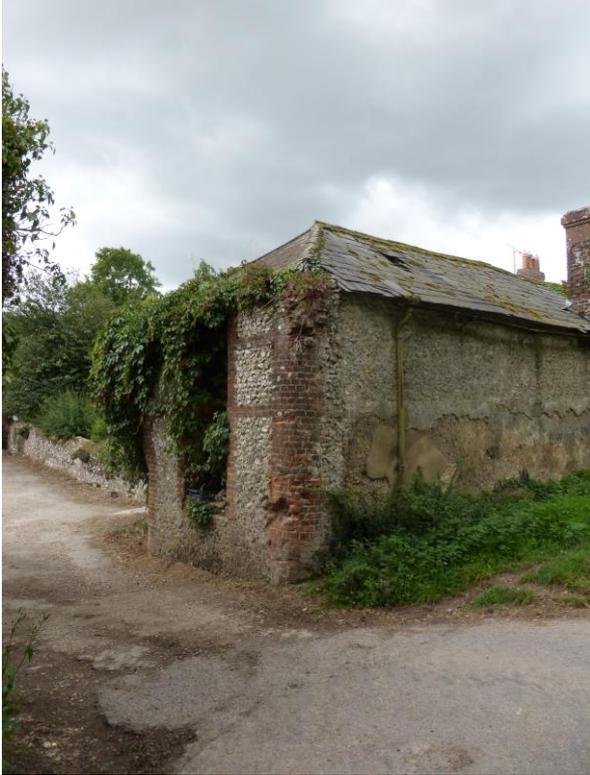
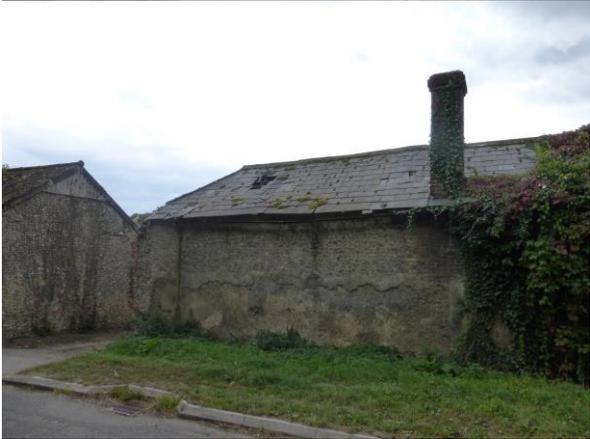
<p>Condition:</p> <p><i>Roof:</i> Slate – poor with significant slips and loss</p> <p><i>Walling:</i> Side wall – flint with brick bands. Some damage by machinery and loose bricks at roof level, worsened by vegetation. Rubble with some brick at the rear – some remedial work but poor condition.</p> <p><i>Pointing:</i> Poor throughout</p> <p><i>Joinery:</i> Very poor</p>

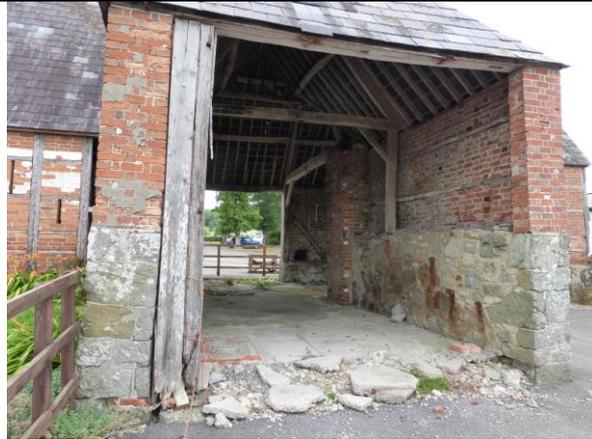
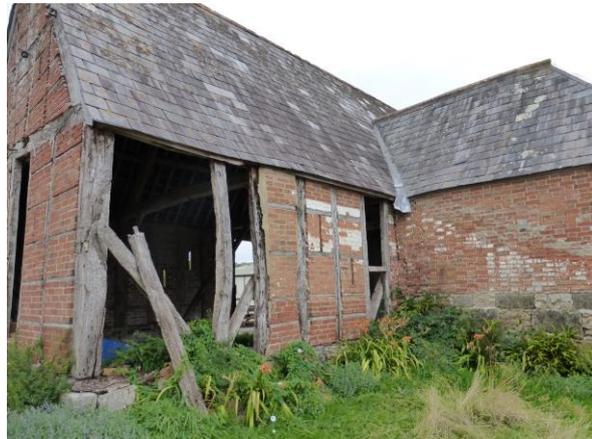
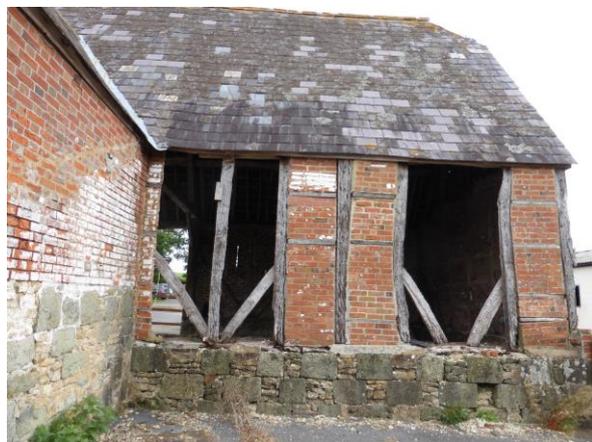
Joinery: Timber lintel of rear door split and buckling. Weather board good. Parts of timber frame collapsed.

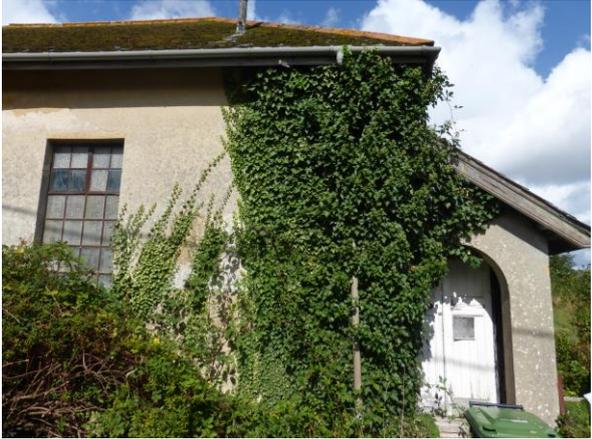
Agricultural		Domestic			Retail		Ecclesiastical	
MAP Reference	Co-Ordinates		Address			Parish	Survey	
	E390443 N108934		Chapel Lane			Pimperne	16/09/13	
SURVEYOR	BOA	RS	CA	LB Grade	Windows	Roofing	WM	SR
DJC	2	4	No		24 panel	Thin slate	Cob Render	
<p>Description:</p> <p>An early 19th Century Methodist chapel, now privately owned. Formerly thatched. Consists of a simple hall and vestibule. Extensive ivy growth into the eaves and obscuring one window. Some damaged glazing. Hall has been divided for use as a workshop. Planning permission was refused in 2011 to convert into a dwelling. Currently being marketed for offers or expressions of interest for ecclesiastical or community use rather than residential.</p> <p>Condition:</p> <p><i>Roof:</i> Thin slate (fair)</p> <p><i>Walling:</i> Areas of significant loss of render – cracks indicate further loss is likely, especially on the roadside wall</p> <p><i>Pointing:</i> n/a</p> <p><i>Joinery:</i> Window panels generally fair, but damp damage on the door and frame</p>
