Christchurch Bay and Harbour Flood and
Coastal Erosion Risk Management Study
Technical Annex 8 – Assessment of Standards of Service

Prepared by
New Forest District Council

Technical Annex 8: Assessment of Standards of Service

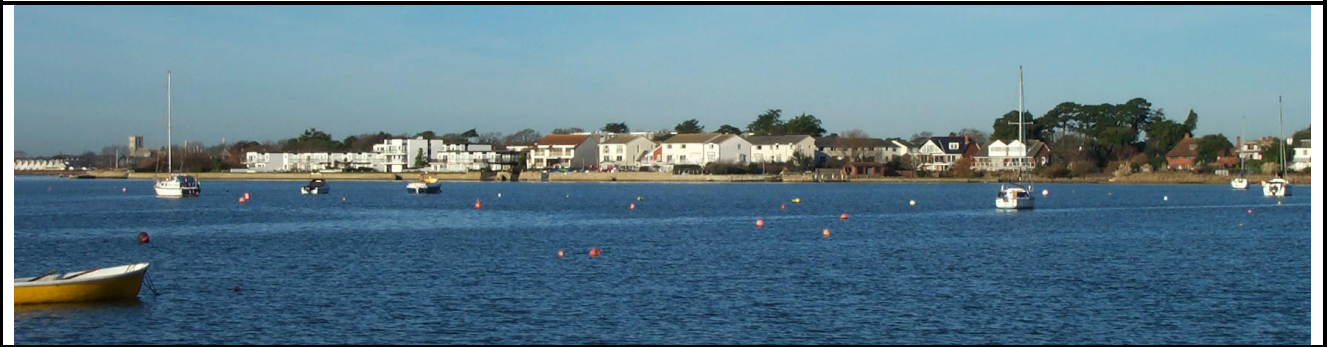
4.4 CHB4 Mundeford Town frontage

View looking approximately northwest from Mundeford Spit towards Mundeford CHB4 frontage.

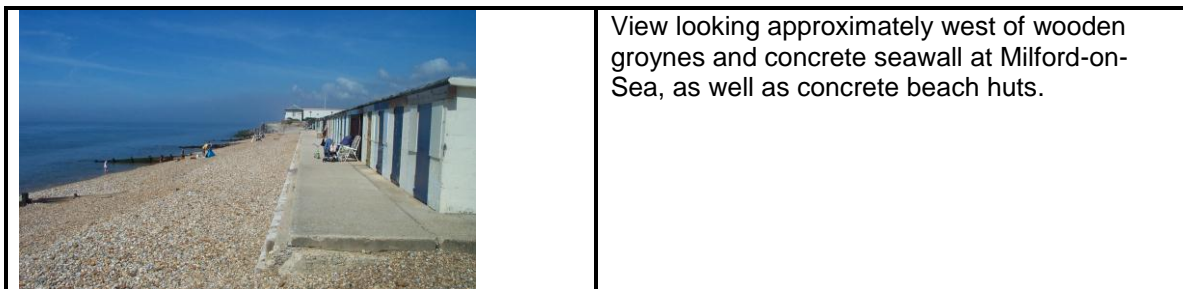
View looking approximately west of concrete seawall and wooden groynes at Milford-on-Sea, as well as timber beach huts.
