What is a conservation area?

- 3. Morden Conservation Area was first designated by Purbeck District Council on 10th July 1990. The boundaries were altered in 2018 see Map 1 and Appendix D.

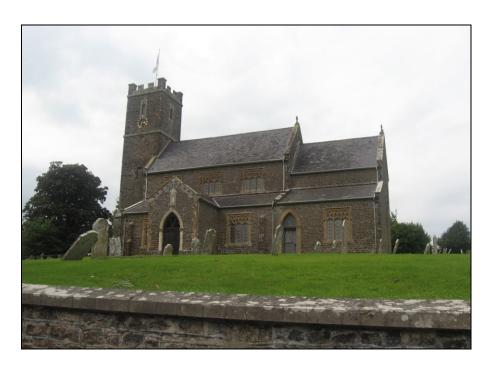
FIG. 1: St. Mary's Church, Higher Street. A picturesque and well positioned building, the church is of particular interest as for being almost entirely constructed from heathstone. Little remains of the medieval church it replaced.

- 21. According to the English Place Name Society the name 'Morden', recorded as 'Mordune' in the 1086 Domesday survey, means 'hill in marshy ground'.
- 22. The lower part of the tower of St. Mary's Church has been dated to the thirteenth century (see FIG. 1 below). The top of the tower and remainder of the building were constructed in the 1870s.

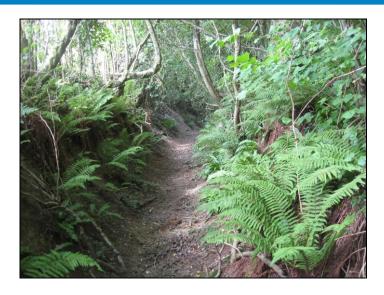
FIG. 2: Collins's Lane. The lane is a sunken track which remains a right of way. It connects Goodwin's Lane with Lower Street.

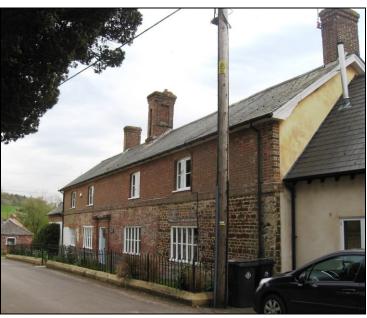
FIG. 3: Buildings of the sixteenth and seventeenth centuries. Left: 60 Higher Street, the heathstone end gable of which is seventeenth century. Right: Home Farm a building of sixteenth century origin likewise rebuilt in the eighteenth century.

24. References to Ridgeway Mill which formerly stood just south of Whitefield occur by 1550. A number of extant buildings within the conservation area have been identified as of sixteenth and seventeenth century origin. The rate of survival would have been higher had a wave of late 1960s-1970s demolition not claimed at least five others (see further discussion below). The earliest domestic buildings still in existence are thought to be Home Farm House in Higher Street (FIG. 3 below), West Morden Farm House and Paddock Cottage (see FIG. 21), which are each of late sixteenth century origin. Evidence for rebuilding of earlier heathstone houses in brick can be seen at Home Farmhouse, No. 60 Higher Street – a building of the seventeenth century (FIG. 3 below) – and Hill Farm Cottage, which is of unknown date.

- 31. As referenced on old OS maps (see FIG. 5 below) 'Morden' is the principal part of the settlement centred on Higher Street.
- 32. As noted above, the eighteenth and nineteenth centuries saw some earlier buildings rebuilt and altered. In the cases of 60 Higher Street and Home Farmhouse (FIG. 3 above) the work is evidenced in the contrasting materials used, whilst rebuilding of the parish church employed materials to match, and substantial extension of the Old Vicarage (see FIG. 30) masked the original building. No. 76 Higher Street (FIG. 29) was an addition of the eighteenth century, and Church Villa a stylistically notable contribution of the early nineteenth century.

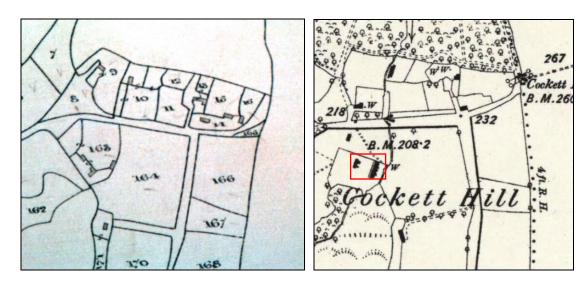
FIG. 4: Cockett Hill. Left: 1847 tithe map shows several cottages most of which remained in 1887 (right). Only Cherry Cottage (boxed) survives – see FIG. 18. Maps reproduced with the permission of the National Library of Scotland.

30. Cockett Hill, east of Morden village, historically contained a cluster of cottages (see FIG. 4 below), but today contains only a single dwelling of eighteenth century origin – Cherry Cottage, once a row of three (see FIG. 18). Though comparison of maps shows that the number of dwellings contracted slightly during the second half of the nineteenth century, and a further dwelling was lost during the 50 years following,

several dwellings remained here post-war and are recorded on contemporary OS maps. All but Cherry Cottage were subsequently demolished. The sites of cottages on the north side of the lane are now covered by woodland.

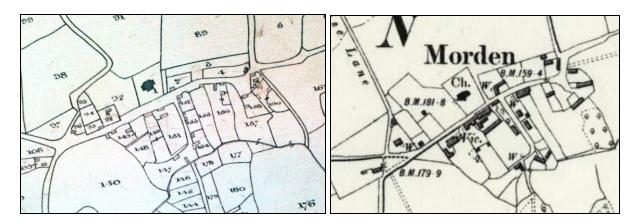
FIG. 5: Morden. Left: 1847 tithe map showing little change since the 1770s. Right: 1900 OS. Reproduced with the permission of the National Library of Scotland.

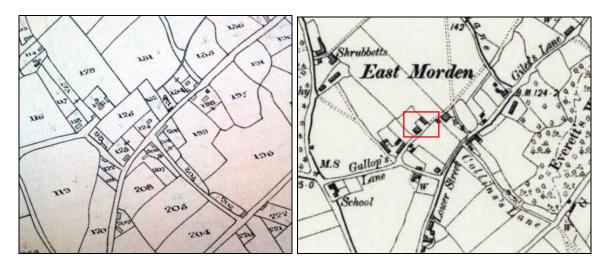
FIG. 6: East Morden. Top and bottom left: 1847 tithe map excerpts showing little change since 1760s. Top and bottom right: 1900 OS excerpts. The scene top right changed considerably during the 1970s. The red box top right indicates the site of the buildings shown in FIG. 8, and that bottom right the building shown in FIG. 7. Maps reproduced with the permission of the National Library of Scotland.

34. As referenced on old OS maps, 'East Morden' represents the area of dispersed settlement south west of Morden village (see FIG. 6 below).

clearly appreciable in early editions of the OS (see FIG. 6). This network has survived for the most part through definition of some routes has been lost through removal of enclosing features (typically hedgerows), and general disuse. As elsewhere in the conservation area the pattern of development here otherwise remained reasonably stable from the 1760s until 1960, after which significant change occurred. Having been up until this point rich in vernacular buildings with a high frequency of thatch, the area became dominated by generic modern housing.

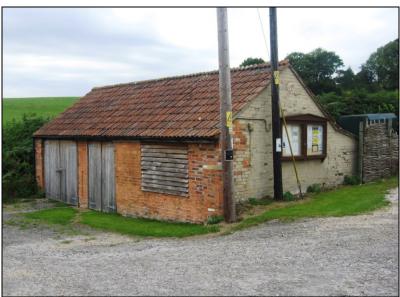
FIG. 7: Features of interest in East Morden. Left: Cock and Bottle Inn sign. Whilst the sign itself is not particularly old, both the unusual name and image have a long history which adds interest. Right: Old smithy opposite Fire Station Cottage, now used as a store. A pound was formerly attached to the gable on which the parish notice board is now located – see FIG. 6 above for map location.

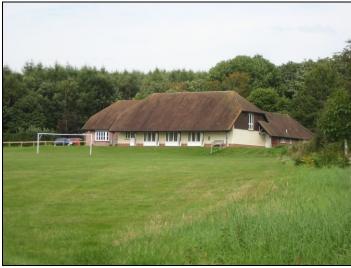
FIG. 9: Shrubbetts. Left: As shown on the 1900 OS. (Reproduced with the permission of the National Library of Scotland). The site is now occupied by woodland and a tin shed. The village hall (above) stands just to the south.

40. Until the 1970s a cluster of dwellings and structures marked 'Shrubbetts' on early OS maps existed roughly north of the current village hall (see FIG. 9 below). The 1900 OS shows a smithy, shown together with other buildings which the RCHM survey records as a seventeenth century cottage and barn, and eighteenth century cottage. None of these buildings now exists, the area now occupied by woodland and a semi-derelict tin shed.

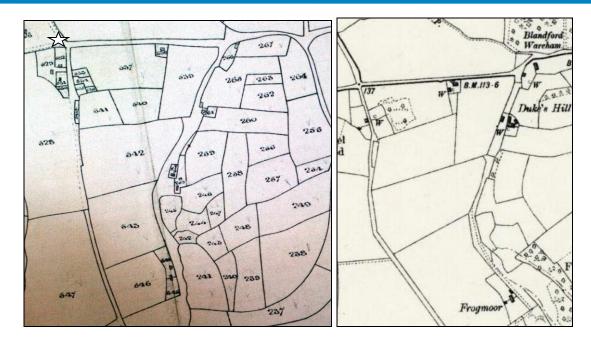
FIG. 10: Frogmoor and Hector's Corner. Note, Hector's Corner is the junction marked with a star. Left: 1847 tithe map. Right: 1900 OS. Only three of the dwellings shown in 1847 survive. The lane running to Frogmore remains a right of way but lacks enclosure south of Frogmore Farm. Maps reproduced with the permission of the National Library of Scotland.

- 41. Frogmore Farm, a building of eighteenth century date, today stands at the end of a short lane running south from Lousey Wood. Several dwellings historically stood on this lane which extended south to a pair of cottages labelled 'Frogmoor' on the 1900 OS (see FIG. 10 below). To the south of Frogmoor lay former common land, now a plantation of conifers. Two cottages located on the centre section of the lane disappeared during the second half of the nineteenth century, though the pair of eighteenth century cottages at Frogmoor, and another seventeenth century dwelling at the top of the lane survived long enough to be identified by the RCHM survey.

- 42. The cottages at Frogmoor and the top of the lane recorded in the 1970 survey were each subsequently demolished. The lane itself remains a right of way though is no longer fully enclosed south of Frogmore Farm. Most of the field boundaries shown in FIG. 10 no longer exist. The site of the two dwellings at Frogmore is currently a pheasant pen.

- 43. A cluster of three dwellings was shown at Hector's Corner in 1847 (see FIG. 10). Maps of 1760 show the cottages standing amidst common land, parts of which had only recently been enclosed at the time of the 1847 tithe. It is possible that the historic group at Hector's Corner may originally have been encroachments on the common (i.e. houses built on common land a traditional form of squatting). Two of these cottages had vanished by 1900, but the third still survives. Other dwellings now present here are of post-war date. The green lane running south survives as an enclosed route despite extensive loss of field boundaries elsewhere, and is a historic landscape feature of particular interest.

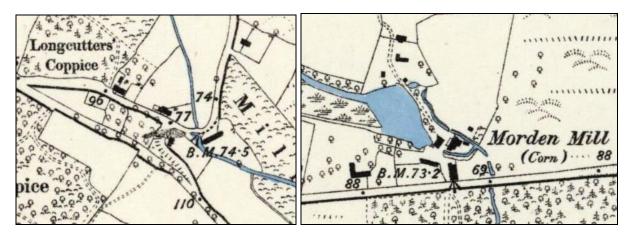
FIG. 13: Mills. Left: Ridgeway Mill and adjacent cottages shown on the 1887 OS map. Right: Morden Mill, adjacent cottages and buildings shown on the 1887 OS map. The mill and farmhouse are pictured in FIG. 14 below.

47. As noted above, Ridgeway Mill was recorded as early as 1550, and in 1887 stood amongst a cluster of cottages to the south of Whitefield (see FIG. 13 below). Post-war the scene was unchanged except for loss of the cottage east of the mill. The RCHM map recorded two surviving eighteenth cottages north and northwest of the mill, though the mill itself may have been lost by this time. Both cottages were also subsequently demolished and no traces remain of any buildings at this location.

buildings and their historically well-ordered context have slipped into decay. Of the other structures present in 1887 (see FIG. 13), only the stable range survives derelict.

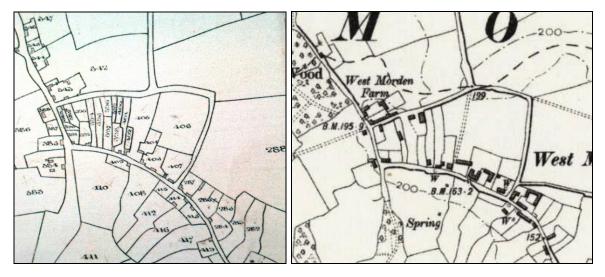
FIG. 15: West Morden. Left: 1847 tithe map showing little change since 1760s. Right: 1900 OS. Maps reproduced with the permission of the National Library of Scotland.

- 49. Buildings in West Morden which originated during the eighteenth century include No. 36 ('Wayside' FIG. 21), the large outbuilding at West Morden Farmhouse, No. 45, and King's Corner Farmhouse, though most of the latter is of nineteenth century date.
- 50. Comparing maps of the area between 1847 and 1900 (FIG. 15 below) there was some contraction in the number of dwellings, four cottages disappearing from the west side of the hamlet: one south of No. 43, one west of No. 36 and a couple north of West Morden Farm. Other notable changes included the construction of farm buildings at King's Corner Farm and opposite West Morden Farm.

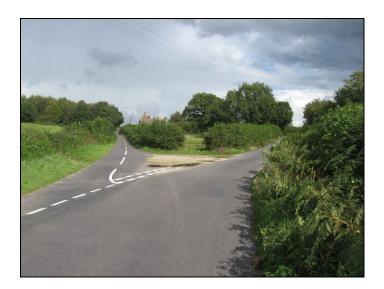
FIG. 16. Junction. Heading away from Whitefield the road splits left to West Morden, right to East Morden, the routes forming two sides of a triangular piece of former common land. Continuing right, Hector's Corner is located at the crossroad whose northern branch forms the third side of the triangle.

- 56. Within the network of lanes junctions are necessarily frequent features. Some of these, such as Hector's Corner and Firestation Corner, are specifically named. The broad junction at the north end of Whitefield is shown in FIG. 16 below.

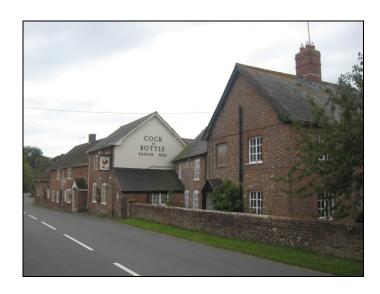
FIG. 17: East Morden building frontage. This is one of only two continuously developed frontages in the conservation area. Variation in building form, orientation and height here provides visual interest.

36. Amongst extant historic buildings, Sticklands Farmhouse (see FIG. 21) was an architecturally distinguished addition of the eighteenth century. The Cock and Bottle Inn (see FIG. 17) – labelled as such on the 1900 OS – and No. 90 also originated during this period. Notable nineteenth century additions included the school and school house (see FIG. 35), old fire station and smithy (FIG. 7 below), and Merraway (originally known as Morden Villa), which bears some architectural similarity with Church Villa (see FIG. 22).

64. The orientation of buildings relative to the street again varies, adding visual interest and variety where differences occur in close proximity (for examples see FIGs. 17 and 22). Historic dwellings standing in isolation or scattered amongst the fields typically adopt an independent orientation, though it is noted that a south facing aspect is favoured by a number of such dwellings in the central part of the conservation area. Elsewhere, though it is most common for buildings to be positioned parallel to and facing the street, many exceptions occur. These include No. 48 West Morden and a number of buildings adjacent to the Cock and Bottle where a perpendicular orientation occurs, and King's Corner Farm where the house backs directly onto the road.

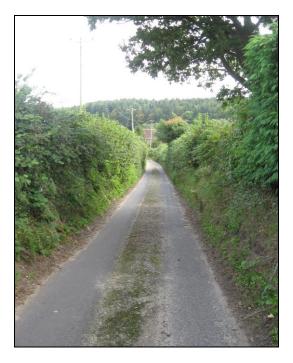
FIG. 19: Hedges. Below: fragments of a hedge at Whitefield. Some field boundaries are in a similar condition. Right: hedges contribute to the heavily enclosed feel of Gallop's Lane.

- 67. Hedgerows play an important role in defining field boundaries along lane edges, and make a particularly notable contribution to character where narrow lanes are slightly sunken below the level of adjacent land. Along parts of New Lane and Gallop's Lane this provides a heavily enclosed feel to the road (see FIG. 19 below).

- 68. Within fields themselves a few notable hedges exist, such as that running between Shrubbetts and New Lane. Compared to the boundaries shown on old maps however the number of hedges appears to have been substantially reduced, and there are surprisingly few hedgerow trees. There is no evidence of traditional hedgerow management anywhere in the conservation area, and this has resulted in progressive thinning and generally poor condition particularly where also heavily flailed (see FIG. 19 below). Continuing to treat hedges this way may lead to their eventual loss.

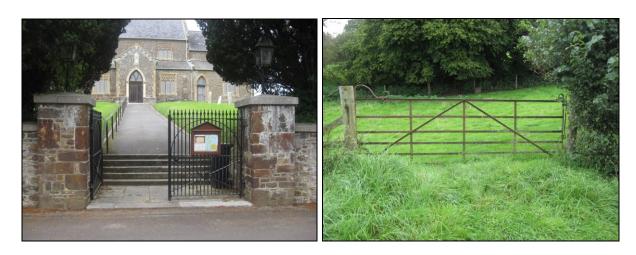
FIG. 20: Gates. Left: the entrance gateway to the parish church. Note the lanterns either side. Right: a typical estate gate. Numerous examples of this design can be seen around the conservation area.

69. Gates are typically used to close field accesses. The use of particular design of iron estate gate, numerous examples of which can be seen around the conservation area (see FIG. 20 below), is a distinctive local feature. The condition of these gates varies, many remaining in use, others overgrown. Most would benefit from a protective coat of paint.

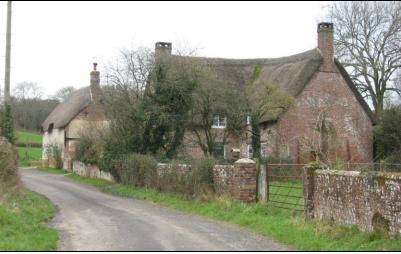
FIG. 21: Architectural variation. Left: Stickland's Farmhouse, the original part of which features a bold symmetrical frontage with high quality brickwork and detailing. Right: Paddock Cottage and No. 36 West Morden ('Wayside'), two vernacular structures showing possible variation in historic status.

- 71. Solid roofed brick cottages of the late eighteenth and nineteenth centuries appear more orderly in composition but generally 'plain' in appearance. Detailing is simple, and typified by segmented arches over openings, but is not consistent between buildings, indicating continued absence of formal design. Such buildings represent a later phase of the vernacular. A sense of formal 'style' is infrequent, the best examples being Stickland's Farmhouse (FIG. 21 below), a building of clearly high status, and remodelled elements of the Old Vicarage (FIG. 30). Nos. 149 (see FIG. 26) and 155 Whitefield also provide interesting examples of simple styling applied at a more modest scale.

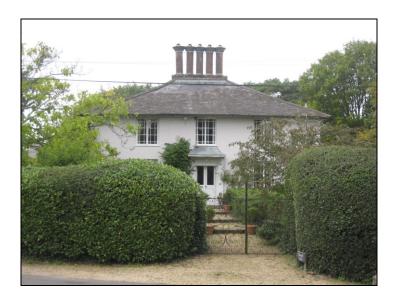
FIG. 22: Church Villa. This early nineteenth century building has an ornate Regency design. The chimney stacks are a particularly notable feature.

72. The conservation area contains two interesting examples of Regency design represented by Church Villa and Merraway, the latter originally named Morden Villa (see FIG. 22 below). Church Villa has a particularly distinctive appearance given its unusual chimney stack design, whilst both buildings feature a range of stylised components.

- 101. Window designs featuring margin lights are important stylistic elements in the designs of Church Villa and Merraway see FIG. 22). At Merraway these are also used in the porch, whilst the frontage additionally features an occulus.

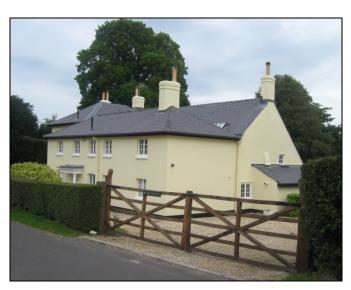
FIG. 30: The Old Vicarage, Higher Street. The roof of this building has recently been re-covered with Welsh slate. The original part of the property is to the rear and can be identified by the steeply pitched roof with catslide – similar to others within the conservation area. Clay tiles are likely to have covered the oldest part of the building originally, though slate would have suited the lower pitches used when enlarged during the nineteenth century.

82. As noted above, render provides the typical finish for cob. Render is otherwise provides a formal and stylistic finish to several other buildings – Church Villa, Merraway and the Old Vicarage (see FIG. 30).

86. Roof forms show some interesting variation (for examples see FIG. 29) which is sometimes, though not exclusively, related to the materials used as covering. This lends significant visual character to the street scene. Buildings with asymmetrical pitched roofs are unusually frequent, these commonly equipped with a rear catslide roof. The latter can be seen on the original part of the Old Vicarage in Morden (see FIG. 30), at Brickfield Farm, Church Cottage and No. 165 (see FIG. 29).

91. Slate is most typically a feature of nineteenth century buildings within the conservation area, reflecting in part the period in which distribution from North Wales was facilitated by growth of the railways. The best examples of slate roofed buildings are the parish church (FIG. 1) and old school (FIG. 35). In some cases slate may have replaced earlier roof coverings or superseded them when modifications were undertaken. This was the case for example at Home Farm in Higher Street, and is likely to have also been the case at the Old Vicarage (FIG. 30 below) and No. 74 Higher Street (FIG. 29 above). The Old Vicarage has recently had its attractive covering of distinctively coloured heather blue Penryhn slate renewed.

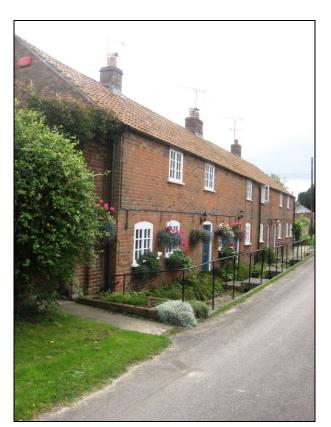
FIG. 31: Double Roman tiles. As seen on the roofs of Nos. 64-67 Higher Street (left), a building at Hill Farm (top right) and the Old Post Office Higher Street (bottom right).

- 96. More unusually double Roman tiles find historic use in a domestic context around the conservation area. This is most notably seen along Higher Street where Nos. 64-67 and the Old Post Office (FIG. 31 above) are fully roofed by the tiles. At the latter an ornamental crested ridge tile is also used. Past domestic use elsewhere is more restrained including use to roof the rear wing of No. 90 Gallop's Lane and a side extension of Orchard Cottage.

- The Old Post Office, Higher Street. (see FIG. 31) An architecturally attractive historic building which occupies a prominent position on Higher Street and makes a strongly positive contribution to the street scene.

- War memorial, Higher Street. (see FIG. 36 above). The war memorial is a modest structure of great local importance. Not currently listed.
- 64-67 Higher Street. (see FIG. 31). An attractive row of nineteenth century brick cottages.

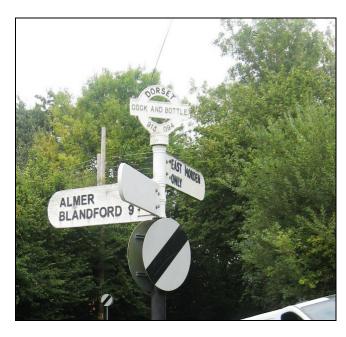
FIG. 32: Street furniture. Left: Pillar box in West Morden. The Victorian box is fitted into the wall of an agricultural building at King's Corner Farm. Note the chequered Flemish bond brickwork using red stretchers and blue headers. Right: Finger post at the Cock and Bottle. Two fingers have clearly been replaced, but it retains its original roundel which records the location. The appearance of the post is spoiled by the speed sign attached below. Surprisingly the speed limit here is 60 mph.

104. Three finger posts are located in the conservation area. That adjacent to the Cock and Bottle (FIG. 32 below) is in good condition and retains its distinctive roundel. That adjacent to the old school (see FIG. 37) is in poor condition and has lost its roundel, though retains its historic cast lettering. Old maps record presence of a milestone on the site, though this appears to have been removed. A third finger post at the junction of the B3075 with the roads to East Morden and West Morden is in reasonable condition though lacks a roundel and appears to have lost some of its pointers. The roundel from a fourth finger post at Morden park Corner is now awkwardly mounted on top of a modern highways sign adjacent to the junction.

- 105. Rectangular wall mounted posting boxes occur at a number of locations. Three periods are represented: the cipher of Queen Victoria on the box at West Morden in the wall of a building associated with King's Corner Farm, of George VI in a free standing brick pillar at Firestation Corner, and of Elizabeth II in a freestanding brick pillar on Higher Street. As the building at West Morden is listed this protection also extends to the post box.

- Fingerposts (see FIGs. 32 and 38). Locally distinctive items of Dorset street furniture widely installed during the 1920s and 1930s.
- Old agricultural buildings including those at Sellars Farm, to the east of Coppins, opposite Orchard Cottage (FIG. 37), Hill Farm (FIG. 31), and the old smithy building in East Morden (FIG. 7). These functional buildings of largely nineteenth century date make a strong contribution to the historic rural character of the conservation area

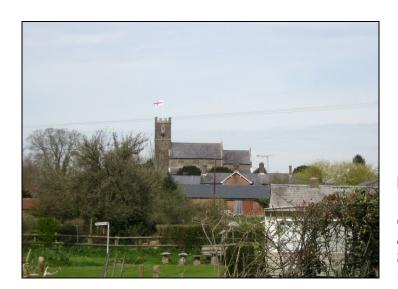
FIG. 34: The parish church viewed from the south. The church towers over buildings below which gradually rise up the slope. Note intrusion by wires

- 120. The elevated site of the parish church lends it localised prominence in Morden (see cover photo and FIG. 34 below). The church is the principal focus of views from the south and east (see view from Cockett Hill on the front cover) to a point at which the ground again rises abruptly to reach a similar level. In other directions a more immediate rise in ground level greatly reduces visibility, though a good view does exist from Morden Drove. The churchyard itself provides good views to the south.

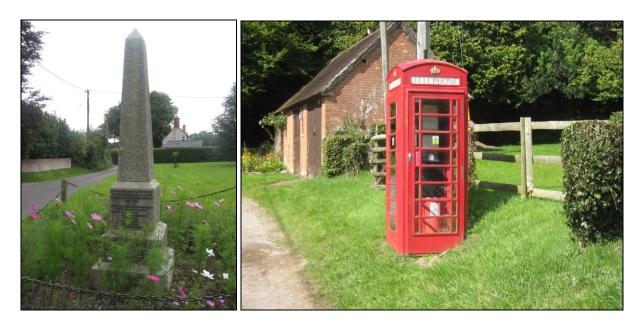
FIG. 36. War memorial in Higher Street, and telephone kiosk at Whitefield.

- K6 phone boxes at Fire Station Corner, Higher Street and Whitefield. (see FIG. 36 below). These are classic townscape features. As noted above, all are 'jubilee' models typically installed 1935-52.

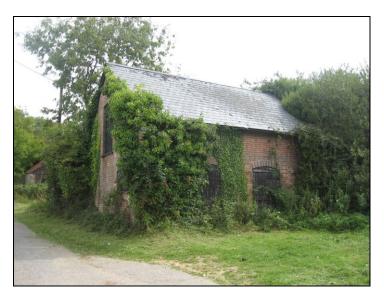
FIG. 37: General neglect. A range of structures within the conservation area show signs of general neglect. Top left: overgrown building opposite Orchard Cottage. Top right: ivy clad obelisk in the parish churchyard. Bottom: barn at West Morden Dairy.

124. A range of unlisted 'positive' structures within the conservation area are observed to be in poor condition. This appears to be principally a result of neglect, often arising from disuse. Some of these structures, such as the derelict tin sheds north of the village hall, are of limited interest, whilst others such make a contribution to local character and interest that could be enhanced by their renovation. Examples are provided in FIG. 37 below.
