There are over 60 listed cob buildings in East Dorset, but many more 'curtilage' buildings, unlisted buildings and cob walls. From time to time the Council receives requests from owners of cob structures seeking advice on how to look after them. This booklet summarises the main causes of cob failure and common techniques of repair. Importantly, it lists where local specialist expertise can be sought.

Cob Walling

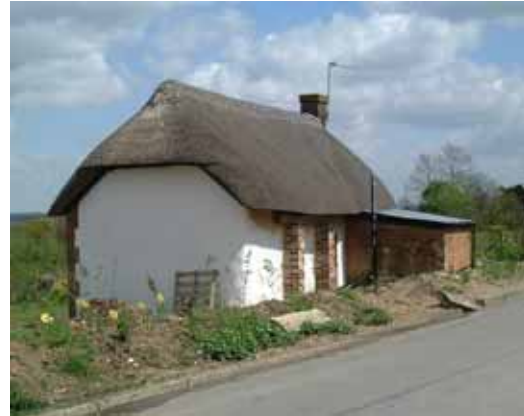
19th c plastered cob cottage.

Corners of buildings tend to be rounded. Traditionally, the walls are faced with smooth lime-based render (lime and river sand with animal hair added) for weather protection and lime-washed or painted off-white. Coloured walls are not characteristic of East Dorset.

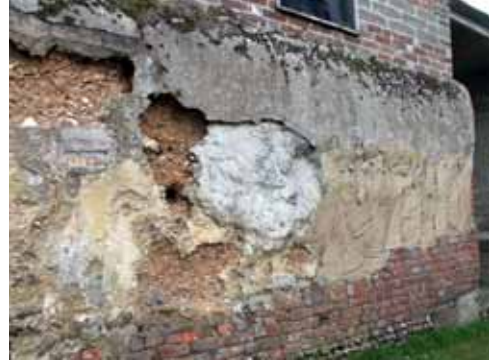
Erosion of cob made worse by crude attempts to patch up. Free-standing cob walls are particularly susceptible to neglect.
