Land at Christy's Lane, Shaftesbury

Flood Risk Assessment

Project No.	1552
Revision	B
Date	17 th August 2023
Client	Planning Issues Ltd
Prepared	O Clarke
Checked	L Blackmore
Authorised	C Yalden
File Ref.	p:\1552 land at christy's lane, shaftesbury \c documents\reports\1552 - land at christy's lane, shaftesbury - flood risk assessment.docx

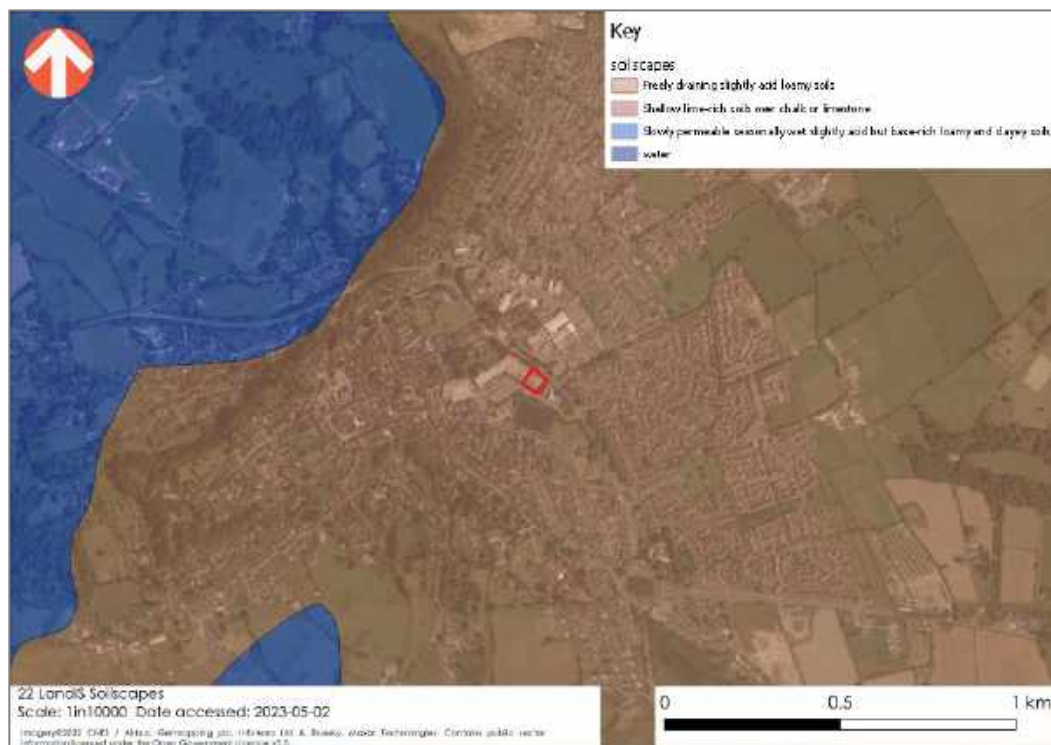
Figure 2.3 – Soilscape mapping

- 2.15 The site is located within an area with soils described by the Soilscape dataset as “freely draining slightly acid loamy soils” as seen in Figure 2.3.

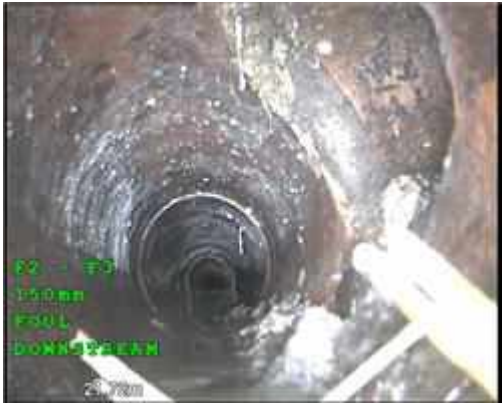
Pos	Video Ref	Code	Description	Image
21.70m	0:03:18	CN	Connection other than junction at 02 o'clock: 100mm Diameter	Image Provided - Ref: 1_13

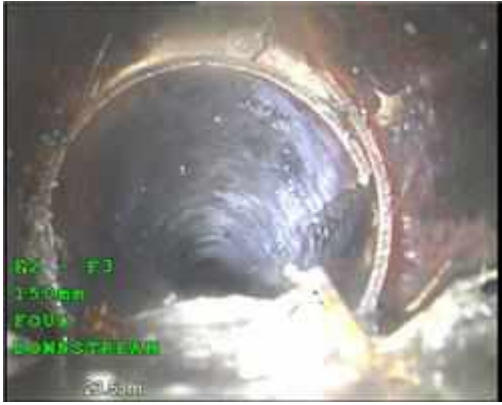
22.00m	0:03:23	DES	Settled deposits fine: 10% Cross sectional area loss - Severity 3	
22.20m	0:03:32	WL	Water level: 10% Height/Diameter	
22.50m	0:03:32	WL	Water level: 20% Height/Diameter	
23.14m	0:03:36	RJ	Roots at joint - Severity 3 FINE ROOTS AT JOINT	
23.60m	0:03:46	FL	Fracture longitudinal at 03 o'clock - Severity 3	Image Provided - Ref: 1_18
