Wareham Historic Urban Character Area 4 The Town Walls

Wareham Historic Urban Character Area 4 Structure of Character Area

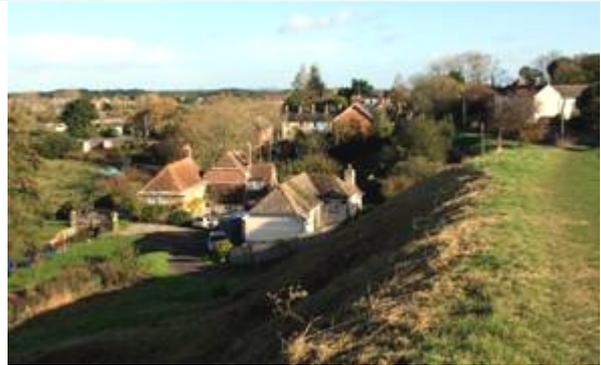
Figure 85: North Mill viewed from the North Walls..

There are very few buildings in this area. The oldest structure is North Mill dating from the 17th century with a 19th century extension forming an L- shaped plan. Westport Cottages are a short terrace of early 19th century houses. Belle Vue is a typical late Victorian detached suburban villa built in 1885. The Town Pound is a square walled structure with an entrance in the north-west wall.

North Mill House is built in a mixture of brick and stone rubble with a hipped tile roof with stone easing course. Westport Cottages are rendered with tile roofs. The Town Pound has brick walls.
