## INTRODUCTION

## THE PROCESS

### Stage 1 – assessment against Neighbourhood Plan objectives

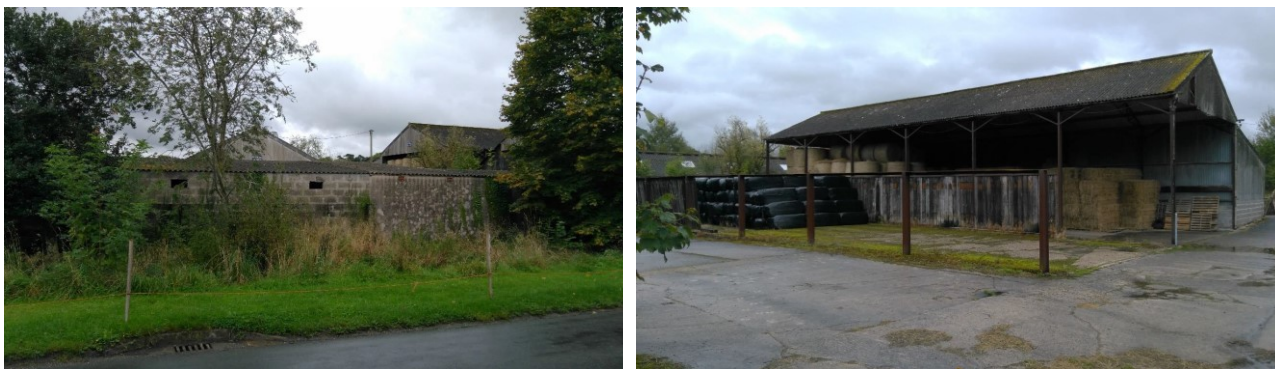
## Site 2: Church Farm Barns

Observations: Existing farmyard (in active use) with large, open farm buildings of no intrinsic architectural or historic merit on relatively level site. Adjoining farmland, with residential properties to north-east and across road to north-west. Site size (entire area): 0.39ha

Observations: Just outside existing 30mph zone. Existing vehicular access appears fine, but there is no pavement into the village from this site. Area outside school can be busy at school pick-up / drop-off times.

Observations: Rural agricultural character. Large open ditch and occasional trees running along road frontage. No other notable features. Farm buildings do not contribute significantly to landscape character – potential for visual enhancement. Farm buildings may provide possible bat / bird roosts.

Observations: Large open ditch running along road frontage. Brownfield site – although no specific risks identified there may be contamination from slurry and other agricultural processes.

DCC FRM comments: the site is shown by relevant mapping to be at significant (theoretical) risk of surface water flooding, with the received flow running through the site towards the north-east and Motcombe Stream. Any redevelopment proposals would need to consider both the prevailing risk of received surface water, and the management of surface water runoff generated by the site.

- Manage surface water flows to reduce possible flood risk – to be determined through detailed flood risk assessment
- Secure relocation of farmyard uses to acceptable alternative site (unless current site is redundant)
- Secure biodiversity gains – to be determined through biodiversity mitigation and appraisal plan
- Landscape planting scheme to provide suitable soft edge to the adjoining former orchard and enhance character of streamside ditch
- Replacement buildings to be of reduced height and bulk (ie more domestic scale) with sensitive forms and materials appropriate to village edge character
- Provision of footway / improved pedestrian safety to school
- Contamination checks during build phase

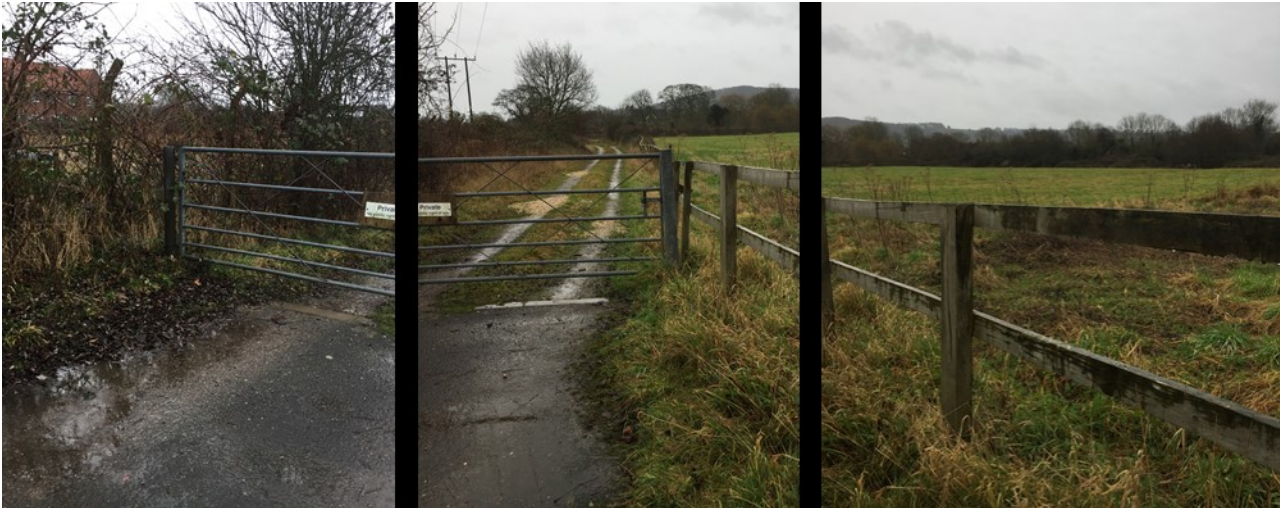
### Site 13: Shorts Green Farm, The Street

Observations: relatively flat pasture, adjoining mainly residential areas, watercourse and lane to south with links through the farmland (to north-east) and to Motcombe Meadows (across road to west).

Observations: Existing vehicular access off The Street. Pavement only on west side of road at this point.

Observations: Stream and related vegetation along southern edge. Woody hedgerows along site boundaries. No other notable features.

Observations: Stream runs along southern edge

DCC FRM comments: the site is shown by relevant mapping to be at significant (theoretical) risk of surface water flooding, with the received flow running through the site towards the watercourse along the south and west boundaries. Any redevelopment proposals would need to consider both the prevailing risk of received surface water, and the management of surface water runoff generated by the site.

- Manage surface water flows to reduce possible flood risk – to be determined through detailed flood risk assessment
- Secure biodiversity gains – to be determined through biodiversity mitigation and appraisal plan
- Landscape planting scheme to retain / reinforce hedgerow boundaries and enhance character of stream
- Provision of footway along east side of the Street

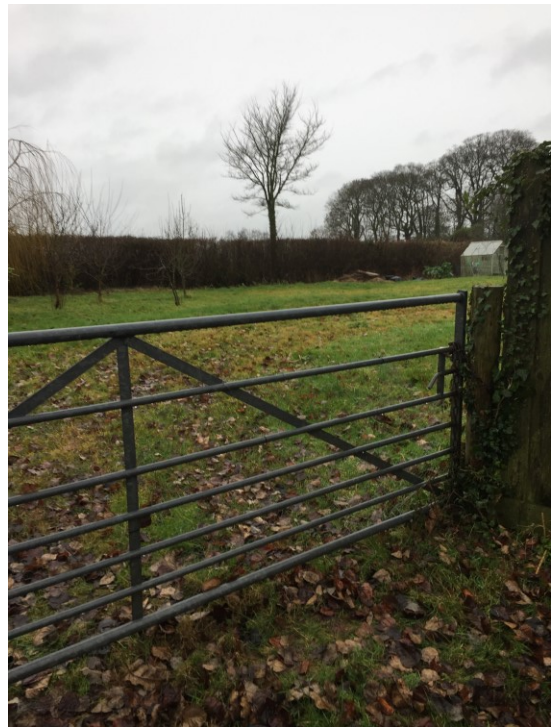
## Site 19: Garden at Sunset Ridge

Observations: Garden / paddock area adjacent to residential property. Broadly level site adjoining housing to east side, farmland to rear and west. Noted that planning decision 2/2017/0472 suggests the site remains outside the residential curtilage.

Observations: Existing vehicular access off Elm Hill. No pavements at this point.

Observations: No notable features. Impact on heritage assets considered likely to be similar to site 20/21

Observations: Small site on high ground – no risks identified from current use.

DCC FRM comments: The site is not shown to be at risk of flooding. However any development proposals would need to consider the management of surface water runoff generated by the site.

- Retain and strengthen hedgerow boundaries to north and west.
- Improved vehicular access
- Provision of footway / improved pedestrian safety into village if feasible

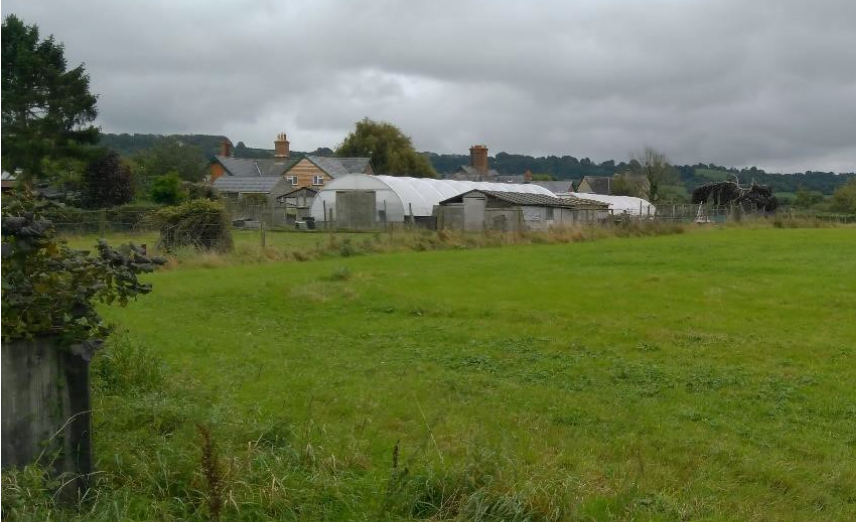
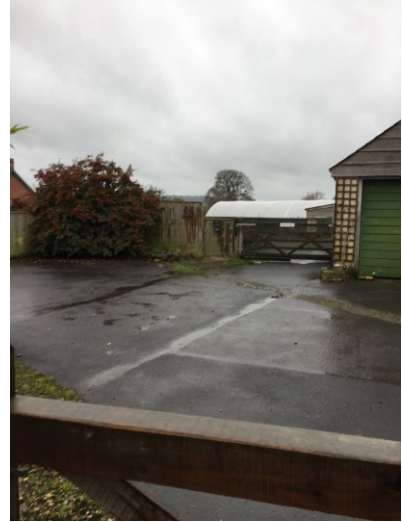
## Site 25: The Nursery (The Street)

Observations: former plant nursery with collection of nursery sheds / poly tunnels. Broadly level site adjoining (to rear of) housing to west side, farmland to east.

Observations: Existing vehicular access off The Street. Pavement along side of road at this point.

DCC comments: Need clarification that 2.4m by 43m visibility splays can be provided at the junction with The Street – may limit number of dwellings possible.

Observations: No notable features. Current buildings do not contribute to landscape character – potential for visual enhancement. Site visible from public bridleway to north-west.

Observations: Brownfield site – no risks identified from current use.

- Landscape planting scheme to eastern boundary
- Replacement buildings to be of reduced height and bulk (ie more domestic scale) with sensitive forms and materials appropriate to village edge character
- Due to the limited nature of the site, the scale, orientation and location of dwellings should avoid over-looking / overbearing impact on adjoining properties.

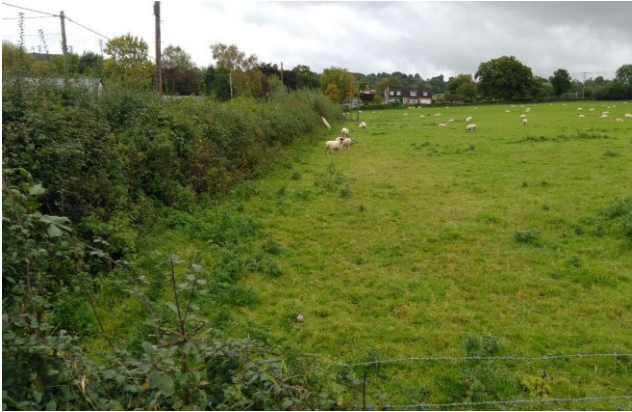
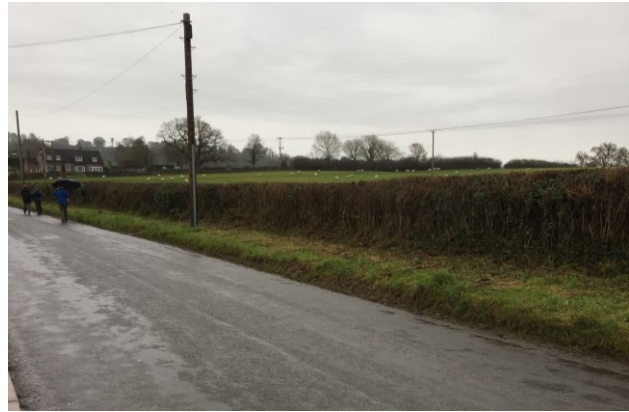
## Site 4: Beside Shire Meadows, Motcombe Rd

Observations: sloping pasture rising up away from road, open in character. Housing along road front to either side.

Observations: Two access points existing and potential to create other access points off Motcombe Road. No pavements alongside the road at this point.

DCC comments: Access can be formed to this site with adequate visibility splays. May need to allow for above 30mph approach speeds from the east? No footway link to settlement centre.

Observations: No notable features other than hedgerow boundaries. Pylons crossing middle of field. Site visible from footpath to east of site, which rises up to south giving wider views.

Observations: Boggy conditions along road frontage, especially at NW corner

DCC FRM comments: The site is not shown to be at (theoretical) risk of flooding, although the adjacent highway is thought to be at risk from surface water flooding during severe rainfall events (1:1000 year). Any development proposals would need to consider the management of surface water runoff generated by the site.

- Landscape planting scheme to southern boundary
- Designs to respect linear pattern of roadside development
- Secure biodiversity gains (particularly if hedgerow needs to be removed) – to be determined through biodiversity mitigation and appraisal plan
- Provision of footway / improved pedestrian safety into village

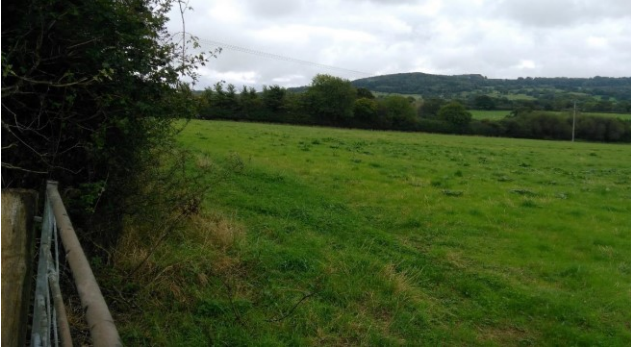
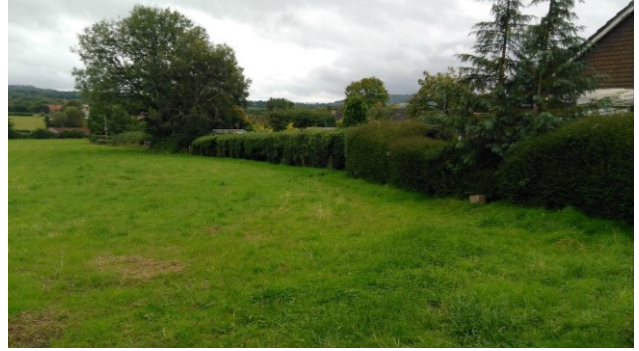
## Site 18: Elm Hill (SE) – land off Knapp Hill

Observations: site on higher ground with sloping pasture falling away from road, open and elevated in character. Housing opposite and to either side, farmland to rear.

Observations: Field gate close to junction with Elm Hill. No pavements alongside the road at this point. Safety concerns unless improved.

DCC comments: Access can be formed to this site with adequate visibility splays but will need to be sited away from the dwelling on the bend to achieve them. No footway link to settlement centre.

Observations: No notable features other than hedgerow boundaries.

Observations: No issues identified

- Landscape planting scheme to southern boundary
- Designs to respect linear pattern of roadside development
- Secure biodiversity gains (particularly if hedgerow needs to be removed) – to be determined through biodiversity mitigation and appraisal plan
- Improved vehicular access
- Provision of footway / improved pedestrian safety into village

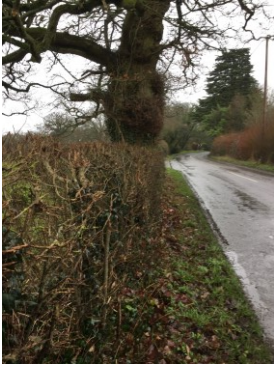
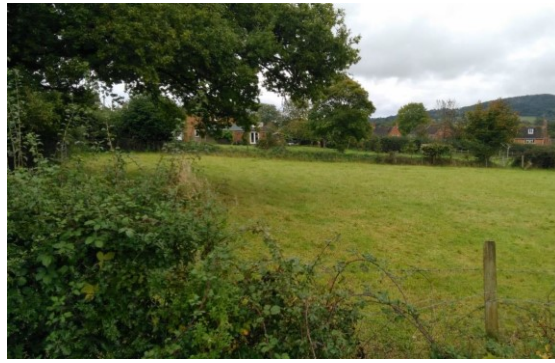
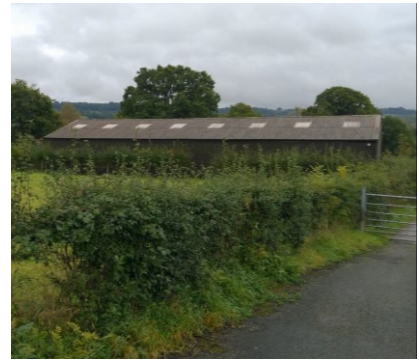
## Sites 20 and 21: Elm Hill (SW) - land west of Highfields

Observations: paddock and pasture on higher ground with a detached farm building lying within the site. Moderately open and elevated in character sloping gently away from road. More intimate character to fields achieved through subdivisions. Housing to east, farmland to remaining sides.

Observations: Existing vehicular access to barn, in proximity to sharp bend and junction. No pavements alongside the road at this point. Safety concerns unless improved.

DCC comments: Access can be formed to this site with adequate visibility splays. No footway link to settlement centre.

Observations: Mature (oak) trees within site and hedgerow boundaries. Site visible from public bridleway to west.

Heritage expert comments: East Coppleridge Farm (Grade II Listed) lies to the north of the site - a typical farmhouse with associated farm buildings falling within its immediate and close curtilage. Existing hedgerows provide comprehensive visual barriers particularly from the south, east and west. Also North of the allocations is the post-medieval/modern orchard immediately to the east of the farm (HER Number MD027906). To the east of the site allocations and now covered by properties within Elm Close is another entry on the Record (HER Number MDO27907) again a post medieval to modern (1800 AD? to 1950 AD) orchard. The farmhouse and adjacent orchard both are sufficiently divorced from the site allocation which together with existing screening and topography would not result in harm being caused.

- Landscape planting scheme to southern and eastern boundary
- Retention of mature deciduous trees.
- Secure biodiversity gains (particularly if any hedgerows need to be removed) – to be determined through biodiversity mitigation and appraisal plan
- Improved vehicular access
- Provision of footway / improved pedestrian safety into village
