# Shaftesbury

Agricultural		Domestic			Retail		Ecclesiastical	
MAP Reference	Co-Ordinates		Address				Parish	Survey
ST862222	E386364 N122297		Holyrood Farm, Watery Lane				Shaftesbury	19/09/13
SURVEYOR	BOA	RS	CA	Grade	Windows	Roofing	WM	SR
MRW/DJC	2	3	No	II	Casement	Interlocked tile	Brick/stone	4*

## Description:

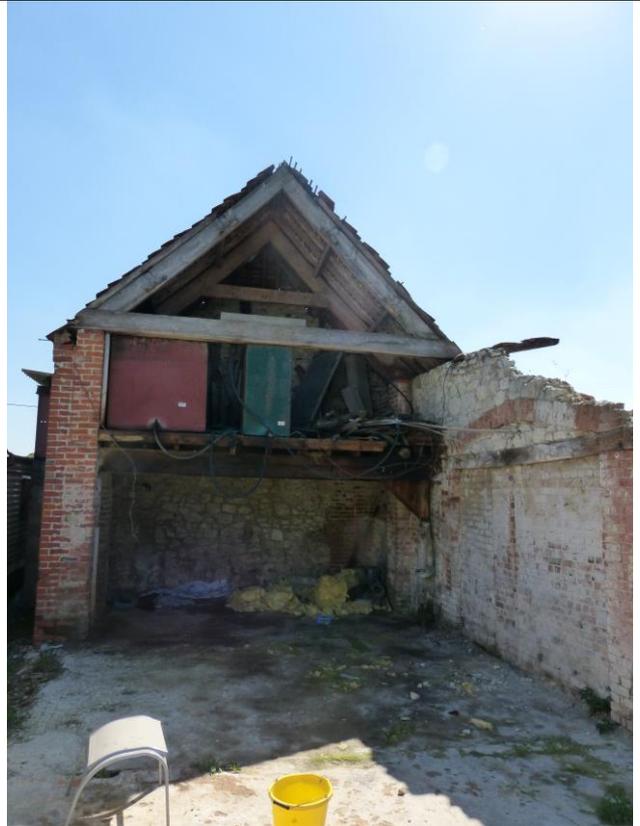
*Roof:* Some clay tiles left on barn (extremely poor).

*Walling:* Extremely poor (barn). Walls on farmhouse show signs of movement (poor).

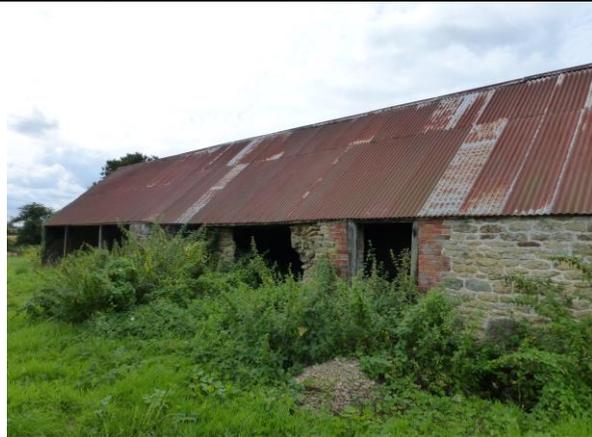
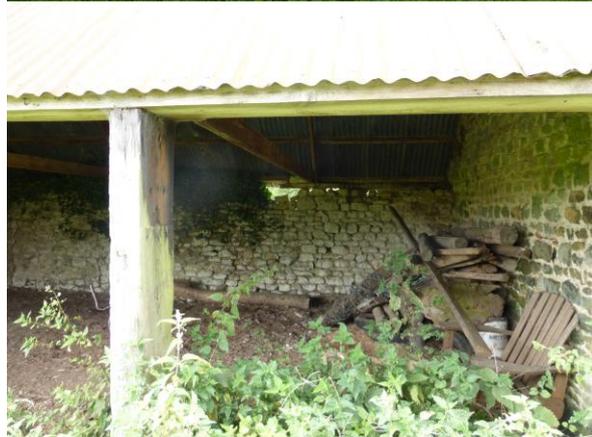
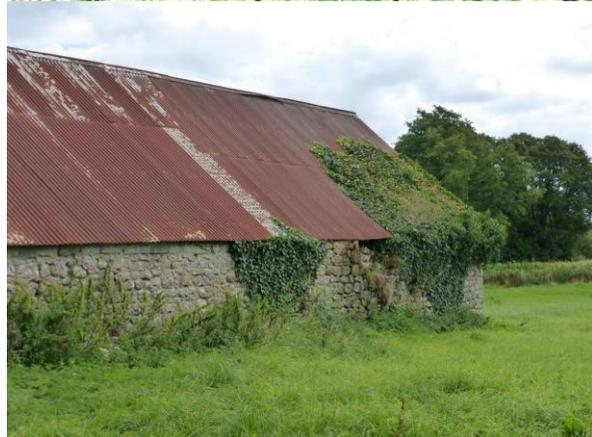
*Pointing:* Poor

*Joinery:* Roofing timbers good.

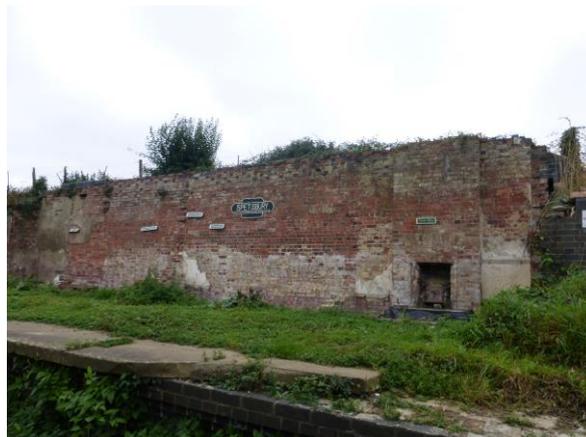
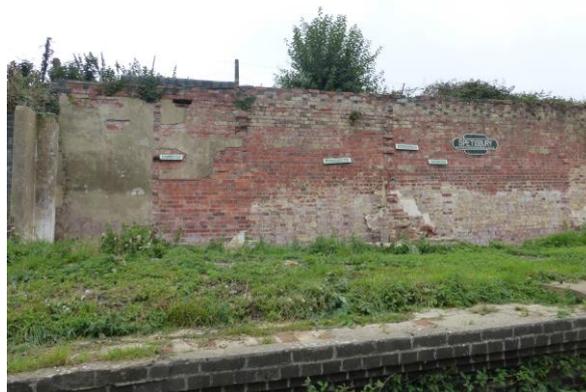
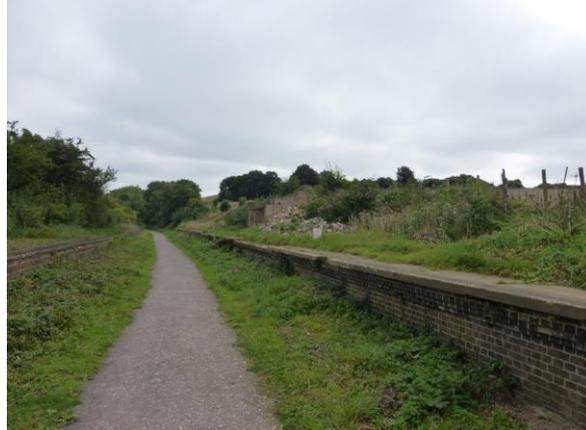
*Pointing:* Very poor

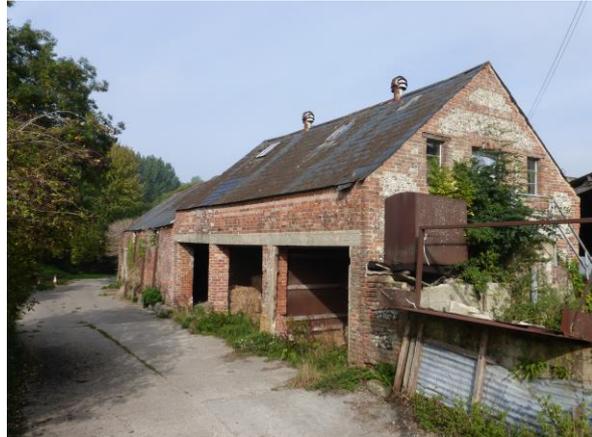
*Pointing:* Significant mortar loss – vegetation growth between the bricks

*Joinery:* Poor throughout

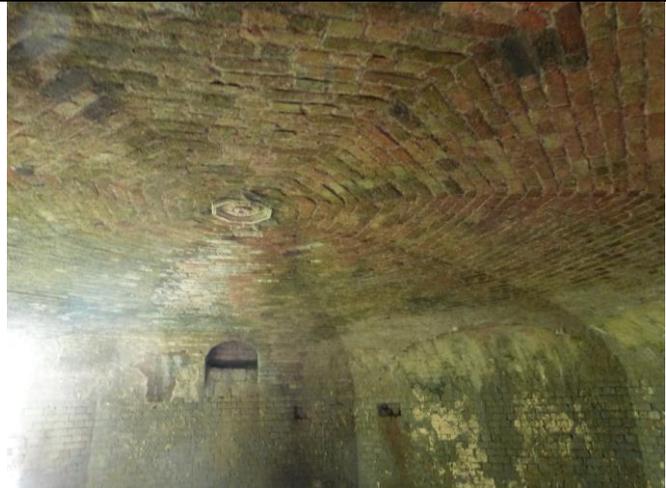
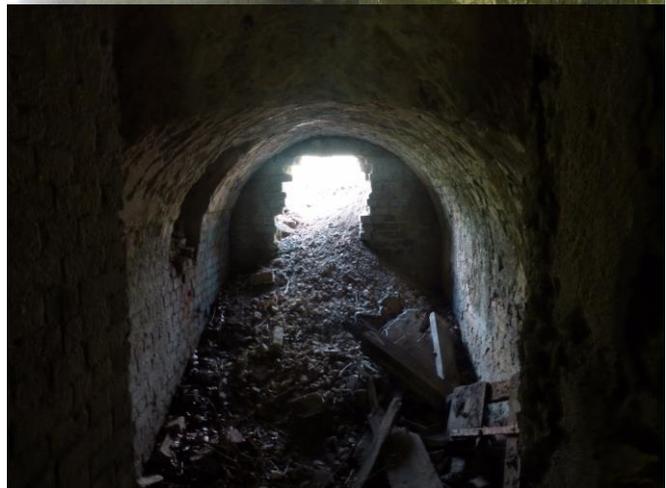
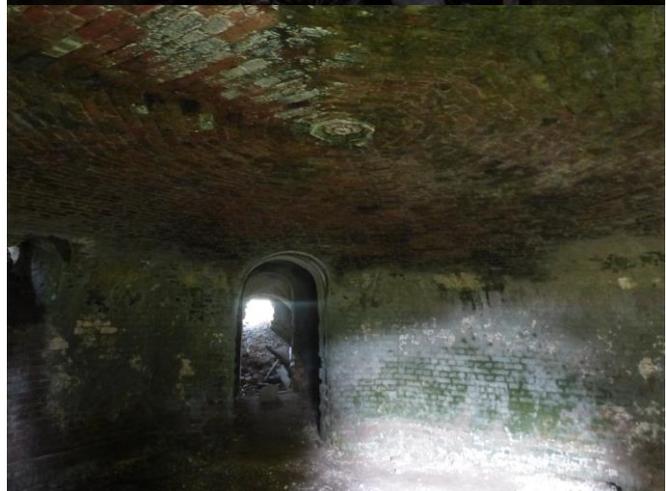
*Roof:* Unknown

*Walling:* Brick and render

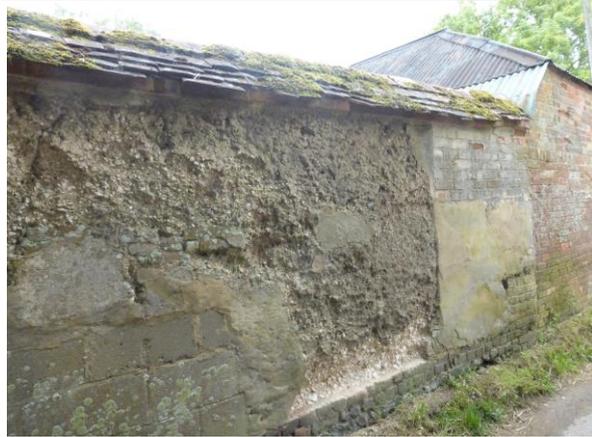
*Walling:* Cob with brick plinth. Significant loss of fabric and some recent vehicle damage (poor).

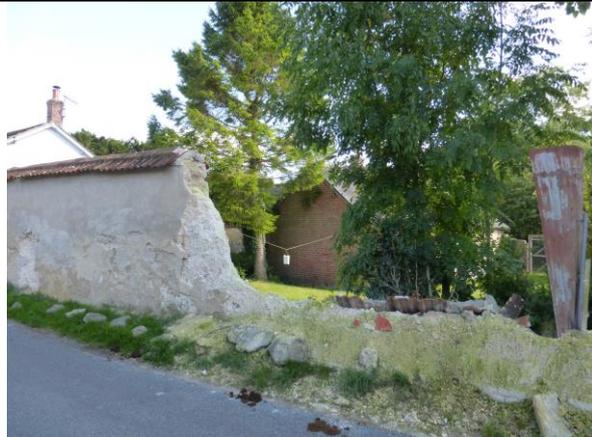
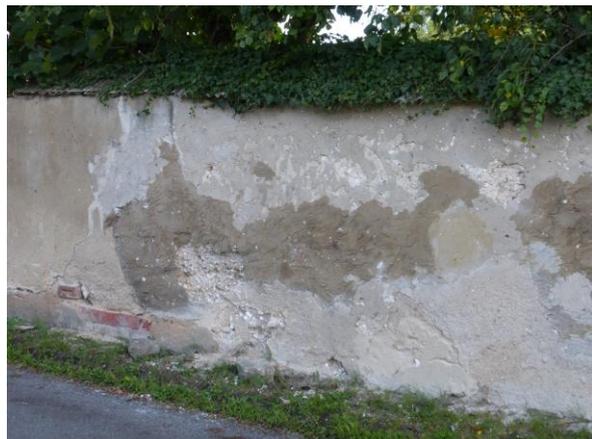
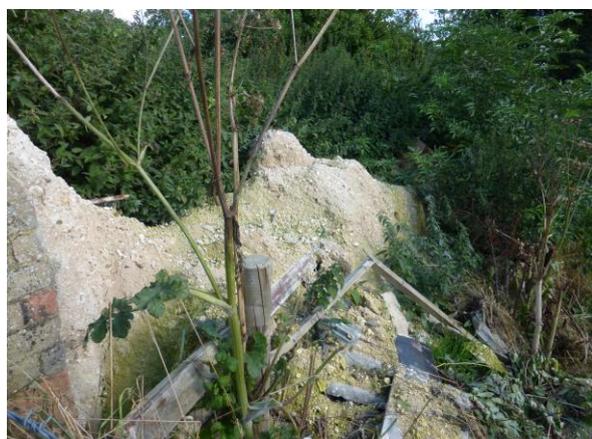
*Walling:* Very poor with sections on the road and field side collapsed completely. Significant loss of render and cracks on the standing wall. Some evidence of remedial work with cement but will not prevent further inevitable damage. Potential hazard.

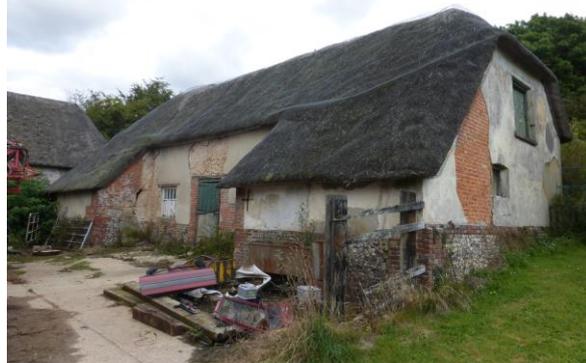
*Pointing:* Fair

*Joinery:* Very poor.
