Christchurch Bay and Harbour Flood and
Coastal Erosion Risk Management Study
**Technical Annex 7: Condition Assessment & Beach Profile
Analysis**

Prepared by
New Forest District Council

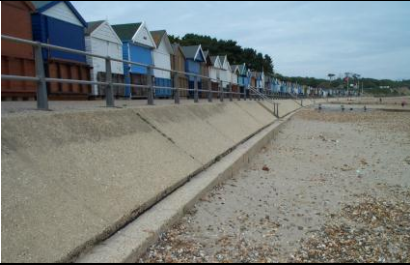
Plate C2.2 Looking northeast, view of concrete seawall on Avon Beach

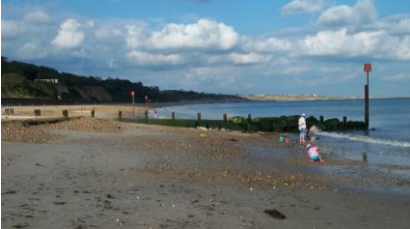
Plate C2.2 Looking east, view of wooden groyne on Avon Beach

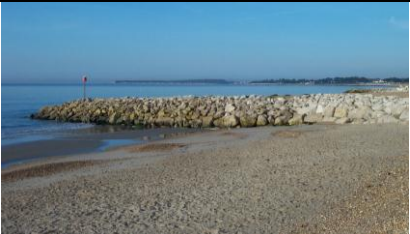
Plate C2.3 Looking west, view of rock strong point on Highcliffe Beach

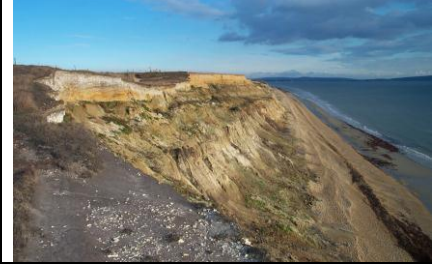
<p>Plate C5.1 Looking east, view of undefended frontage at Becton, east of Strong Point 25 at Barton-on-Sea</p>

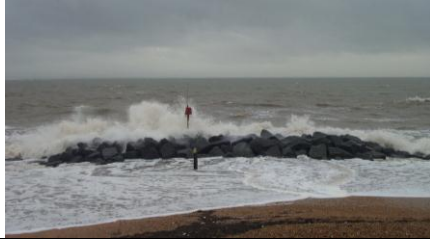
Plate C7.1 Looking west, view of offshore rock breakwater, Hurst Spit
